Attachment A

Location Plan and Site Photos

Cooper Street and Adelaide Street Reserves, Surry Hills

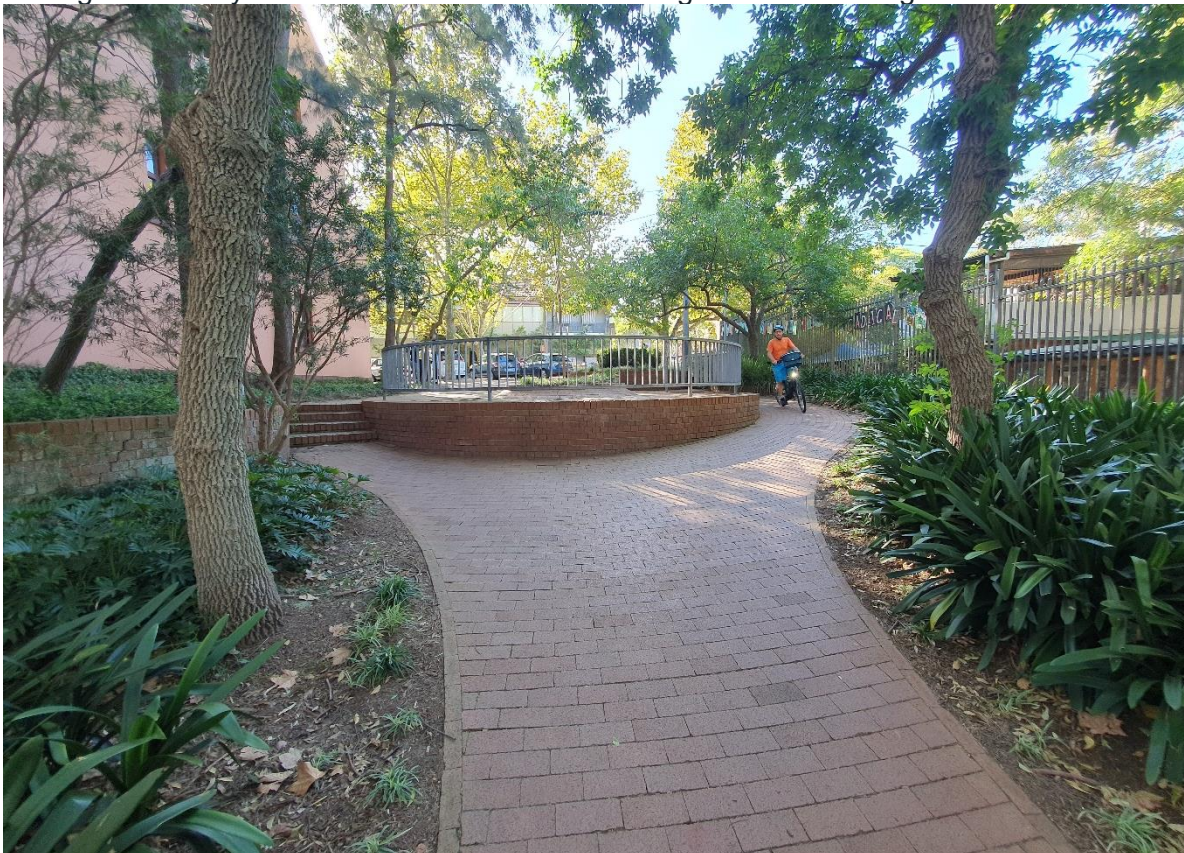
Upper Cooper - Looking east towards Riley Street from Cooper Street. The balustrade and walls act as visual and physical barrier. Planting is looking tired. Mature trees flank the reserve. Steep level change across the site visible.
