# **Attachment A**

**Location Plan and Site Photos**

# Cooper Street and Adelaide Street Reserves, Surry Hills

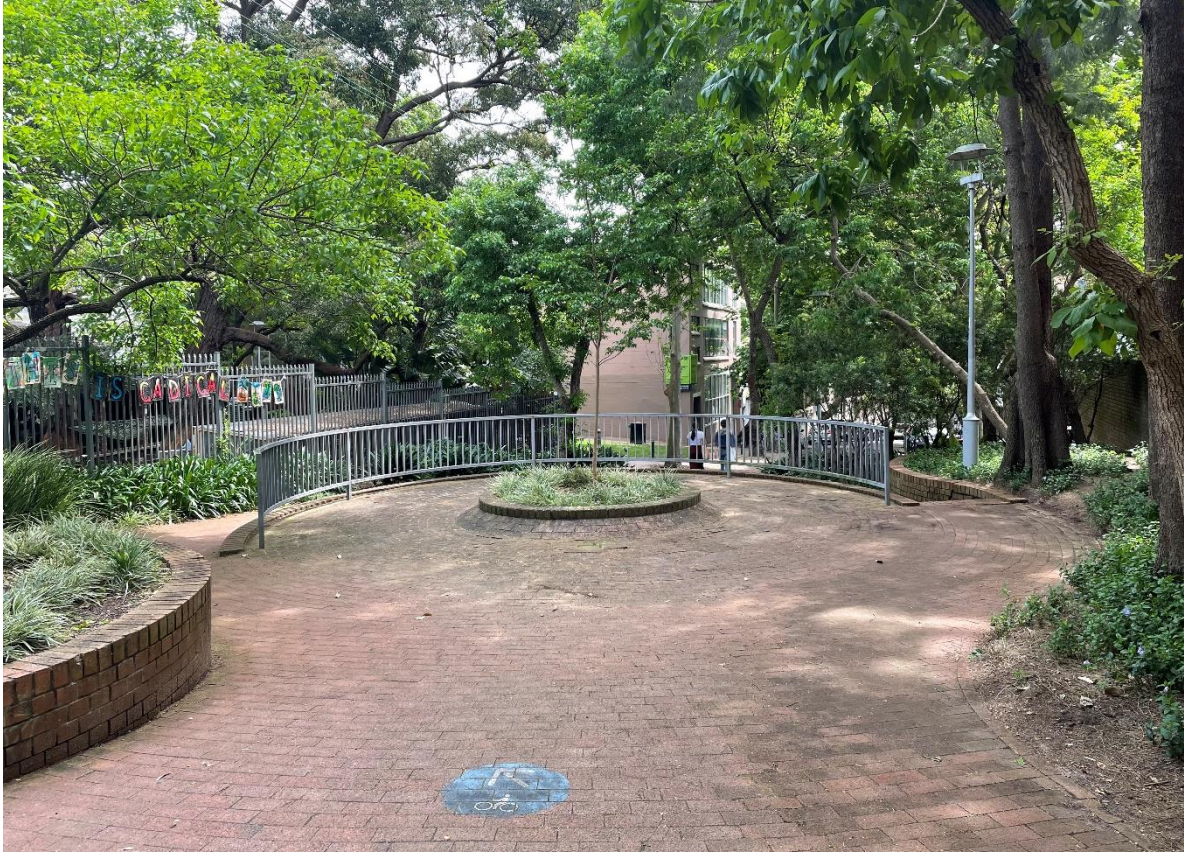
Upper Cooper - Looking west towards Cooper St from Riley St. Layout of pathways & barriers confusing for users. Cyclists have created an unsafe desire line through the planting. A small “low value” tree is in the centre of the unused plaza with no seating. End of life lighting visible amongst the many mature shade trees. The retaining walls are damaged due to tree roots.

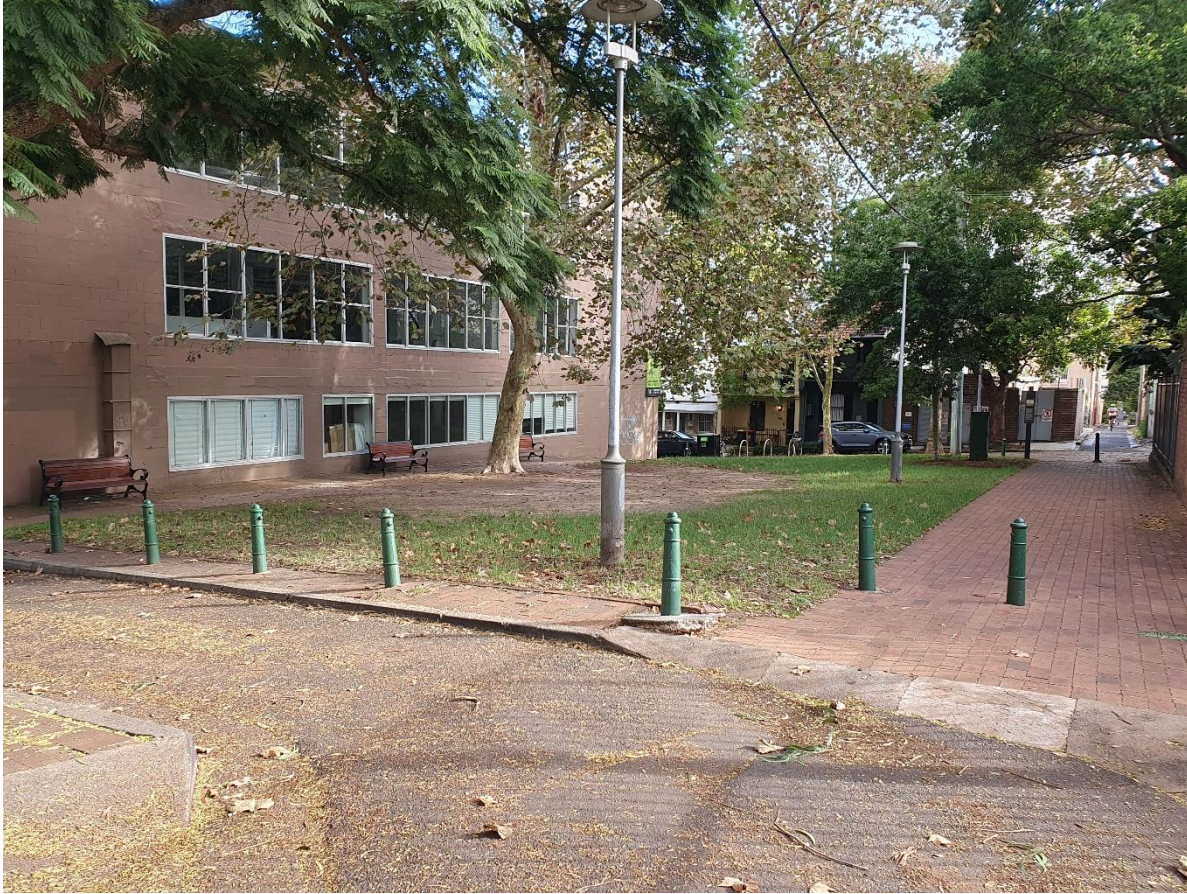
Lower Cooper – Looking north to Cooper Street. The turf is heavily worn out under the canopy of both the existing mature trees. Paths are in a good condition with some tree root lifted paving around the Plane tree. One bollard is dislodged. Existing benches are in good condition. Lighting is at end of life.

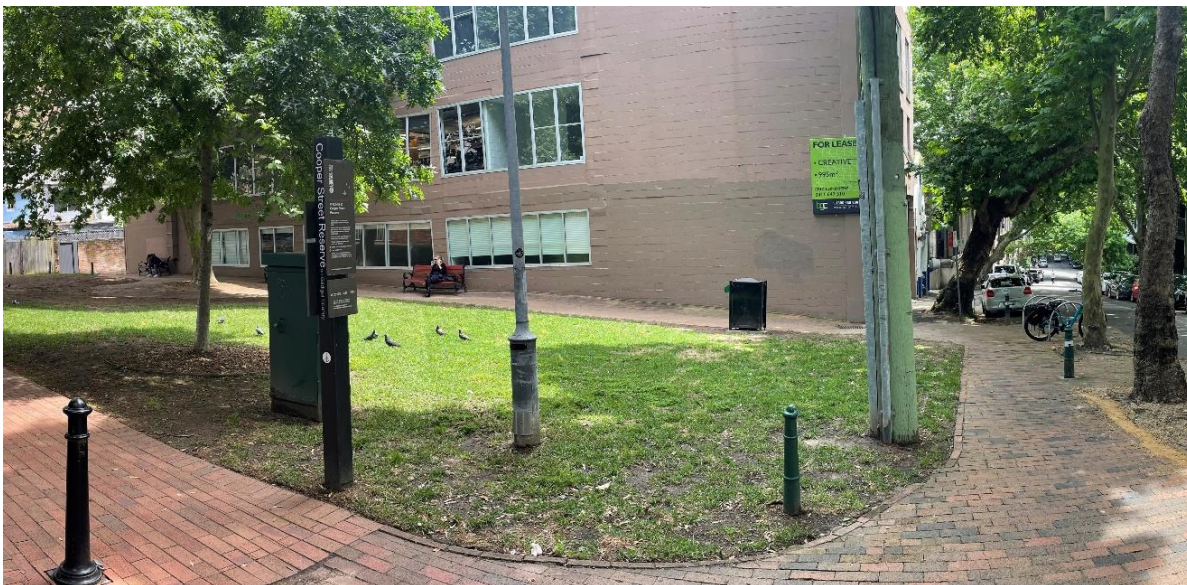
Lower Cooper - Looking southwest. The turf is worn out on the corners due to pedestrian movements. Footpath along Cooper Street is narrow and obstructed by the turf. Lots of vertical fixtures cluttering this view.

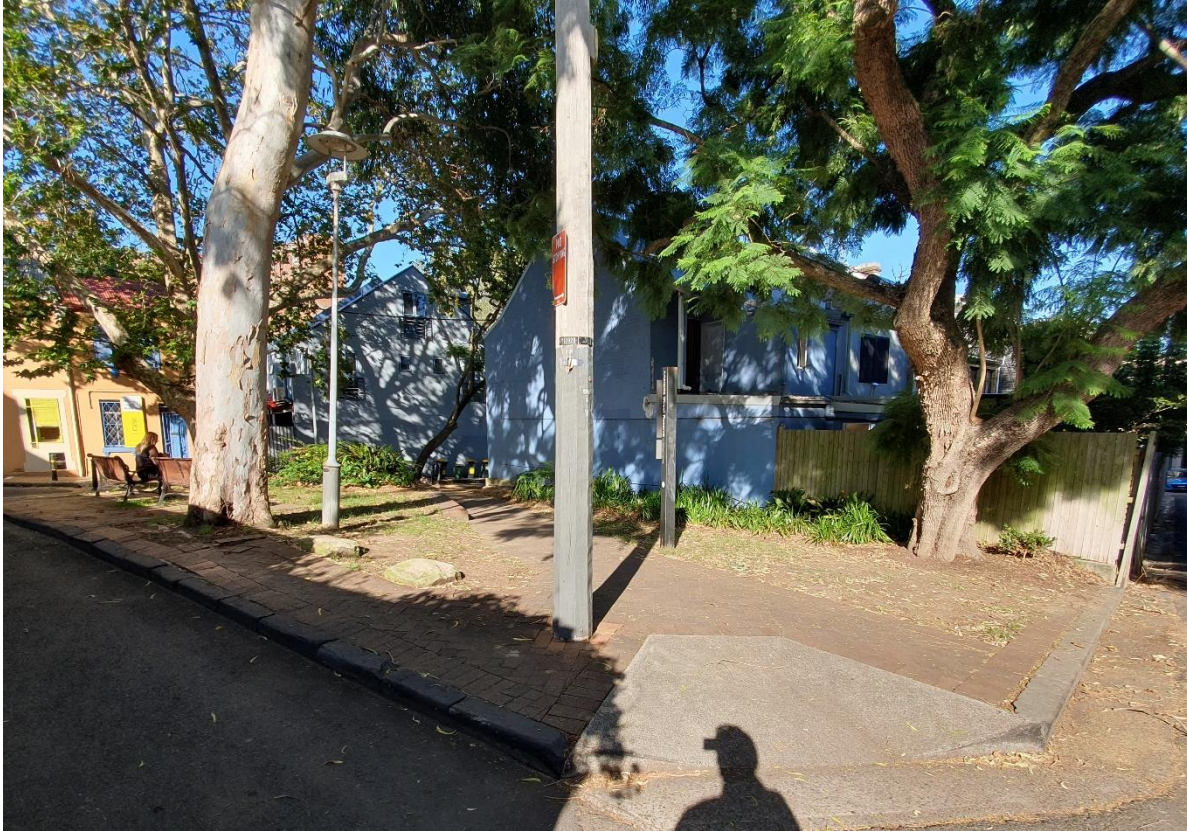
Adelaide Street Reserve – looking southwest towards Adelaide Street from Little Riley Street. Turf is in poor condition due to pedestrian traffic and shade from mature existing trees. Paths are in a good condition with some tree root lifted paving around Eucalyptus tree. End of life lighting and signage is visible.

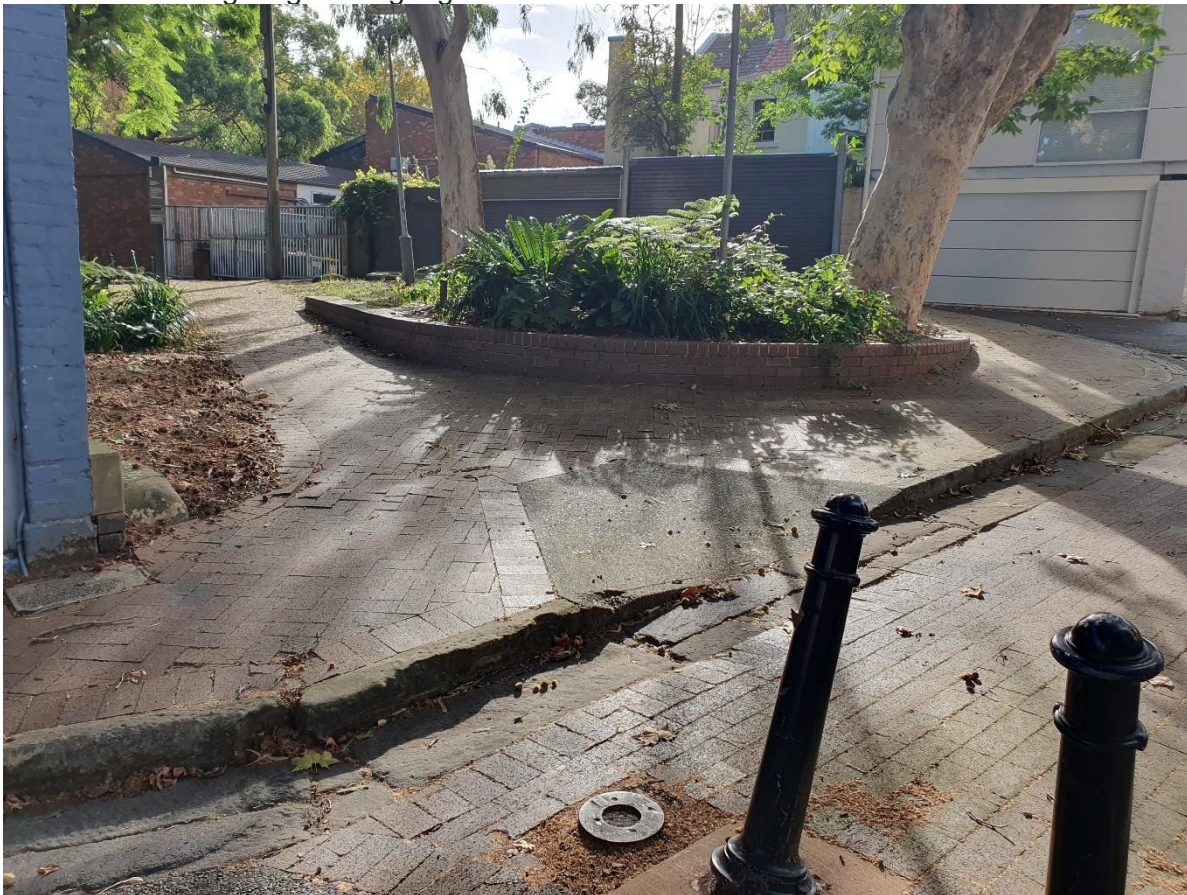
Adelaide Street Reserve – looking northeast towards Little Riley Street from Adelaide Street. Some blank spaces in planter beds. Retaining wall and paths are in a good condition with some pavers lifted. Shade from mature existing trees.
