**Inspection Report  
18, 18A and 20 O'Dea Avenue and 19 and 21  
Dunkerley Place, Waterloo**

**Council investigation officer Inspection and Recommendation Report  
Clause 17(2), Part 8 of Schedule 5, of the Environmental Planning and Assessment  
Act 1979 (the Act)**

**Premises: 18, 18A & 20 O’Dea Ave, 19 & 21 Dunkerley PI Waterloo**

**Re: INSPECTION REPORT  
WATERFALL BY CROWN  
18 O'DEA AVENUE WATERLOO ("the premises")**

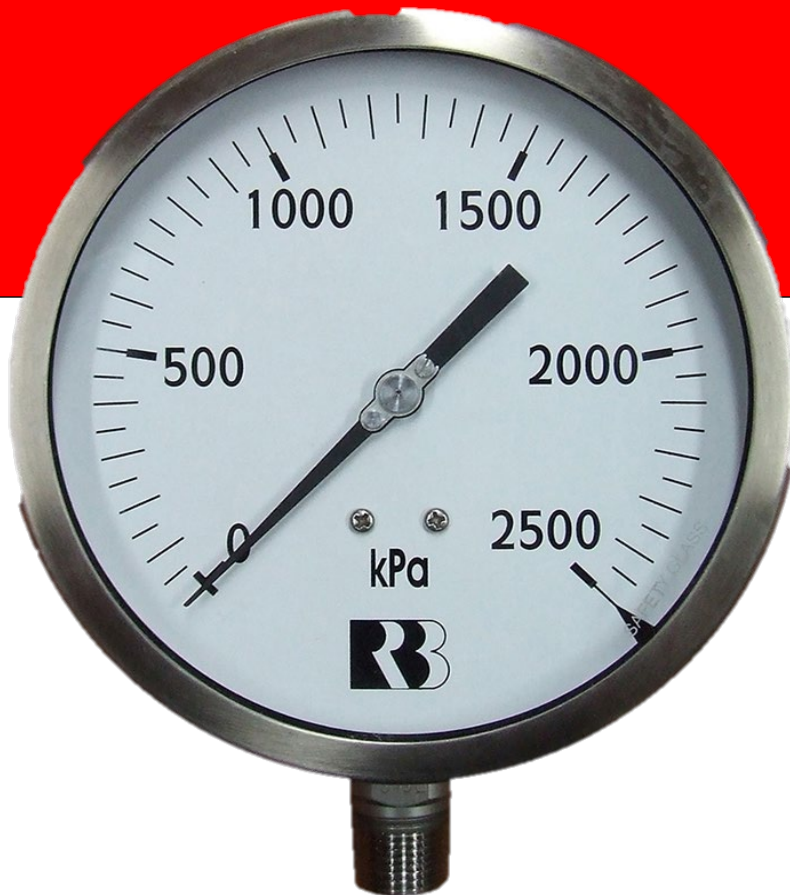
Figure 1

Additional signage should be installed at the 150mm pressure gauge similar to *Figure 1*, to advise firefighters of the required pressure at the RELAY PUMP discharge.

**FRNSW**  
**WHEN USING THE**  
**MANUAL START RELAY**  
**PUMPSET**  
**FOR FIRES L??-ROOF**  
**THIS PRESSURE**  
**GAUGE IS TO**  
**DISPLAY XXXX KPA**

FRNSW position statement [FRNSW pump performance for high rise buildings](#) states, the fire hydrant system is to be designed for a 'Boost Pressure' of 950 kPa being input into the fire brigade booster connection from a standard FRNSW pumper, for buildings having an effective height greater than 50 m and requiring a fire brigade relay pump. FRNSW are of the opinion that the boost pressure signage should state, BOOST PRESSURE 950kPa and the relay pump be modified to ensure correct operational pressures.
