# **Attachment E**

**Inspection Report  
5 Sam Sing Street, Waterloo**

**Council investigation officer Inspection and Recommendation Report  
Clause 17(2), Part 8 of Schedule 5, of the Environmental Planning and  
Assessment Act 1979 (the Act)**

**Premises: 5 Sam Sing Street Waterloo NSW 2017**

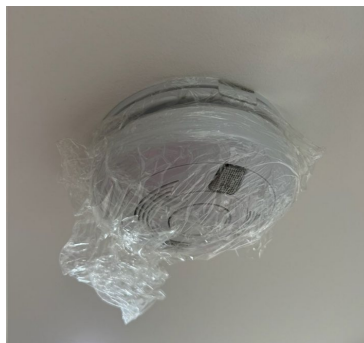
- *This is an airbnb and they have the smoke alarm covered in plastic. It has been reported to airbnb and they said to lodge a complaint here. We were just concerned that not only was it illegal but could cause a fatality in the future.*

A photograph was provided with the correspondence and has been attached below.

The correspondence received indicated Unit 11401 was being used as an Airbnb and the smoke alarm within the unit was covered with plastic. Access was not available at the time of the inspection to verify the validity of the concern.
