Attachment F

**Inspection Report
15 Gadigal Avenue, Zetland**

Council Investigation Officer Inspection and Recommendation Report; Clause 17(2) Part 8 of Schedule 5 of the Environmental Planning and Assessment Act 1979 (the Act)

Premises: 15 Gadigal Avenue, Zetland

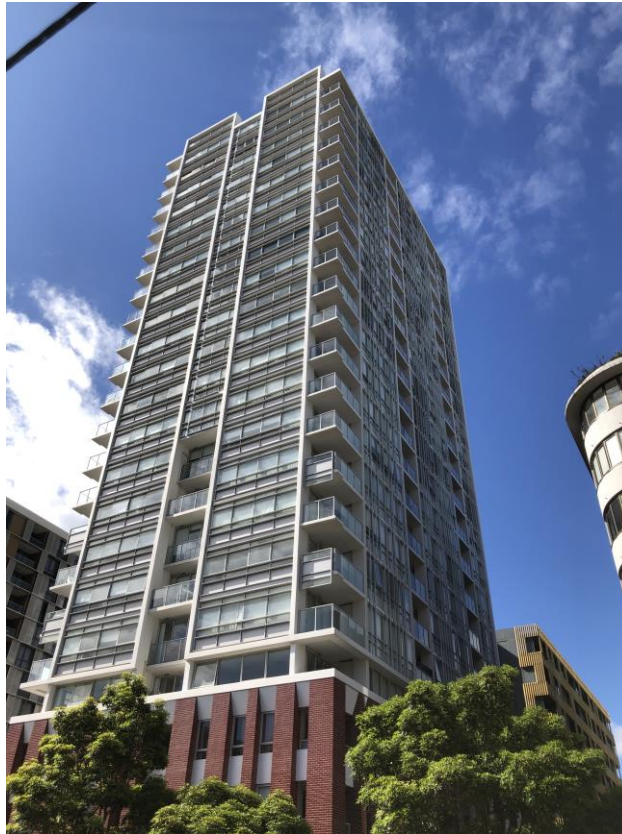
Figure 1: 15 Gadigal Avenue, Zetland, viewed from the south-east
