# **Attachment G**

**Inspection Report  
108 Parramatta Road, Camperdown**

**Council Investigation Officer Inspection and Recommendation Report; Clause 17(2) Part 8 of Schedule 5 of the Environmental Planning and Assessment Act 1979 (the Act)**

**Re: INSPECTION REPORT  
BEST WESTERN SUITES  
108 PARRAMATTA ROAD CAMPERDOWN ("the premises")**

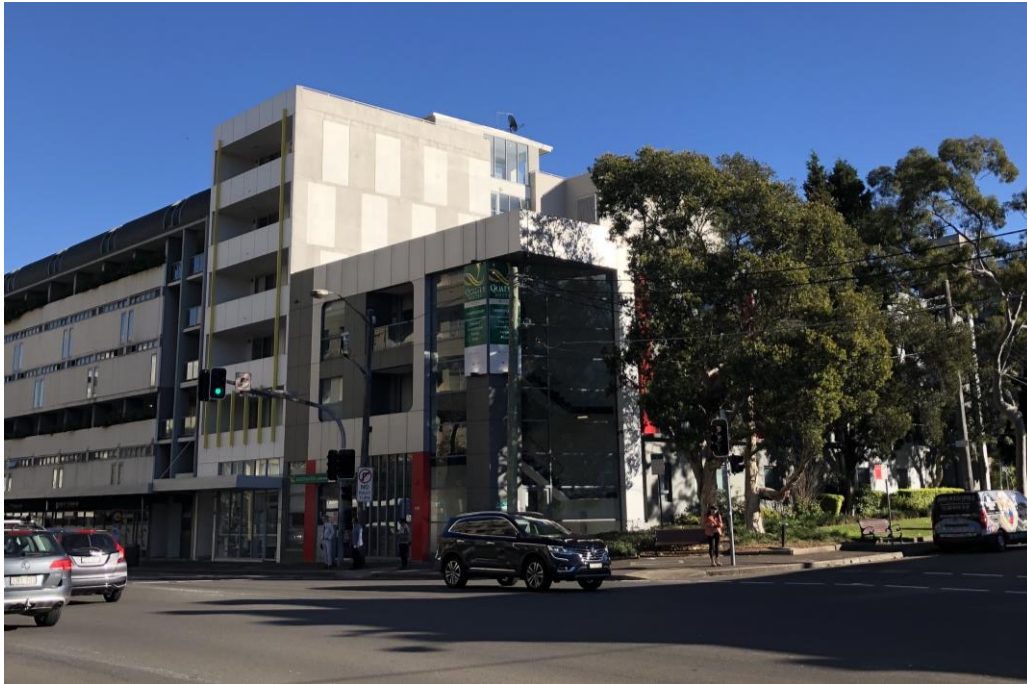
**Figure 1:** 108 Parramatta Road, Camperdown, viewed from the north-west
