**Inspection Report
352 Sussex Street, Sydney**

Council Investigation Officer Inspection and Recommendation Report; Clause 17(2) Part 8 of Schedule 5 of the Environmental Planning and Assessment Act 1979 (the Act)

Premises: 352 Sussex Street, Sydney

**Re: INSPECTION REPORT
LANDMARK APARTMENTS
348-352 SUSSEX STREET SYDNEY ("the premises")**

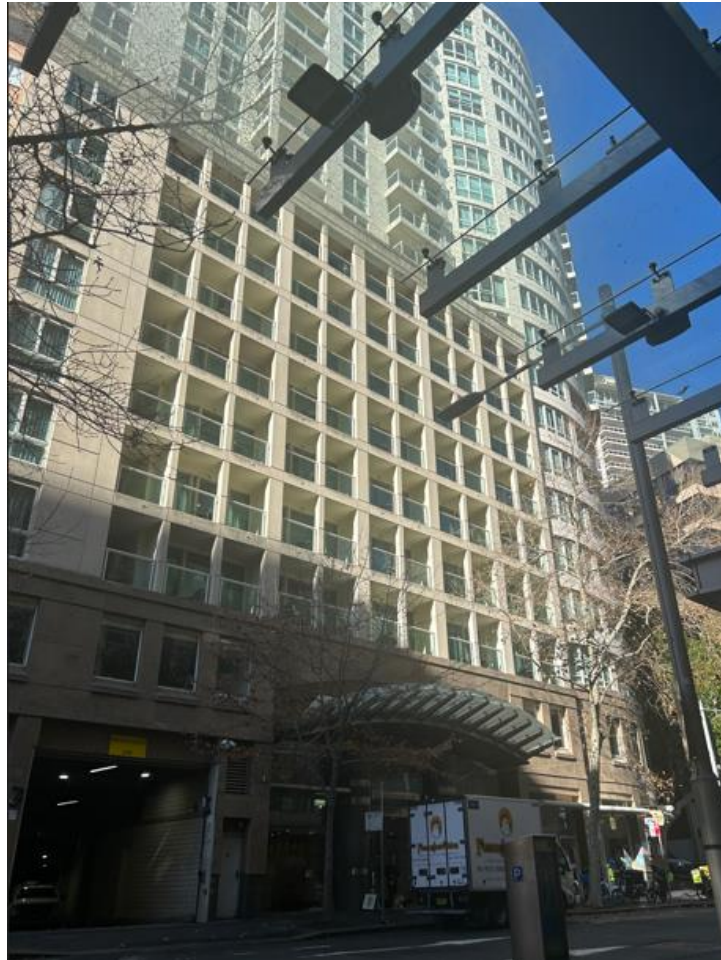
Figure 1: 352 Sussex Street, Sydney, viewed from the west
