# **Attachment B**

**Inspection Report  
234 William Street, Potts Point**

# **Council Investigation Officer Inspection and Recommendation Report; Clause 17(2) Part 8 of Schedule 5 of the Environmental Planning and Assessment Act 1979 (the Act)**

**Premises:** 234 William Street, Potts Point (Banque Apartments)

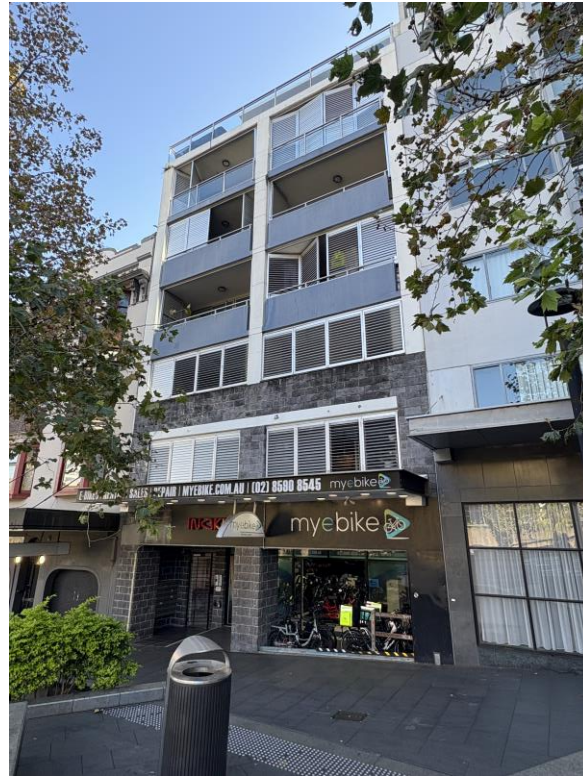
**Figure 1:** 234 William Street, Potts Point viewed from the south
