**Inspection Report
199 Clarence Street, Sydney**

Council Investigation Officer Inspection and Recommendation Report; Clause 17(2) Part 8 of Schedule 5 of the Environmental Planning and Assessment Act 1979 (the Act)

Premises: 199 Clarence Street, Sydney

**Re: INSPECTION REPORT
COMMERCIAL BUILDING
199 CLARENCE STREET, SYDNEY ("the premises")**

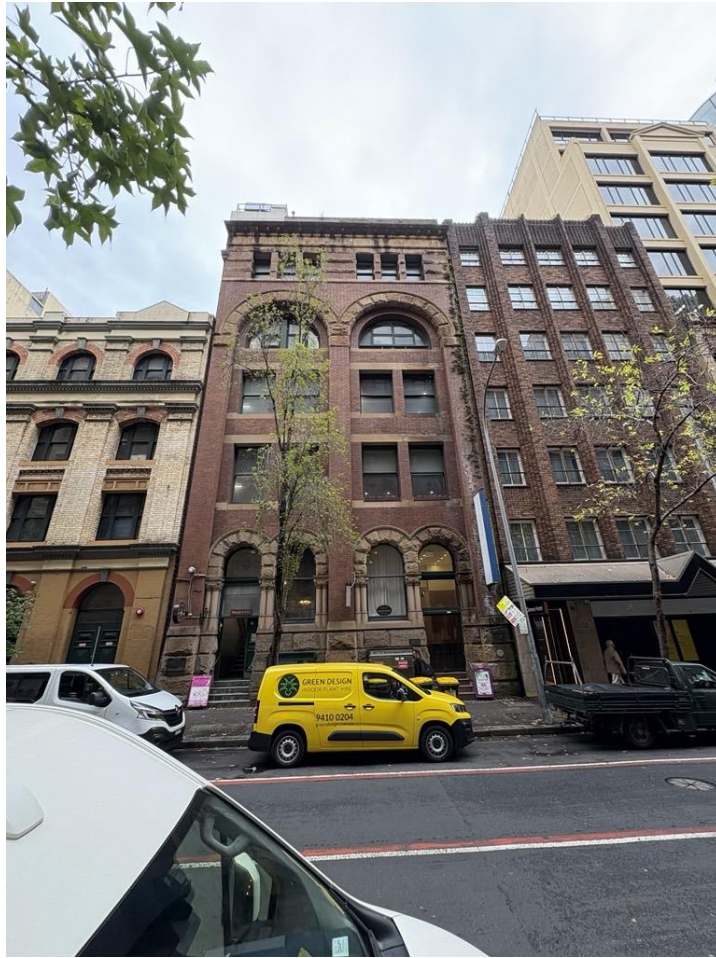
Figure 1: 199 Clarence Street, Sydney, viewed from the east
