Existing Building Services Condition Report

**230655 PARK ROYAL HOTEL
REDEVELOPMENT**

Client:
UOL

Revision:
C

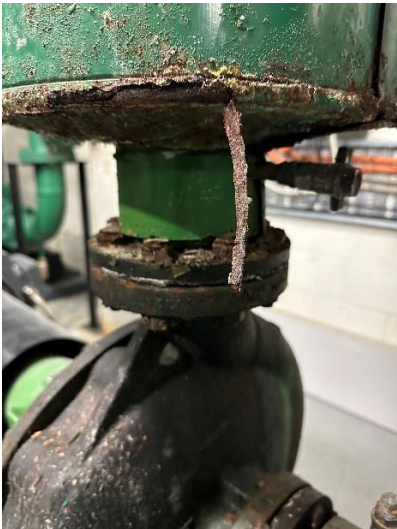
| Infrastructure | Image and General Condition | Re-use Considerations |
|---|---|---|
| Chilled water pipework | <p>Fair to Poor</p> | <ul style="list-style-type: none"> - Must re-evaluate pipe sizing based on updated heat loads in detailed design - Pipe conditions and extent of corrosion cannot be determined from visual inspection and will require ultrasonic non-intrusive testing for re-use evaluation. - Insulation provided required to be updated to latest NCC - Pressure class to be evaluated. Depending on final plant arrangement, can be sufficient. |

| Asset | Service | Recommendations |
|--|---|--|
| Chilled Water Pipework | Mechanical | Conduct pipe ultrasonic scans of existing chilled water pipework for new hotel rooms to determine suitability of re-use. Maintain or replace according to findings of testing. Bolster insulation accordingly to meet latest NCC standards Replace main chilled water pipework to meet new increased demand and to suit new architectural scheme. |

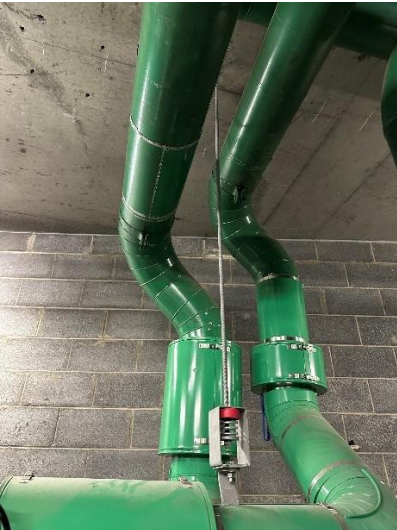
| Infrastructure | Image and General Condition | Re-use Considerations |
|---|---|---|
| Condenser water pipework | <p>Good to Fair</p> | <ul style="list-style-type: none"> - Must re-evaluate pipe sizing based on updated heat loads in detailed design - Pressure class to be evaluated. Depending on final plant arrangement, can be sufficient. - Pipe conditions and extent of corrosion cannot be determined from visual inspection and will require ultrasonic non-intrusive testing for re-use evaluation |

| Asset | Service | Recommendations |
|--|---|--|
| Condenser Water Pipework | Mechanical | Conduct pipe ultrasonic scans of existing condenser water pipework to determine suitability of re-use. Maintain or replace according to findings of testing. Replace main condenser water pipework to meet new increased demand and to suit new architectural scheme. |

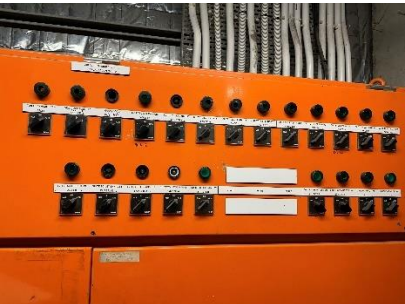
| Infrastructure | Image and General Condition | Re-use Considerations |
|---|---|---|
| Mechanical Electrical | <p>Fair to Poor</p> | <ul style="list-style-type: none"> - Requires detailed analysis if conduits sufficient for new plant loads - Requires upgrade to the latest wiring and electrical standards - Boards are at the end of economic life - Low probability of re-use |

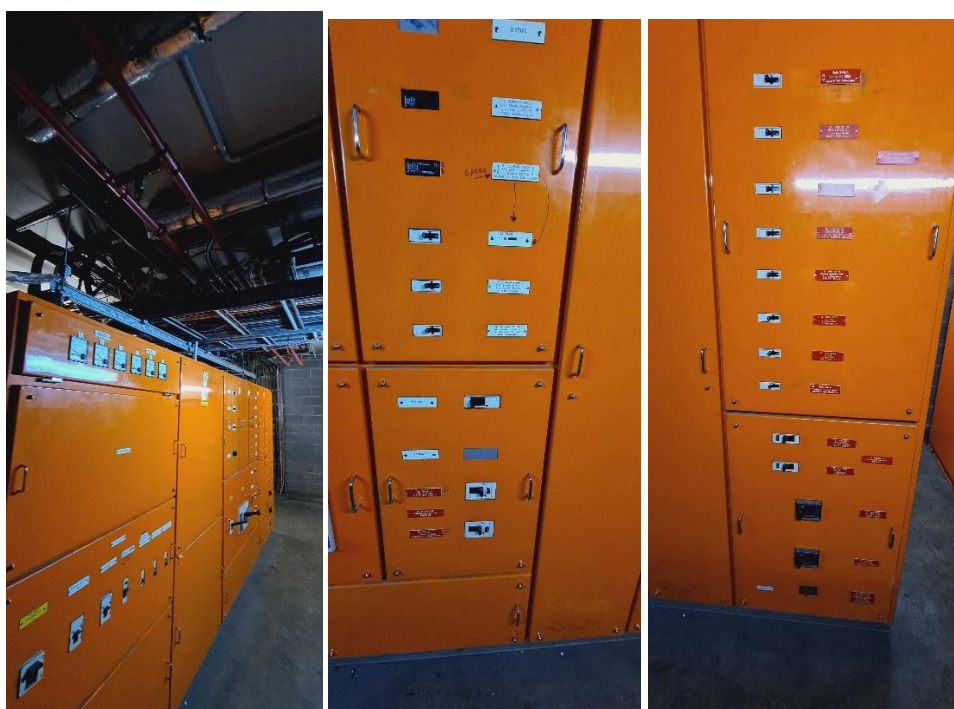
Figure 4-1 : Main Switchboard

The main electrical services Main Switch Room (MSR) is located in the upper basement and serves as the central point of electrical services distribution for the entire building. The switchboard is approaching end of life with no service protection device (SPD) and is not compliant to the current standards(AS 61439). The consumer mains currently originate from Ausgrid substation S.7983(Sussex Sand) and currently has half sized neutral which is also non-compliant to current AS/NZS 3000 requirements.

| Asset | Service | Recommendations |
|---|---|--|
| Main Switchboard | Electrical | Replace to meet latest NCC Standards and to meet new increased demand |

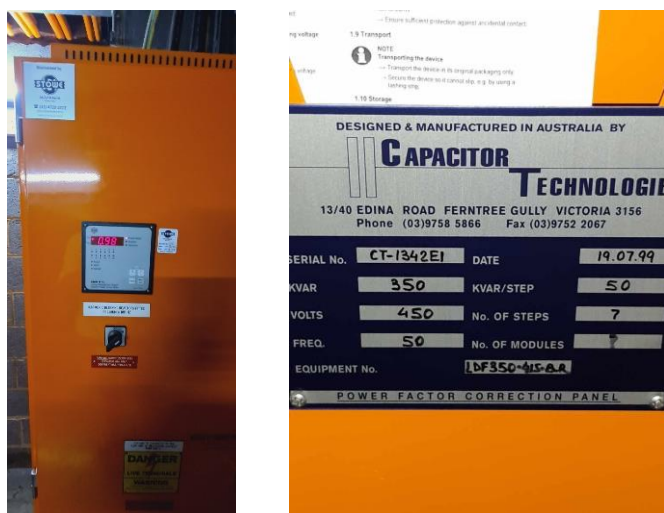
Figure 4-3 : Power Factor Correction Unit

The power factor correction units were installed circa 1999 and the equipment have been maintained well, with annual inspections conducted per manufacturers recommendations with maintenance labelling observed on the PFC unit. The expected services life for PFC units is around 15 years before contactors begin failing, and therefore it is expected this equipment will require replacement in the coming years.

| Asset | Service | Recommendations |
|---|---|--|
| Power Factor Correction Units | Electrical | Replace due to equipment being end-of -life |

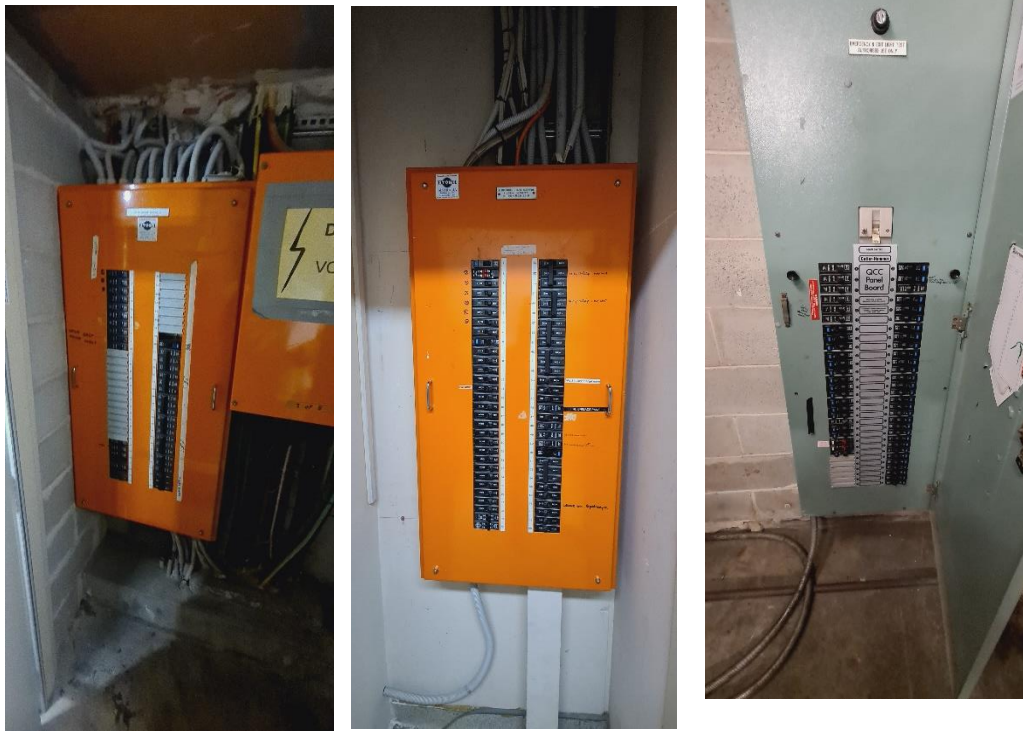
Figure 4-4: Typical Distribution Boards

The development includes various electrical distribution boards (DBs) throughout the building, housed in plant areas, hotel level corridors within dedicated services cupboards and risers to enable efficient distribution of electrical power. These include house distribution boards (supplying general power and lighting circuits) and DBs dedicated to certain plant (such as security, telecommunications or hydraulics). During the site inspection, it was observed that these boards are end of life. The boards cannot be retained and would have to be upgraded to meet current standards.

| Asset | Service | Recommendations |
|---|---|--|
| House and Services Distribution Boards | Electrical | Replace to meet latest NCC Standards and to meet new increased demand |

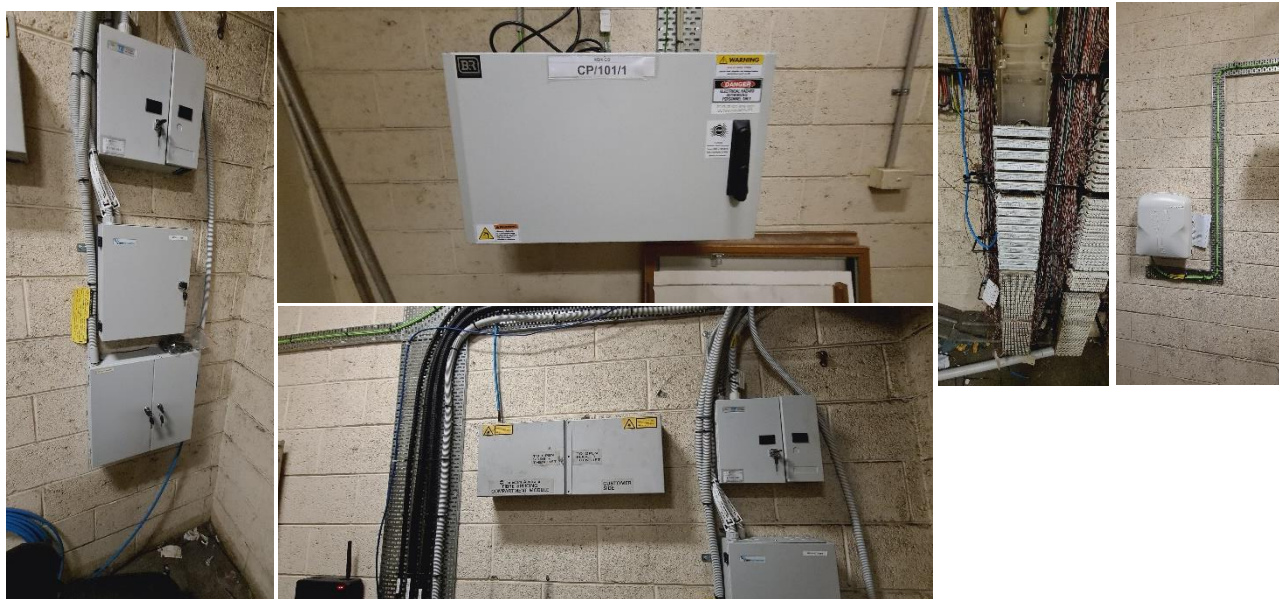
Figure 4-5: MDF Room

The main communications room is located in the upper basement and serves as the central point of communication incoming services from the street. The site currently has NBN and other service providers terminating their services in the MDF room. The room and services could be retained in its current location for existing and future development needs however needs to be cleaned, repainted and finished internally to the current requirements of S009.

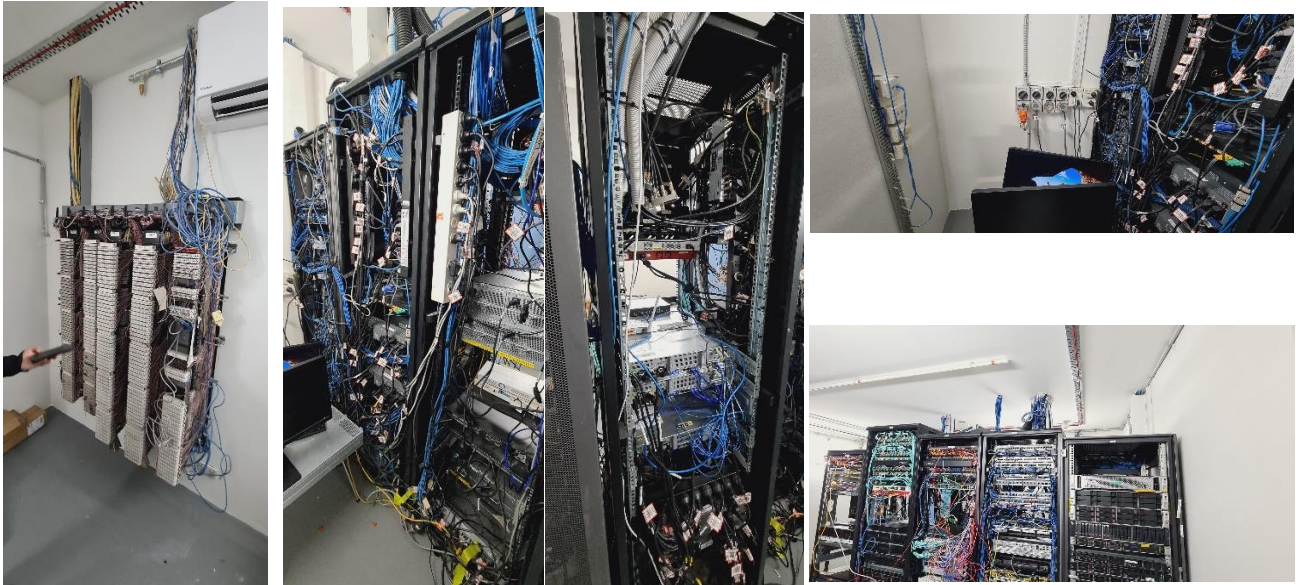
Figure 4-6: Building Distributor Room

The main building distributor room is located in the lower basement and serves as the central point of distribution for the entire building. The room currently houses 5 racks. The room and services could be retained in its current location for existing and future development needs however needs to be cleaned, repainted and finished internally to the current requirements of S009.

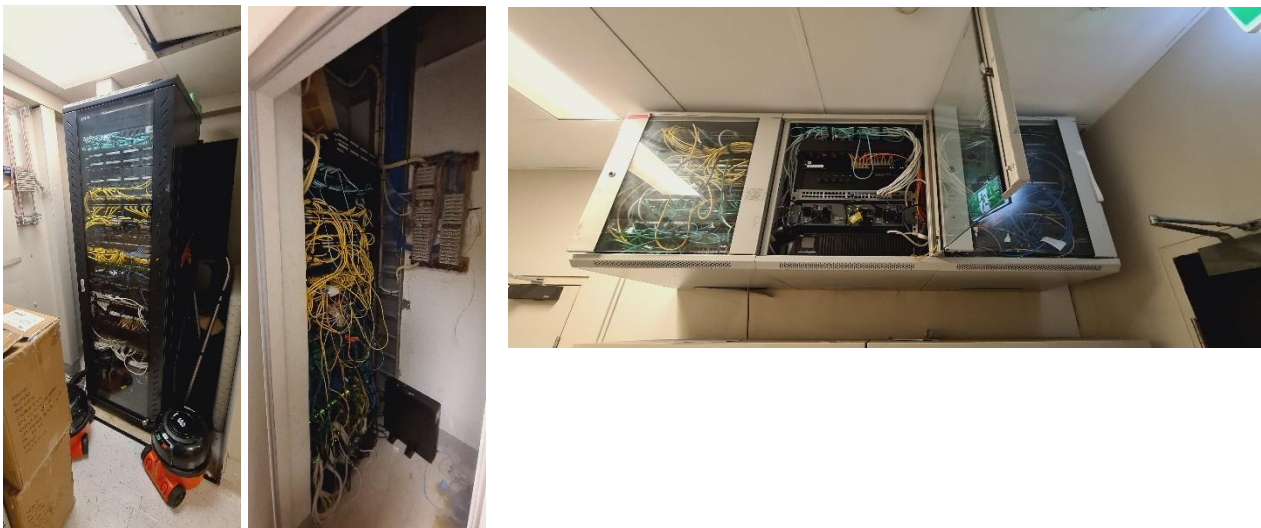
Figure 4-7: Floor Distributor Room

The floor distributor room is located on every level and serves as the central point of distribution on every floor. The room currently houses 1 rack. The space allocation for this room would need to be reviewed in conjunction with the new lift core arrangement for the new development. In some instances, the rack could be re-used for new works which would be dependent on its age and integrity. Spaces for specific use, for e.g. function spaces have their own small wall mounted racks. The suitability of reusing active gear in the current racks would have to be evaluated by the systems integrator which will be dependent on the technology being deployed for hotel communication infrastructure.

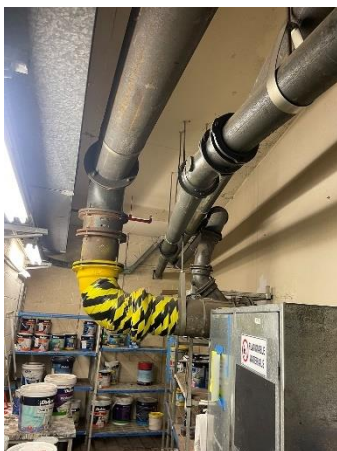
The existing sewer horizontal drainage and stack appears to be in poor condition and is currently sized to accommodate wastewater for the current building scheme. To accommodate the new building scheme, it is envisaged the existing mild steel sanitary drainage services pipework and stack risers would be undersized and should be replaced with new uPVC drainage pipework of adequate size.

Existing Mild Steel sewer drainage.

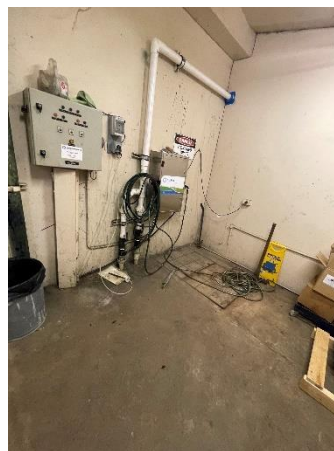
The condition of the existing sewer holding well and associated pumps located on Lower ground Basement is expected to need replacing due to being at it's end of life period. A new sewer holding well and associated pumps will be provided. The existing plantroom the sewer holding well is located within does not incorporate adequate ventilation for personnel to enter and work within. The ventilation to the room will be upgraded.

Existing sewer pump station.

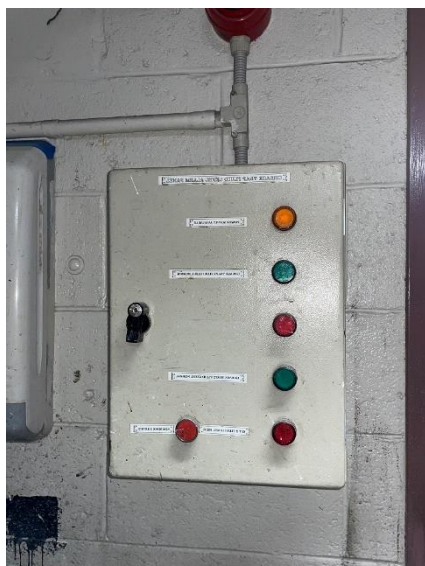
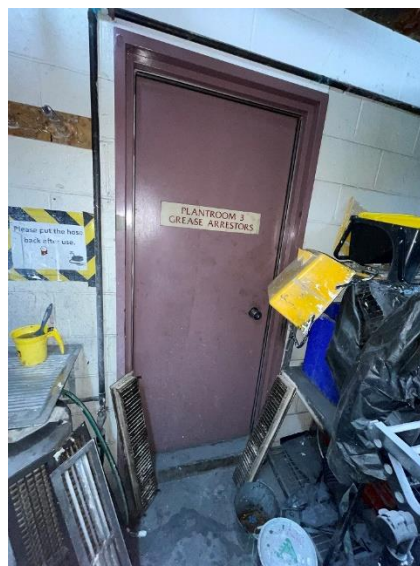
The current grease arrestors are sized to cater for the grease waste usage for the current commercial kitchen areas within the building. As part of the new building scheme, additional restaurant tenancies are being proposed and it is envisaged the existing grease arrestors would not be able to accommodate any additional grease waste. New grease arrestors will be provided and adequately sized to accommodate the grease waste anticipated for the new building scheme in the basement and coordination has considered access of equipment.

Grease Arrestor level alarm.

Existing Grease Arrestor room.

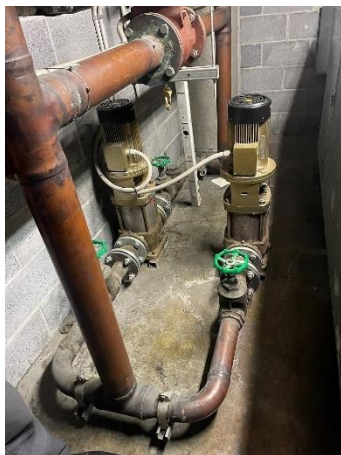
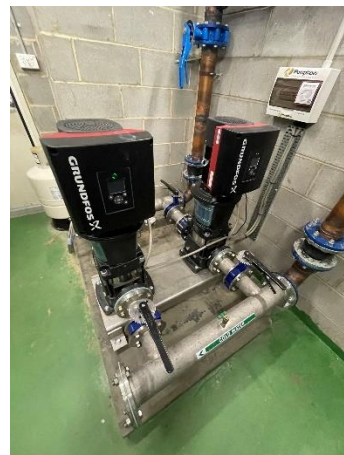
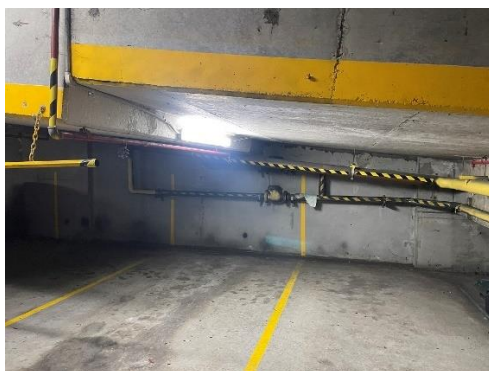
The current potable water services pipework appears to be in poor condition and is sized to cater for the current building scheme. New potable water services pipework should be provided that is adequately sized to cater for the new building scheme,

Existing CW. transfer pumps.

Existing CW. booster pumps.

Existing incoming CW. service.

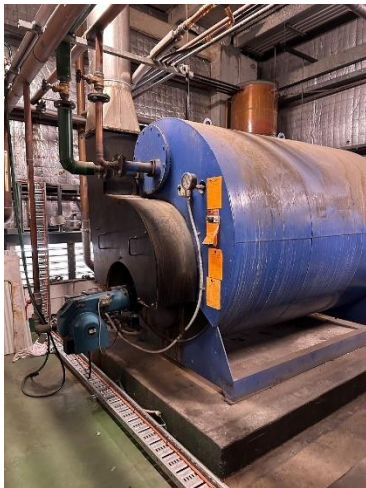
The existing hot water plant is sized based on the current building scheme and is expected to no have spare capacity to accommodate the new building works scheme. The existing hot water plant should be replaced with an adequately sized hot water plant that consist of either:

Existing Domestoc HW boiler.

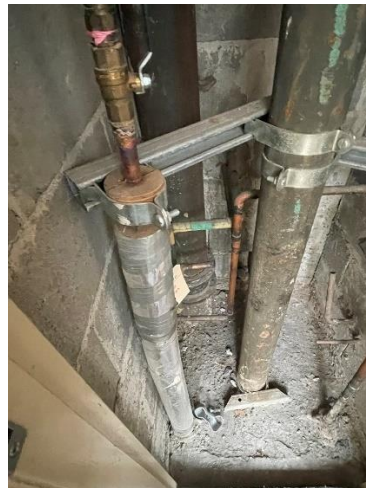
The current hot water services flow and return pipework appears to be in poor condition and is sized to cater for the current building scheme. New hot water flow and return services pipework should be provided that is adequately sized to cater for the new building scheme.

Existing Hot Water services pipework.

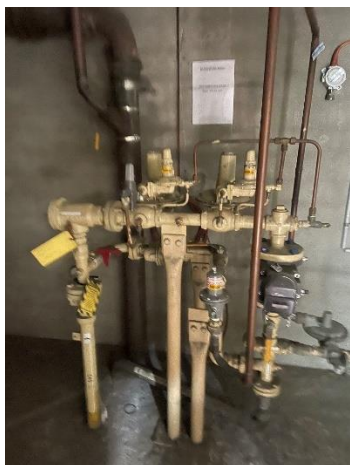
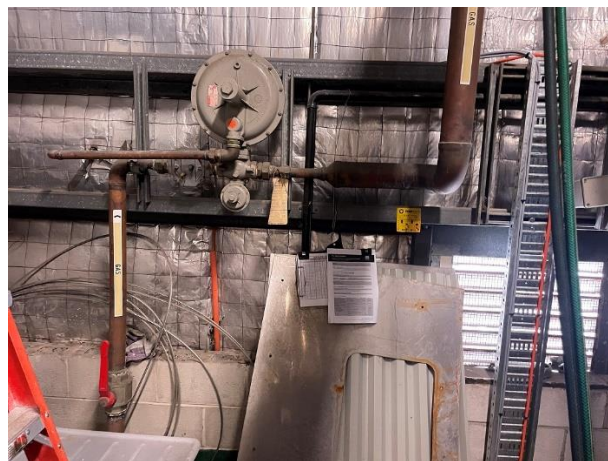
The existing natural gas services reticulates within the building at 100kpa, without being located within a ventilated fire rated shaft in accordance with AS5601. A new boundary regulator will be provided to limit the natural gas supply operating pressure to 7kpa once entering into the building. The building's existing natural gas pipework will be deemed to small to accommodate anticipated natural gas usage at the new lower pressure and will need to be decommissioned and removed. New natural gas service pipework will be run throughout the building to serve to the existing and new gas appliance, sized to cater for the lower gas pressure.

Existing High pressure gas boundary regulator.

Existing Gas regulator serving Domestic HW. plant.

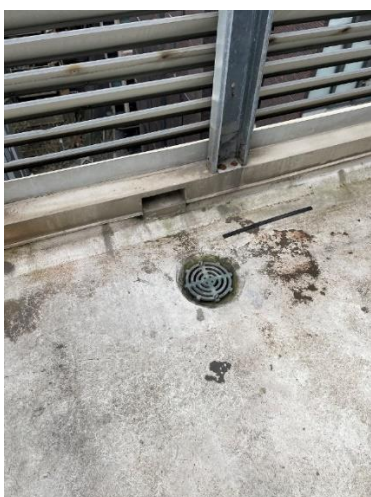
The existing mild steel horizontal stormwater drainage and downpipes appears to be in poor condition and will need to be replaced with new uPVC drainage pipework of adequate size.

Existing L11 roof stormwater outlet and overflow.

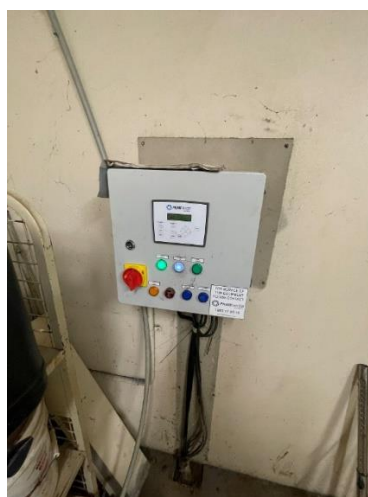
The condition of the existing sewer holding well and associated pumps located on Lower ground Basement is expected to need replacing due to being at it's end of life period. A new stormwater holding well and associated pumps will be provided.

Existing Stormwater pumpstation control panel.

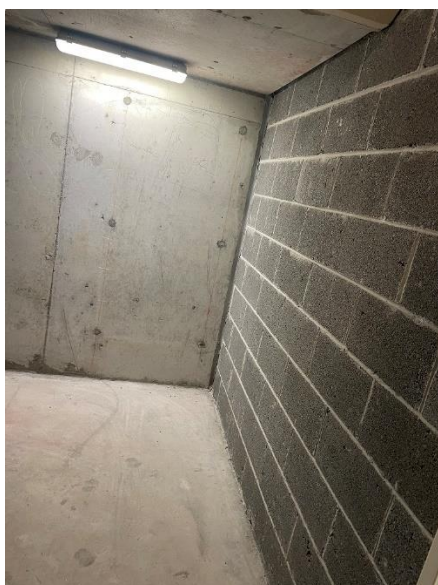
Figure 3: Fire egress stair not containing fire hydrant.

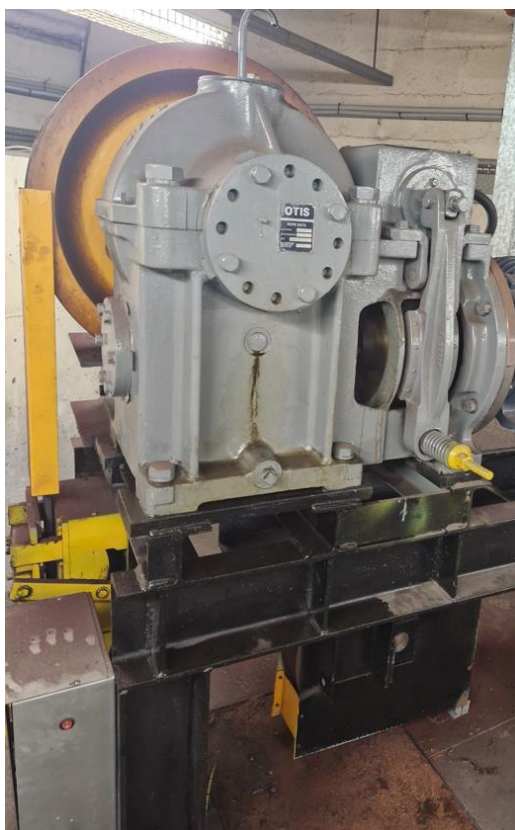
The design life for the modernised components of these lifts is in the order of 15 years for the controllers, drives, lift car and landing control buttons and signalisation, and in the order of 20 years for the car door operator and landing door system. The original Otis Elevator as installed geared machine has reasonably cycled beyond it's operational design life of approx. 25 - 30 years with continuous operation for a period of 33 years.

Original as-installed Otis Elevator Geared Machine

Complete replacement of these lifts with larger lift cars (minimum 21 passenger 1600 Kg rated load) can be reasonably considered and is recommended during the proposed extension works.
