# **Attachment B**

| <p><b>Inspection Report</b><br/><b>47-61 Pymont Bridge Road, Camperdown</b></p> |

**Council Investigation Officer Inspection and Recommendation Report; Clause 17(2) Part 8 of Schedule 5 of the Environmental Planning and Assessment Act 1979 (the Act)**

**Premises:** 47-61 Pyrmont Bridge Road Camperdown

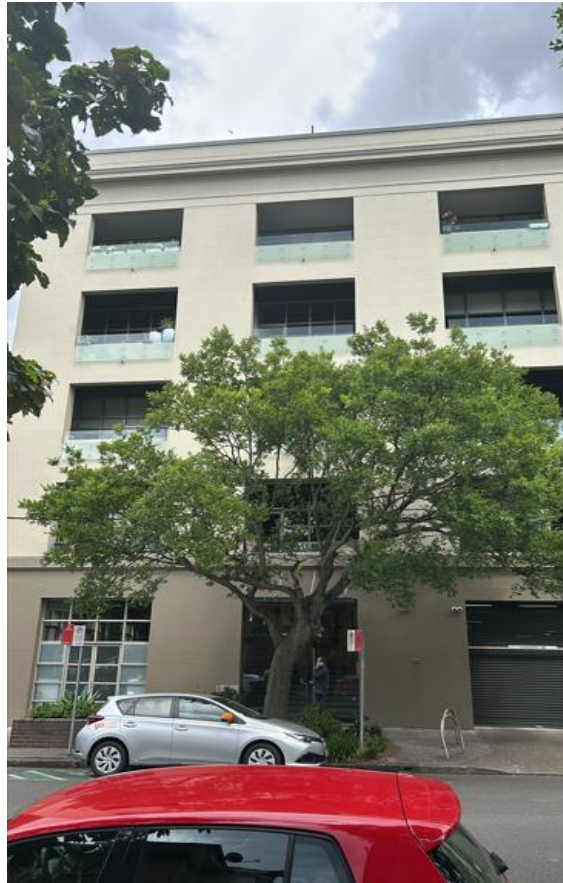
**Figure 1:** 47-61 Pyrmont Bridge Rd Camperdown viewed from the North
