**Inspection Report
120-122 Saunders Street, Pyrmont**

Council Investigation Officer Inspection and Recommendation Report; Clause 17(2) Part 8 of Schedule 5 of the Environmental Planning and Assessment Act 1979 (the Act)

**Re: INSPECTION REPORT
BAYVIEW TOWERS
120-122 SAUNDERS STREET PYRMONT (hereafter "the premises")**

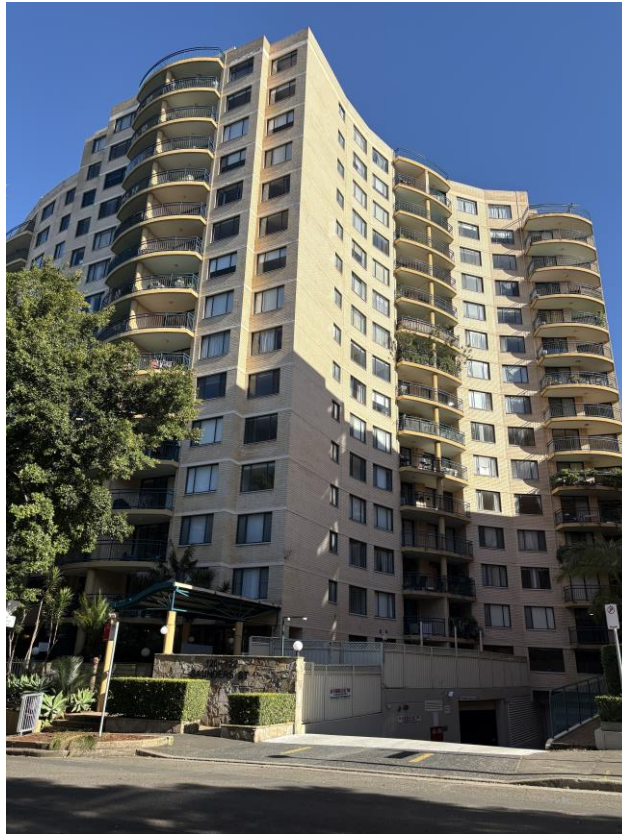
Figure 1: 120-122 Saunders Street, Pyrmont

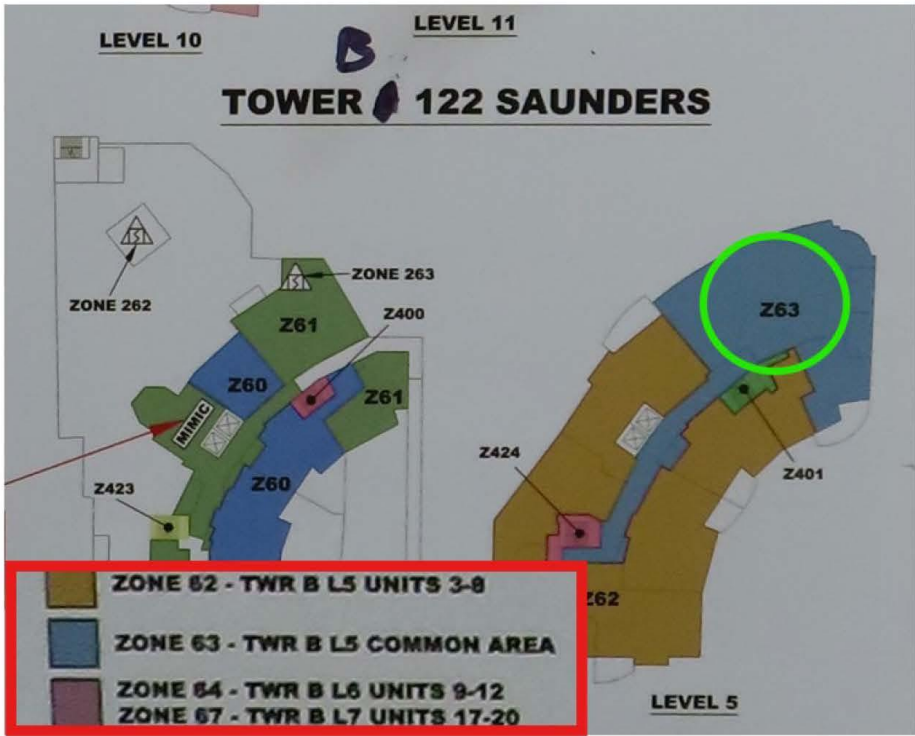
- C. The zone addressing of the fire indicator panel and the building identifiers create confusion for firefighters attending calls of fire at the premises. The block plans have been modified by permanent marker to compensate for FIP addressing.

E.g. The FIP address for Zone 63 is *ZONE 63 – TWR B L5 COMMON AREA* and along with the floor plan, shows Zone 63 as being in Tower B (Figure 1). Zone 63, though, is in Tower A.

When firefighters are advising occupants, they are going to TWR B L5, the occupants direct them to Tower A. Should an incident occur that requires greater FRNSW resources, the incident controller may not be able to provide adequate safeguards to firefighters as firefighting crews may be sent to the wrong building based all information available to the attending crews.

Image 1 - FIP block plan changed to reflect inaccurate zone addressing

- a. Review items 1 and 2 (excluding item 1A(A)) of this report and conduct an inspection.
- b. Review the addressing of the fire indicator panel and/or building identifiers.
- c. Address any other deficiencies identified on the premises.

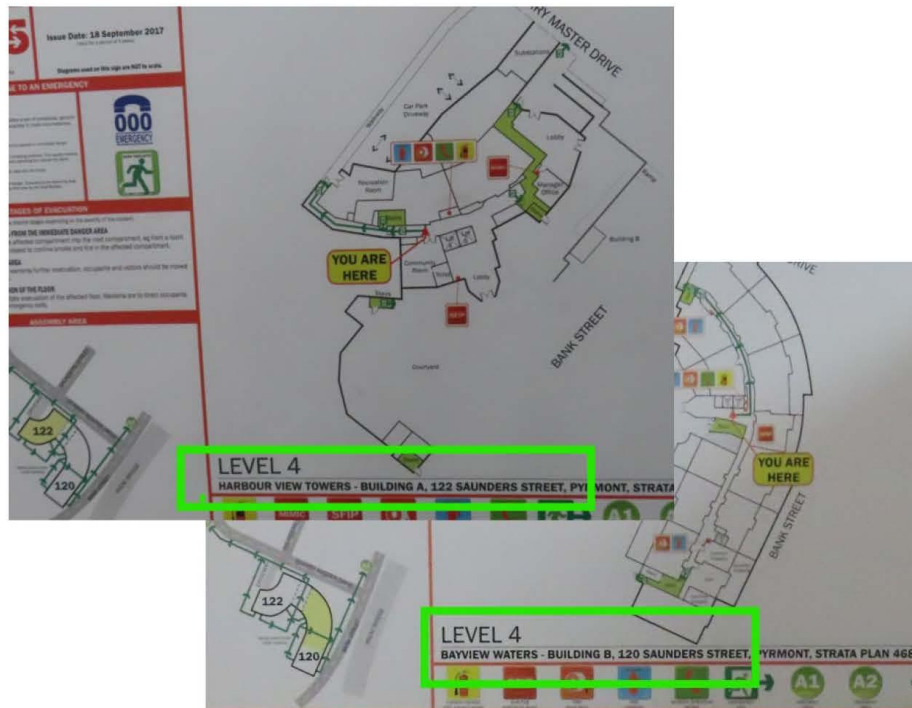
Emergency evacuation plans detail Building A, 122 Saunders and Building B, 120 Saunders (Figure 2).

Image 2 – Emergency Plans with building addresses.
