# **Attachment D**

<p><b>Inspection Report</b> <b>107-109 Darlinghurst Road, Potts Point</b></p>
---

**Council Investigation Officer Inspection and Recommendation Report; Clause 17(2) Part 8 of Schedule 5 of the Environmental Planning and Assessment Act 1979 (the Act)**

**Re: INSPECTION REPORT  
URBAN NOMADS  
107-109 DARLINGHURST ROAD POTTS POINT ("the premises")**

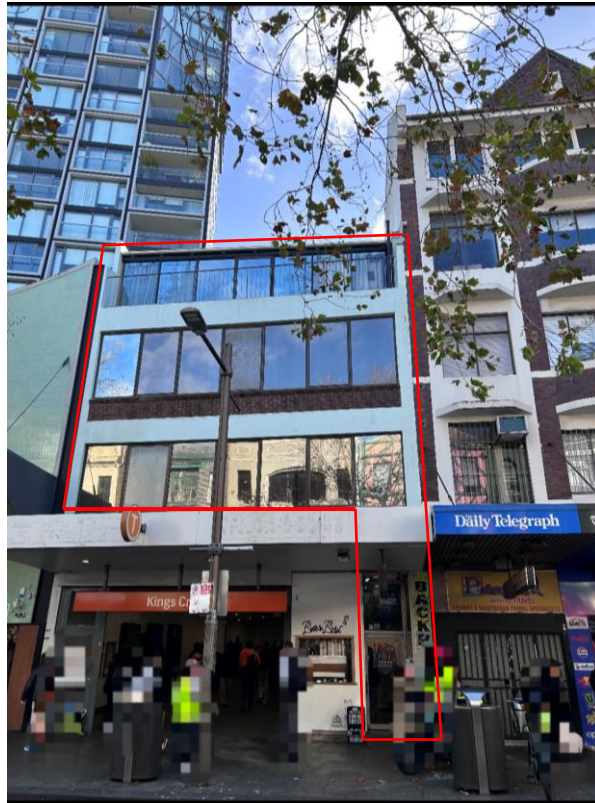
**Figure 1:** 107-109 Darlinghurst Road, Potts Point, viewed from the east, outlined in red

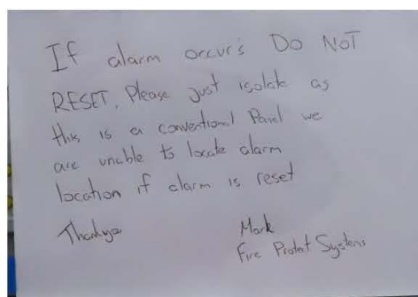
4. The Building Occupant Warning System (BOWS) did not provide sound through all occupied areas contrary to the requirements of Specification S20C7 of the National Construction Code 2022, Volume 1 Building Code of Australia (NCC). The roof top area did not contain any speakers for the BOWS.
5. The smoke detectors within the communal kitchen on level 3 were covered by rubber gloves contrary to the requirements of AS 1670.1–2018.
6. The Fire Indicator Panel included a handwritten note from Mark from Fire Protect Systems (see below). FRNSW do not recommend the isolation of detectors that are able to be reset. Isolation of detectors renders that detector inoperable and will not operate the BOWS to warn occupants in the case of fire.
