Report on Footing Investigation

Park Royal Hotel Redevelopment

150 Day Street, Sydney, NSW

19 March 2025

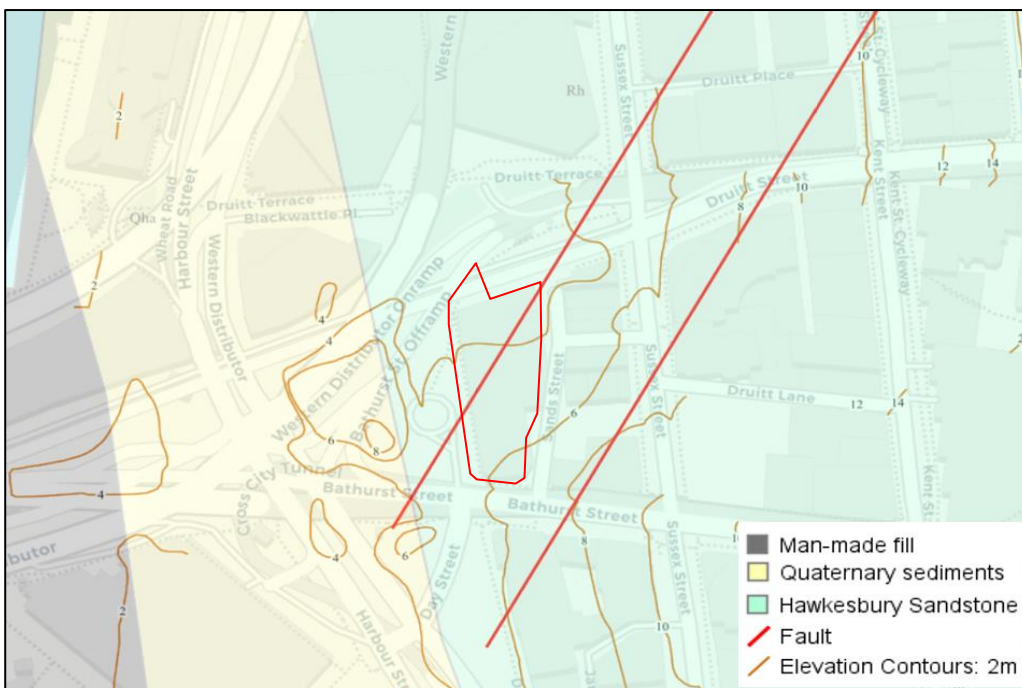
Figure 1: Subject site geology detailing GPO fault zone

Reference to Sydney CBD fault zones map (Pells, Braybrooke & Och, 2004), indicates that the site is located within the G.P.O Fault zone. The fault zone extends from the north-east of the subject site to the south-west. Weaker rock and a higher degree of fracturing within the rock mass is expected in the fault zone. An extract from the geological map overlain by 2 m (AHD) contours is shown in Figure 1.
