# Existing Building Services Condition Report

**230655 PARK ROYAL HOTEL  
REDEVELOPMENT**

**Client:**  
UOL

**Date:**  
24/03/2025

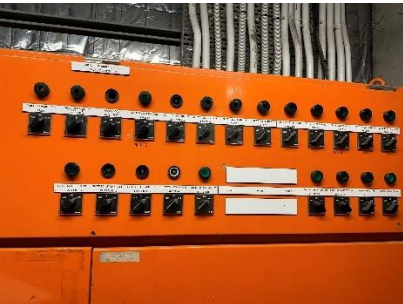
| Infrastructure | Image and General Condition | Re-use Considerations |
|---|---|---|
| <b>Mechanical Electrical</b> | <p>Fair to Poor</p> | <ul style="list-style-type: none"> <li>- Requires detailed analysis if conduits sufficient for new plant loads</li> <li>- Requires upgrade to the latest wiring and electrical standards</li> <li>- Boards are at the end of economic life</li> <li>- Low probability of re-use</li> </ul> |

| Asset | Service | Recommendations |
|---|---|---|
| <b>Mechanical Electrical Wiring</b> | Mechanical | Replace to meet latest NCC Standards and to suit new architectural scheme |

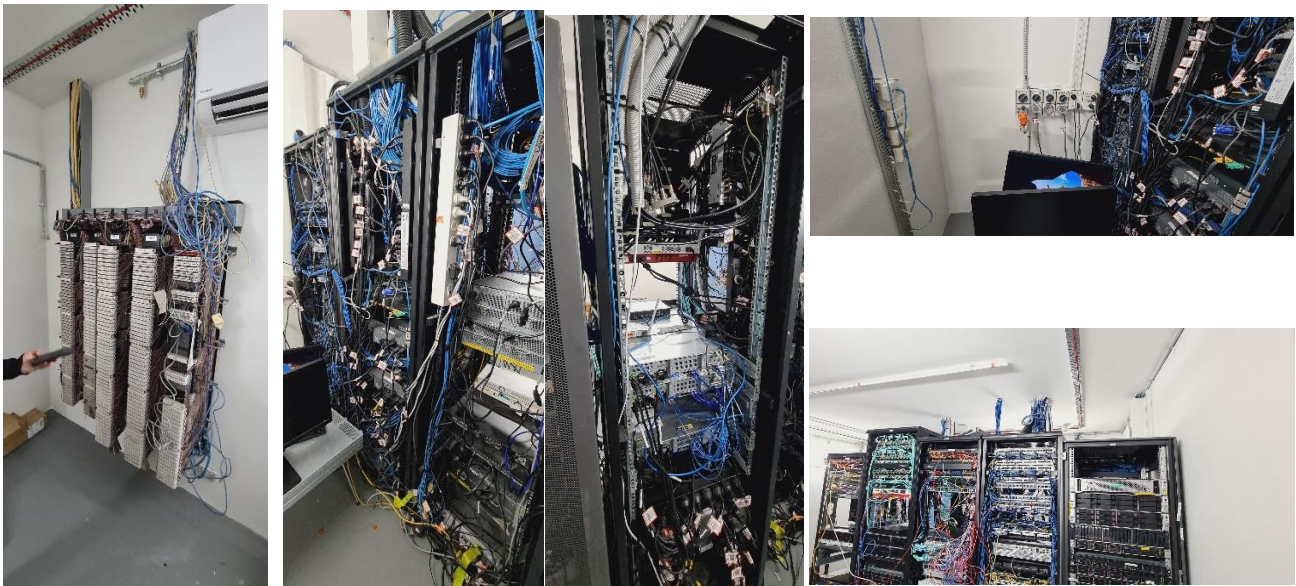
Figure 4-6: Building Distributor Room

The main building distributor room is located in the lower basement and serves as the central point of distribution for the entire building. The room currently houses 5 racks. The room and services could be retained in its current location for existing and future development needs however needs to be cleaned, repainted and finished internally to the current requirements of S009.

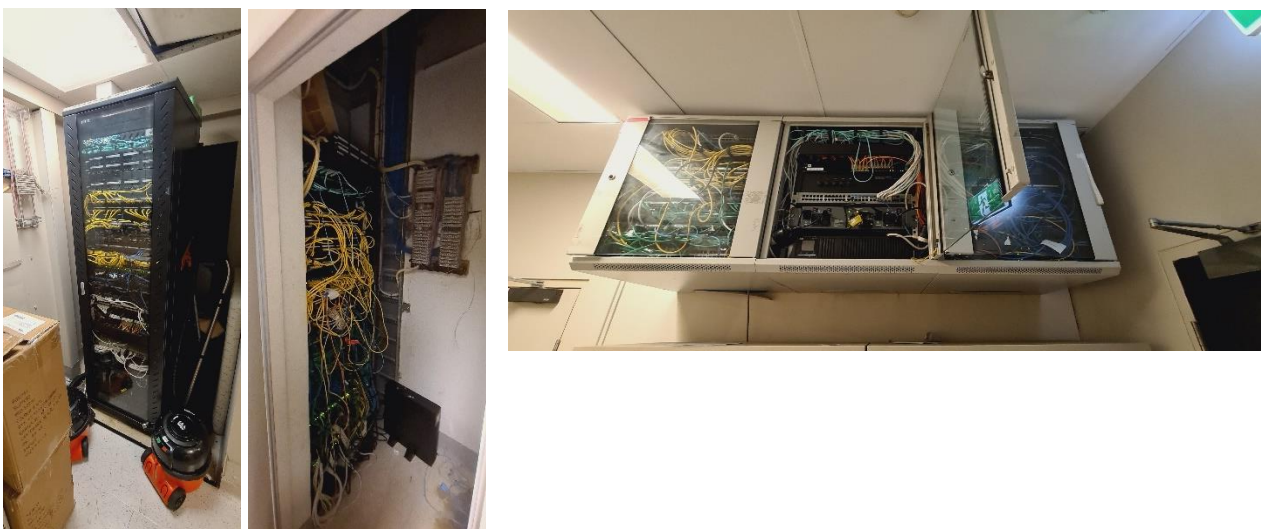
Figure 4-7: Floor Distributor Room

The floor distributor room is located on every level and serves as the central point of distribution on every floor. The room currently houses 1 rack. The space allocation for this room would need to be reviewed in conjunction with the new lift core arrangement for the new development. In some instances, the rack could be re-used for new works which would be dependent on its age and integrity. Spaces for specific use, for e.g. function spaces have their own small wall mounted racks. The suitability of reusing active gear in the current racks would have to be evaluated by the systems integrator which will be dependent on the technology being deployed for hotel communication infrastructure.

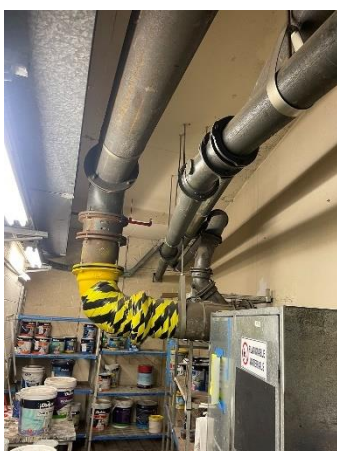
The existing sewer horizontal drainage and stack appears to be in poor condition and is currently sized to accommodate wastewater for the current building scheme. To accommodate the new building scheme, it is envisaged the existing mild steel sanitary drainage services pipework and stack risers would be undersized and should be replaced with new uPVC drainage pipework of adequate size.

Existing Mild Steel sewer drainage.

| Asset | Service | Recommendations |
|---|---|---|
| <b>Sanitary Drainage and sewer stack riser pipework</b> | Hydraulics | Replace to meet latest NCC Standards and to meet new increased demand |

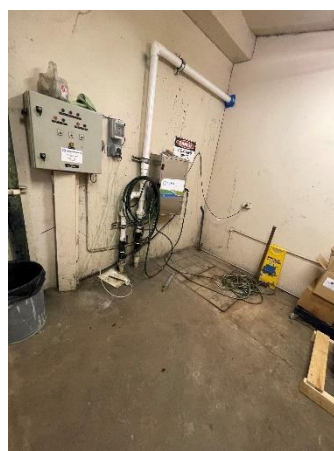
The condition of the existing sewer holding well and associated pumps located on Lower ground Basement is expected to need replacing due to being at it's end of life period. A new sewer holding well and associated pumps will be provided. The existing plantroom the sewer holding well is located within does not incorporate adequate ventilation for personnel to enter and work within. The ventilation to the room will be upgraded.

Existing sewer pump station.

| Asset | Service | Recommendations |
|---|---|---|
| <b>Sewer Holding Well</b> | Hydraulics | Replace to meet latest NCC Standards and to meet new increased demand |

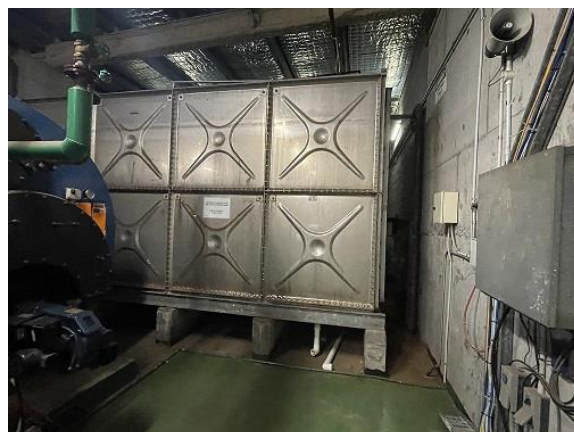
*Existing Combined CW. & FH water storage tank.*

| Asset | Service | Recommendations |
|---|---|---|
| <b>Potable Water Tanks</b> | Hydraulics | Replace to meet latest NCC Standards and to meet new increased demand |

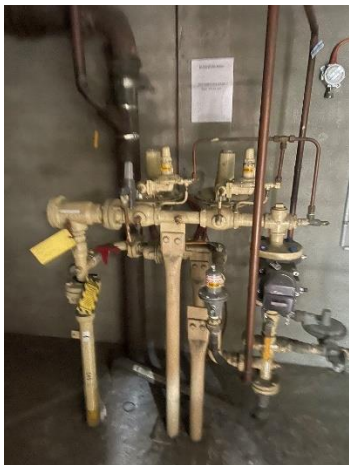
The existing natural gas services reticulates within the building at 100kpa, without being located within a ventilated fire rated shaft in accordance with AS5601. A new boundary regulator will be provided to limit the natural gas supply operating pressure to 7kpa once entering into the building. The building's existing natural gas pipework will be deemed to small to accommodate anticipated natural gas usage at the new lower pressure and will need to be decommissioned and removed. New natural gas service pipework will be run throughout the building to serve to the existing and new gas appliance, sized to cater for the lower gas pressure.

*Existing High pressure gas boundary regulator.*

| Asset | Service | Recommendations |
|---|---|---|
| <b>Gas Services</b> | Hydraulics | Replace to meet latest NCC Standards, City of Sydney Guidelines and to meet new increased demand |

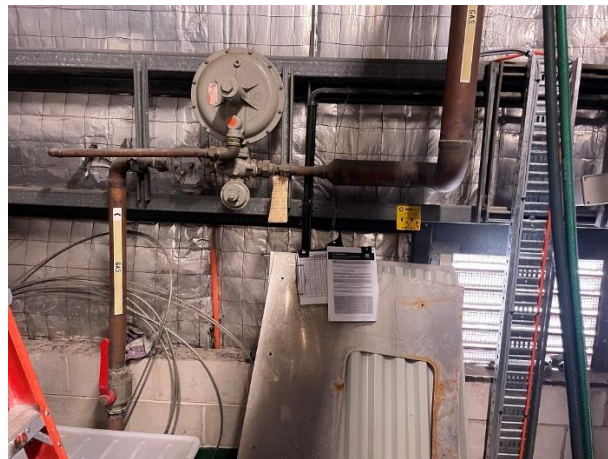
*Existing Gas regulator serving Domestic HW. plant.*

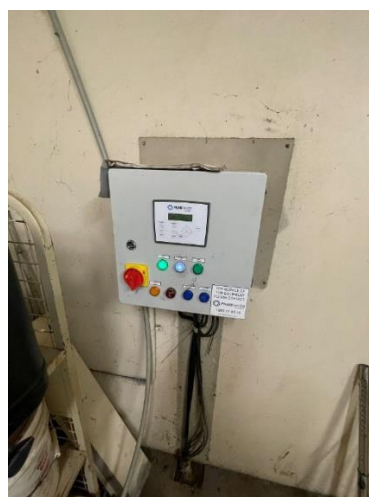
The condition of the existing sewer holding well and associated pumps located on Lower ground Basement is expected to need replacing due to being at it's end of life period. A new stormwater holding well and associated pumps will be provided.

Existing Stormwater pumpstation control panel.

| Asset | Service | Recommendations |
|---|---|---|
| <b>Stormwater Holding Well</b> | Hydraulics | Replace to meet latest NCC Standards and to meet new increased demand |

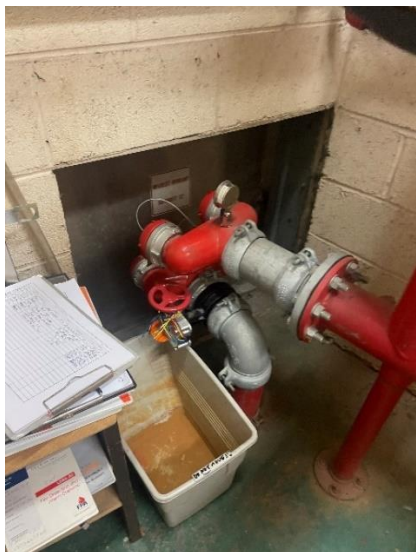
Figure 1: Existing fire hydrant booster assembly

| Asset | Service | Recommendations |
|---|---|---|
| <b>Booster Assembly</b> | Wet Fire | Replace to meet latest NCC Standards and to meet new increased demand |

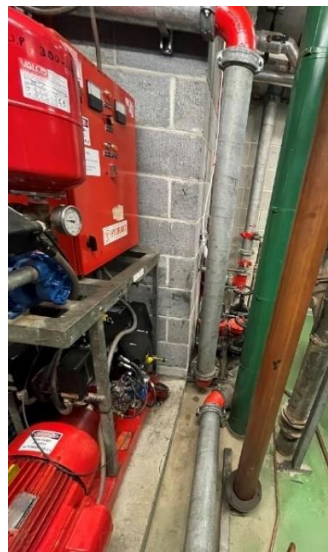
A single hydrant booster pump is located within the roof top plantroom. The pump is a horizontal end suction centrifugal type pump that incorporates both an electric and diesel motors. The hydrant pumps draws water from the fire hydrant storage tank and distributes water to the hydrant landing valves located on levels 11 through to level R. A gravity hydrant service line by-passes the hydrant pump set to serve the hydrants landing valves located on levels Ground floor through to Basement level.

Figure 2: Existing Diesel/Electric Hydrant pump

| Asset | Service | Recommendations |
|---|---|---|
| <b>Hydrant Pumps</b> | Wet Fire | Replace to meet latest NCC Standards and to meet new increased demand |

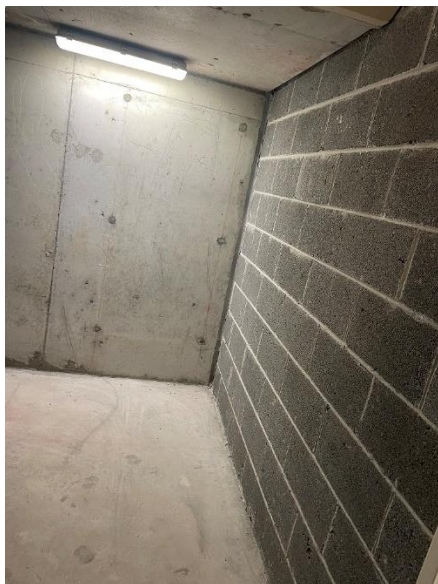
Figure 3: Fire egress stair not containing fire hydrant.

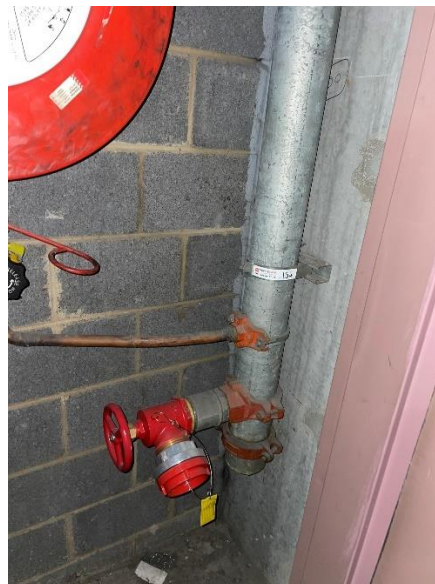
Hydrant landing valves are located on each level, within a dedicated cupboard that is located area adjacent to the door to each fire stair (outside the fire egress stairs).

Figure 4: Fire hydrant in cupboard.

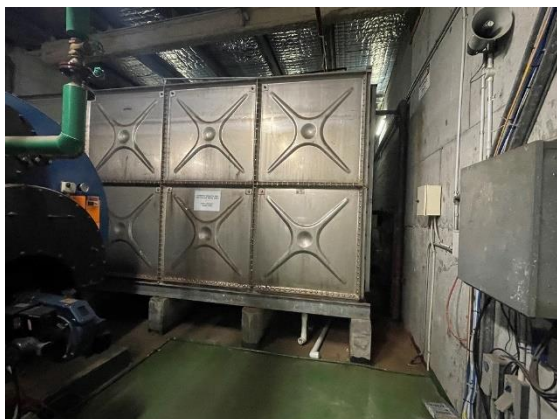
Figure 5: Roof top combined potable/fire hydrant tank.

| Asset | Service | Recommendations |
|---|---|---|
| <b>Hydrant Water Storage Tank</b> | Wet Fire | Replace to meet latest NCC Standards and to meet new increased demand |

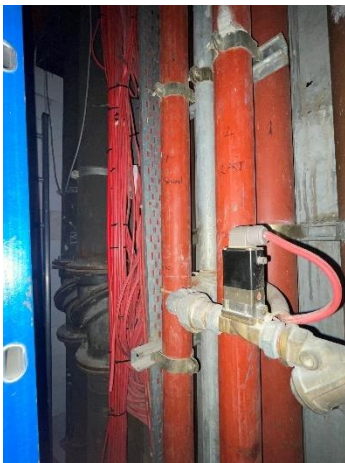
Each floor level contains a sprinkler control valve assembly that is located within a dedicated cupboard. The control valve assembly consists of a monitored isolation valve, flow switch and test/drain-down facilities. A main sprinkler service extends from the control valve assembly to serve the sprinkler services located on that floor level.

Figure 6: On-floor sprinkler control valve assembly

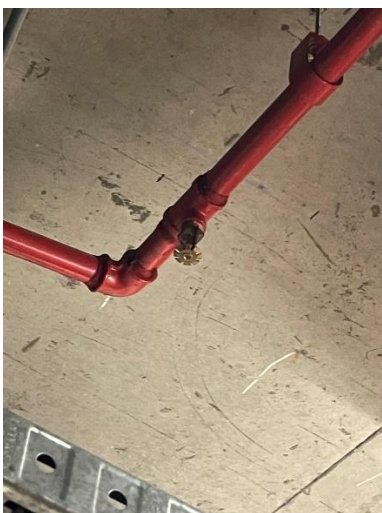
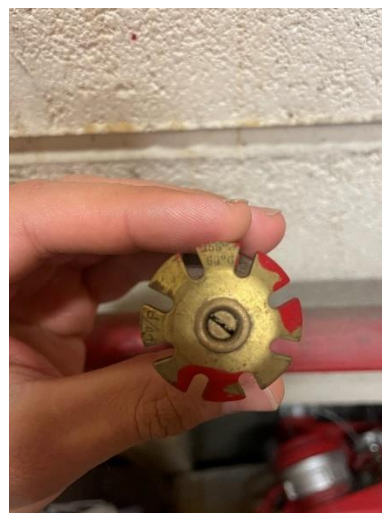
Figure 7: Sprinkler heads example and sprinkler pipes

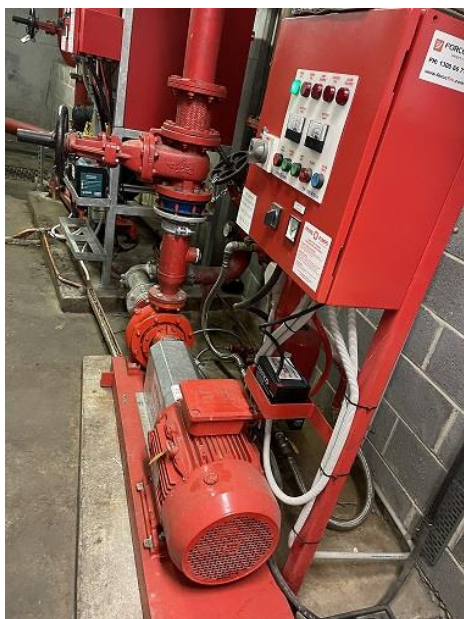
Figure 9: Electric Sprinkler pump

| Asset | Service | Recommendations |
|---|---|---|
| <b>Fire Sprinkler Pumps</b> | Wet Fire | Replace to meet new increased demand |

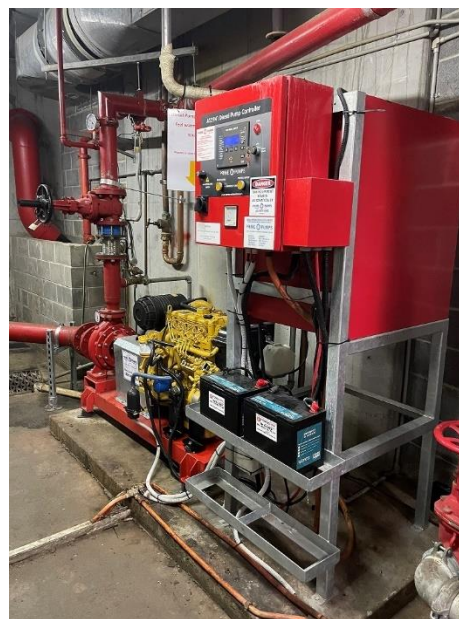
Figure 10: Diesel Sprinkler pump

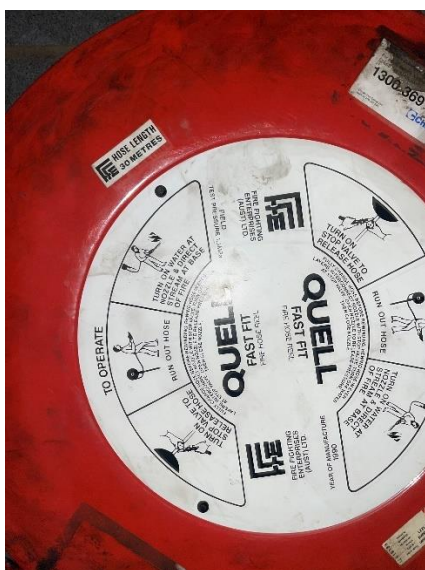
Figure 11: Fire hose reel

| Asset | Service | Recommendations |
|---|---|---|
| <b>Fire Hose Reel</b> | Wet Fire | Replaced existing fire hose reels with new fire hose reels that incorporate a 36m hose.<br>Develop a performance solution to remove all hose reels from all Class 5 areas of the building. |

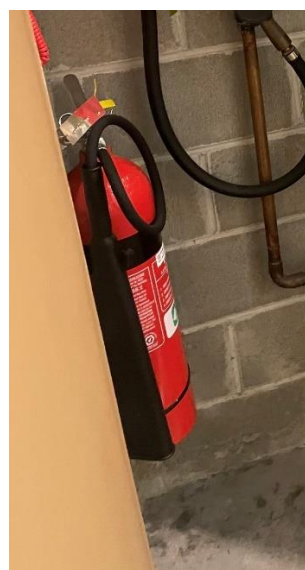
At each hydrant/hose reel location, a CO2 fire extinguisher has been provided.

Figure 12: CO2 Fire extinguisher

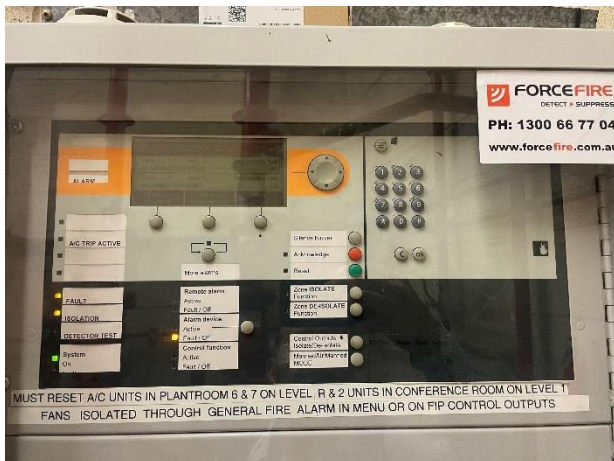
Figure 13: Existing fire indicator panel.

| Asset | Service | Recommendations |
|---|---|---|
| <b>Fire Indicator Panel</b> | Dry Fire | Replace with newer model |

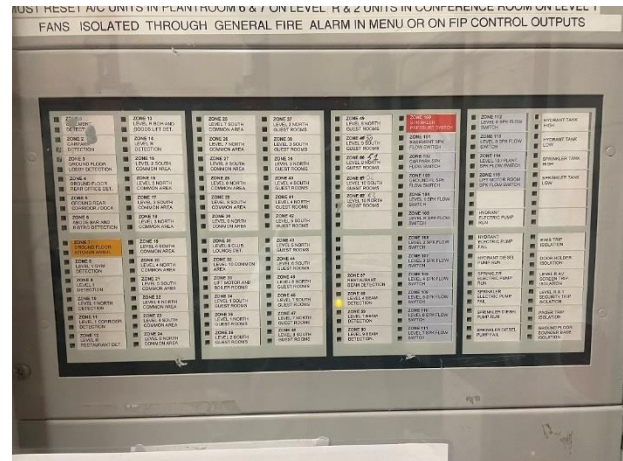
Figure 14: Existing addressable fire indicator panel inc. FFCP

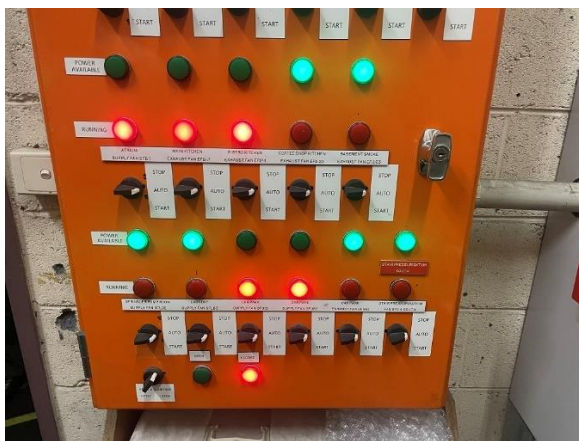
Figure 15: Existing Fire Fan Control panel (FFCP).

| Asset | Service | Recommendations |
|---|---|---|
| <b>Fire Functional Control Panel</b> | Dry Fire | Replace with newer model |

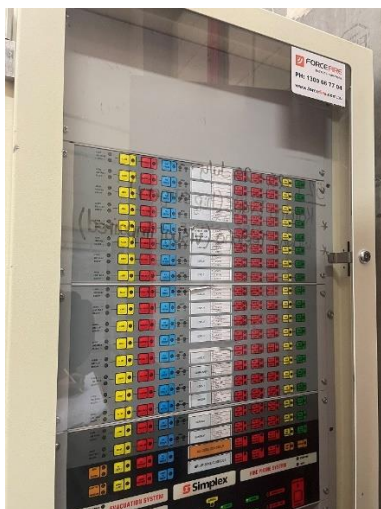
Figure 16: Existing EWIS panel.

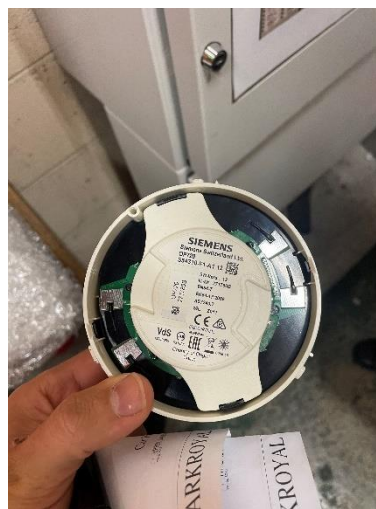
Figure 17: Existing smoke detector.

| Asset | Service | Recommendations |
|---|---|---|
| <b>Smoke Detectors</b> | Dry Fire | Replace to meet latest NCC Standards |

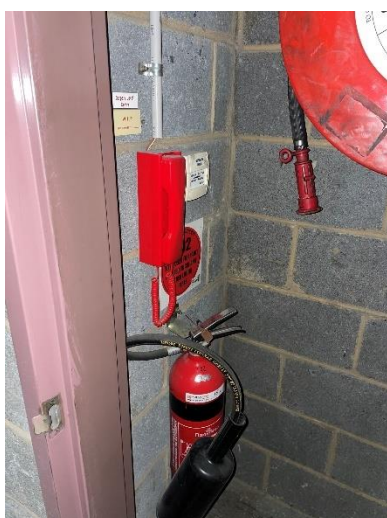
Multiple WIP and ECP's are provided on each level, located within the fire hydrant/hose reel cupboard adjacent to the female amenities.

Figure 18: WIP/ECP points within cupboard.

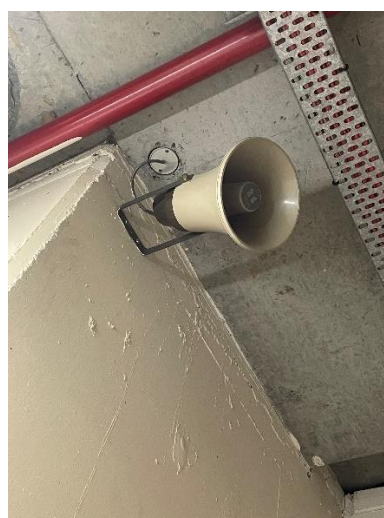
EWIS speakers are provided on each floor level throughout the building. It is unknown if the current spacing of EWIS speakers throughout each floor achieve compliant sound pressure levels and speech intelligibility requirements.

Figure 19: EWIS horn speakers and strobe lights

| Asset | Service | Recommendations |
|---|---|---|
| <b>EWIS Speakers, Phones</b> | EWIS | Replace to meet latest NCC Standards |

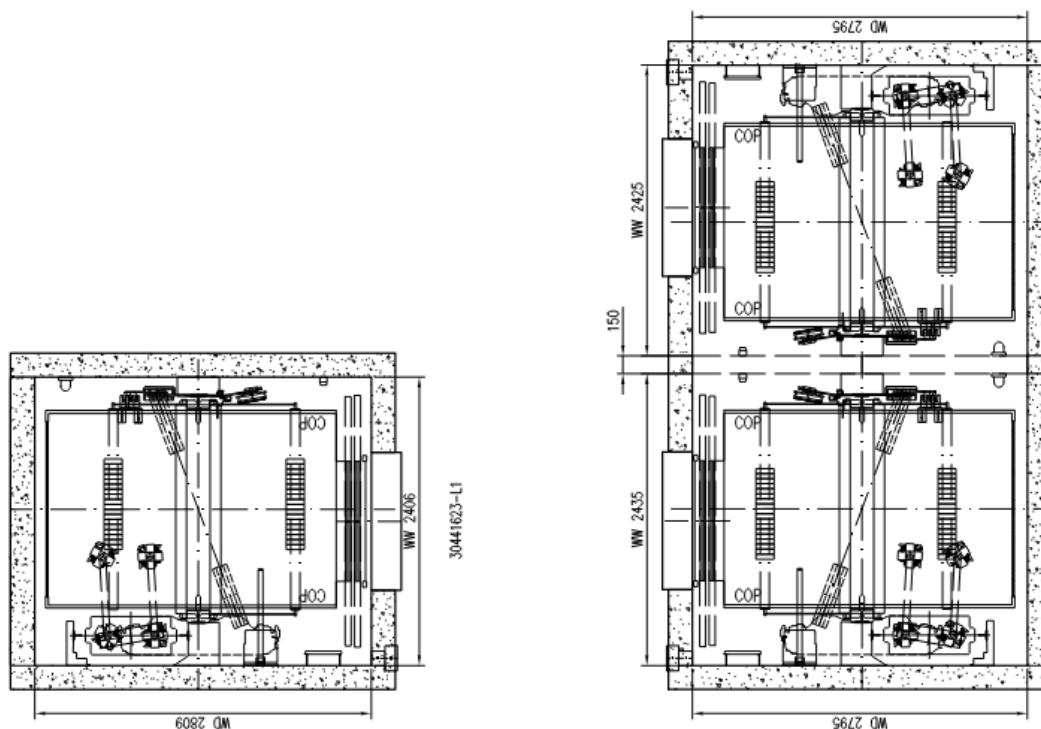
Lift No. 1, 2 & 3

The lift equipment is installed certified complying to AS1735.1:2003 and appears compliant to the current NCC/BCA 2022 mandatory requirements for **C4D11 - Openings in fire-isolated lift shafts** and **E3D8 - Accessible features required for passenger lifts** with the exception of a handrail complying with the provisions for a mandatory handrail in AS 1735.12.

The design life for this model lift is in the order of 20 years subject to usage and continued ongoing maintenance with OEM service schedule. On this basis the current operational life for these lifts should provide for ongoing continuous operation up to approx. 2033 with the view that there will upgrade to Kone LCE controllers and KDM90 drives, and user interface fixturs and fittings with new interior finishes fitout within this period.
