**Inspection Report
47-61 Pyrmont Bridge Road, Camperdown**

Council Investigation Officer Inspection and Recommendation Report; Clause 17(2) Part 8 of Schedule 5 of the Environmental Planning and Assessment Act 1979 (the Act)

**RE: REQUEST FOR COMMENT
THE GRACE
47-61 PYRMONT BRIDGE ROAD CAMPERDOWN ("the premises")
AKA 1 LAYTON STREET**

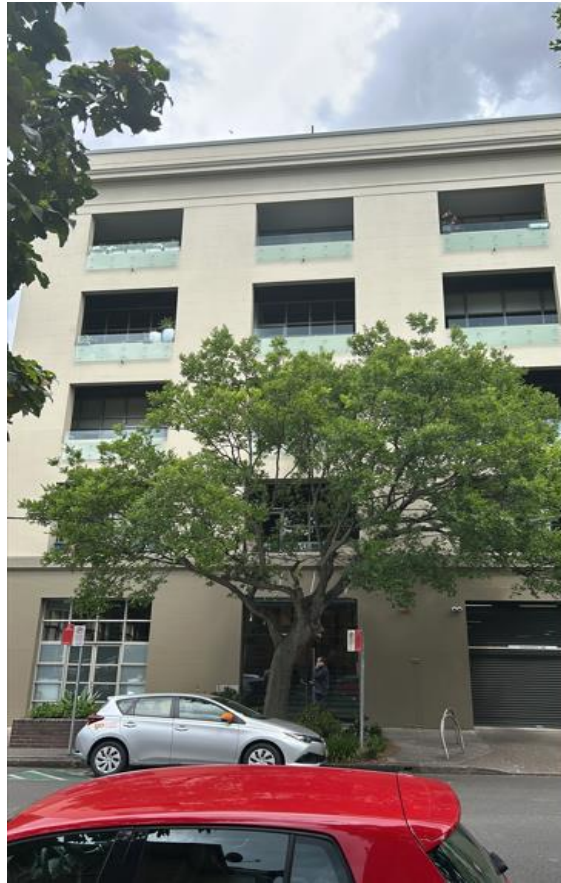
Figure 1: 47-61 Pyrmont Bridge Rd Camperdown viewed from the North
