**Inspection Report  
120-122 Saunders Street, Pyrmont**

# **Council Investigation Officer Inspection and Recommendation Report; Clause 17(2) Part 8 of Schedule 5 of the Environmental Planning and Assessment Act 1979 (the Act)**

**Re: INSPECTION REPORT  
BAYVIEW TOWERS  
120-122 SAUNDERS STREET PYRMONT (hereafter "the premises")**

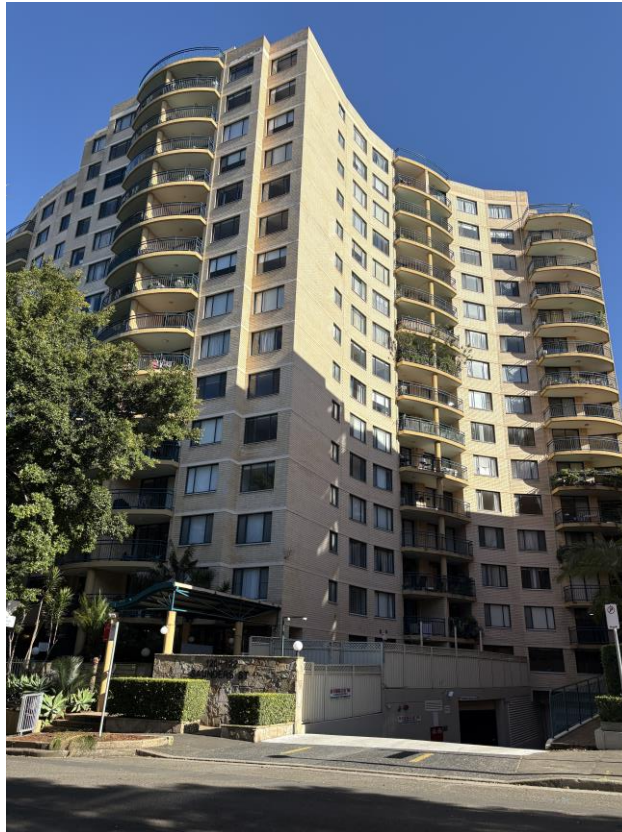
**Figure 1:** 120-122 Saunders Street, Pyrmont

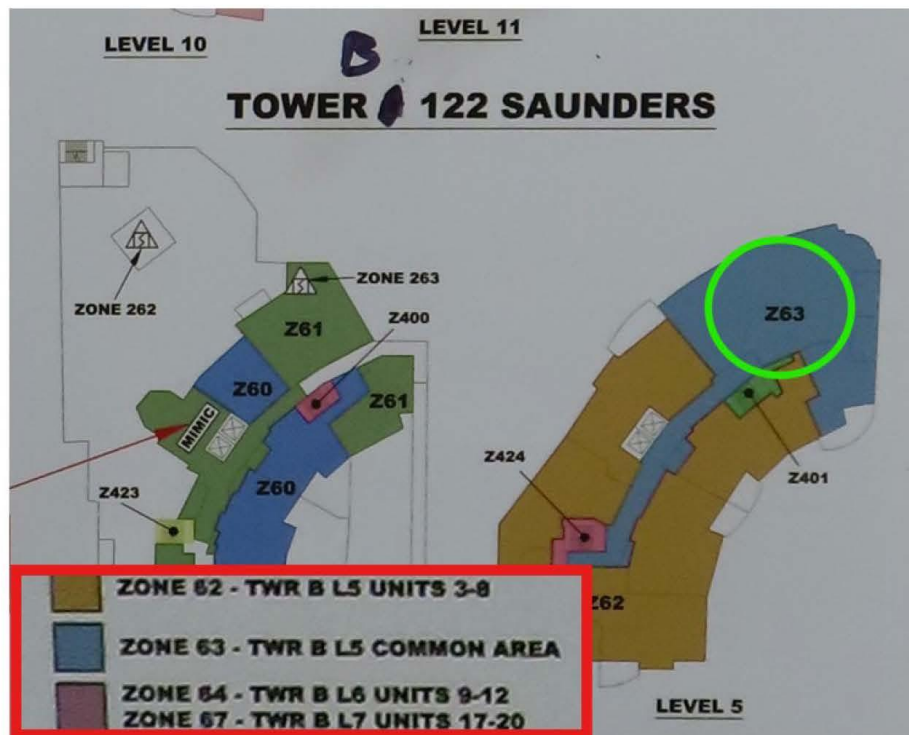
- C. The zone addressing of the fire indicator panel and the building identifiers create confusion for firefighters attending calls of fire at the premises. The block plans have been modified by permanent marker to compensate for FIP addressing.

E.g. The FIP address for Zone 63 is *ZONE 63 – TWR B L5 COMMON AREA* and along with the floor plan, shows Zone 63 as being in Tower B (Figure 1). Zone 63, though, is in Tower A.

*When firefighters are advising occupants, they are going to TWR B L5, the occupants direct them to Tower A. Should an incident occur that requires greater FRNSW resources, the incident controller may not be able to provide adequate safeguards to firefighters as firefighting crews may be sent to the wrong building based all information available to the attending crews.*

Image 1 - FIP block plan changed to reflect inaccurate zone addressing

- a. Review items 1 and 2 (excluding item 1A(A)) of this report and conduct an inspection.
- b. Review the addressing of the fire indicator panel and/or building identifiers.
- c. Address any other deficiencies identified on the premises.

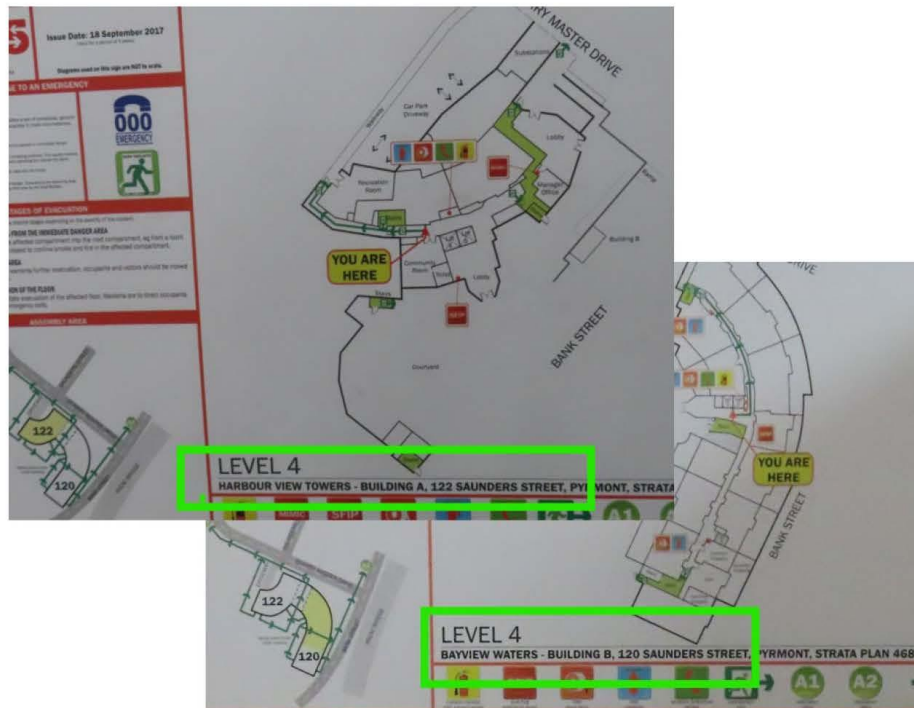
Emergency evacuation plans detail Building A, 122 Saunders and Building B, 120 Saunders (Figure 2).

Image 2 – Emergency Plans with building addresses.
