# **Attachment E**

**Inspection Report  
9-15 Macarthur Street, Ultimo**

**Council Investigation Officer Inspection and Recommendation Report; Clause 17(2) Part 8 of Schedule 5 of the Environmental Planning and Assessment Act 1979 (the Act)**

**Premises:** 9-15 Macarthur Street, Ultimo

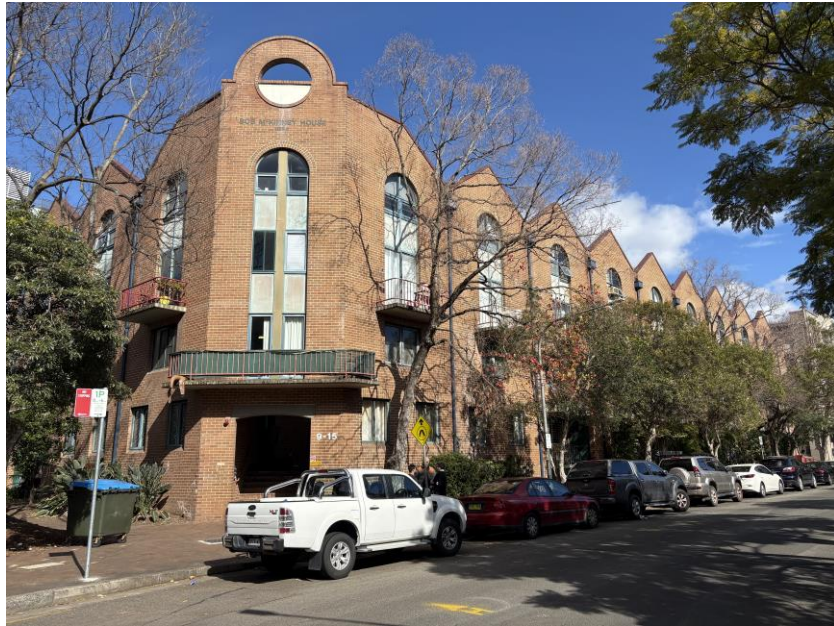
**Figure 1:** 9-15 Macarthur Street, Ultimo, viewed from the north-east
