# Existing Building Services Condition Report

**230655 PARK ROYAL HOTEL  
REDEVELOPMENT**

**Client:**  
UOL

**Revision:**  
C

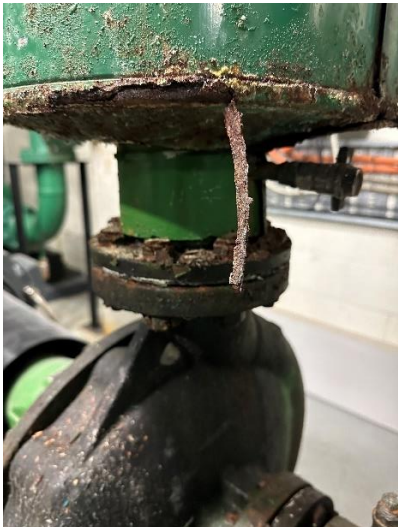
| Infrastructure | Image and General Condition | Re-use Considerations |
|---|---|---|
| <b>Chilled water pipework</b> | <p>Fair to Poor</p> | <ul style="list-style-type: none"> <li>- Must re-evaluate pipe sizing based on updated heat loads in detailed design</li> <li>- Pipe conditions and extent of corrosion cannot be determined from visual inspection and will require ultrasonic non-intrusive testing for re-use evaluation.</li> <li>- Insulation provided required to be updated to latest NCC</li> <li>- Pressure class to be evaluated. Depending on final plant arrangement, can be sufficient.</li> </ul> |

| Asset | Service | Recommendations |
|---|---|---|
| <b>Chilled Water<br/>Pipework</b> | Mechanical | Conduct pipe ultrasonic scans of existing chilled water pipework for new hotel rooms to determine suitability of re-use.<br>Maintain or replace according to findings of testing.<br>Bolster insulation accordingly to meet latest NCC standards<br>Replace main chilled water pipework to meet new increased demand and to suit new architectural scheme. |

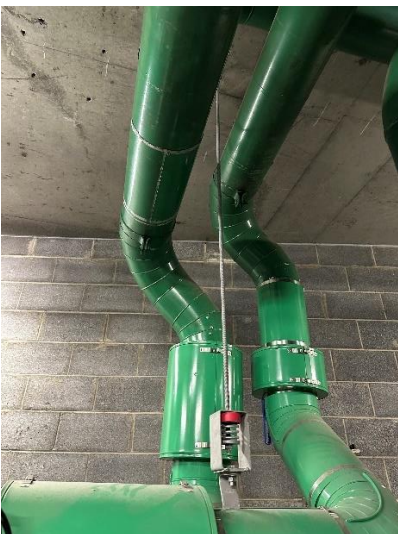
| Infrastructure | Image and General Condition | Re-use Considerations |
|---|---|---|
| <b>Condenser water pipework</b> | <p>Good to Fair</p> | <ul style="list-style-type: none"> <li>- Must re-evaluate pipe sizing based on updated heat loads in detailed design</li> <li>- Pressure class to be evaluated. Depending on final plant arrangement, can be sufficient.</li> <li>- Pipe conditions and extent of corrosion cannot be determined from visual inspection and will require ultrasonic non-intrusive testing for re-use evaluation</li> </ul> |

| Asset | Service | Recommendations |
|---|---|---|
| <b>Condenser Water<br/>Pipework</b> | Mechanical | Conduct pipe ultrasonic scans of existing condenser water pipework to determine suitability of re-use.<br>Maintain or replace according to findings of testing.<br>Replace main condenser water pipework to meet new increased demand and to suit new architectural scheme. |

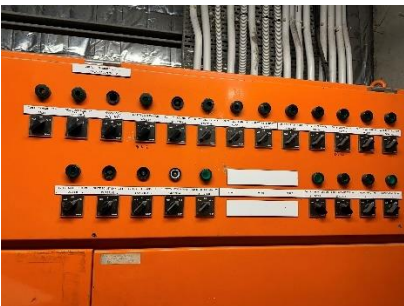
| Infrastructure | Image and General Condition | Re-use Considerations |
|---|---|---|
| <b>Mechanical Electrical</b> | <p>Fair to Poor</p> | <ul style="list-style-type: none"> <li>- Requires detailed analysis if conduits sufficient for new plant loads</li> <li>- Requires upgrade to the latest wiring and electrical standards</li> <li>- Boards are at the end of economic life</li> <li>- Low probability of re-use</li> </ul> |

| Asset | Service | Recommendations |
|---|---|---|
| <b>Mechanical<br/>Electrical Wiring</b> | Mechanical | Replace to meet latest NCC Standards and to suit new architectural scheme |

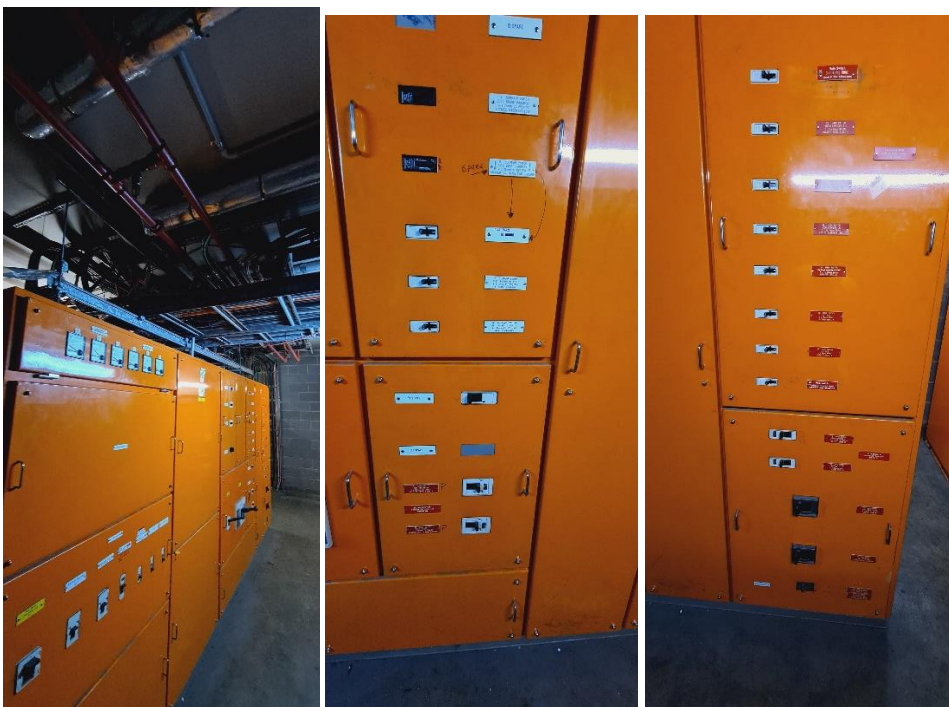
Figure 4-1 : Main Switchboard

The main electrical services Main Switch Room (MSR) is located in the upper basement and serves as the central point of electrical services distribution for the entire building. The switchboard is approaching end of life with no service protection device (SPD) and is not compliant to the current standards(AS 61439). The consumer mains currently originate from Ausgrid substation S.7983(Sussex Sand) and currently has half sized neutral which is also non-compliant to current AS/NZS 3000 requirements.

| Asset | Service | Recommendations |
|---|---|---|
| <b>Main Switchboard</b> | Electrical | Replace to meet latest NCC Standards and to meet new increased demand |

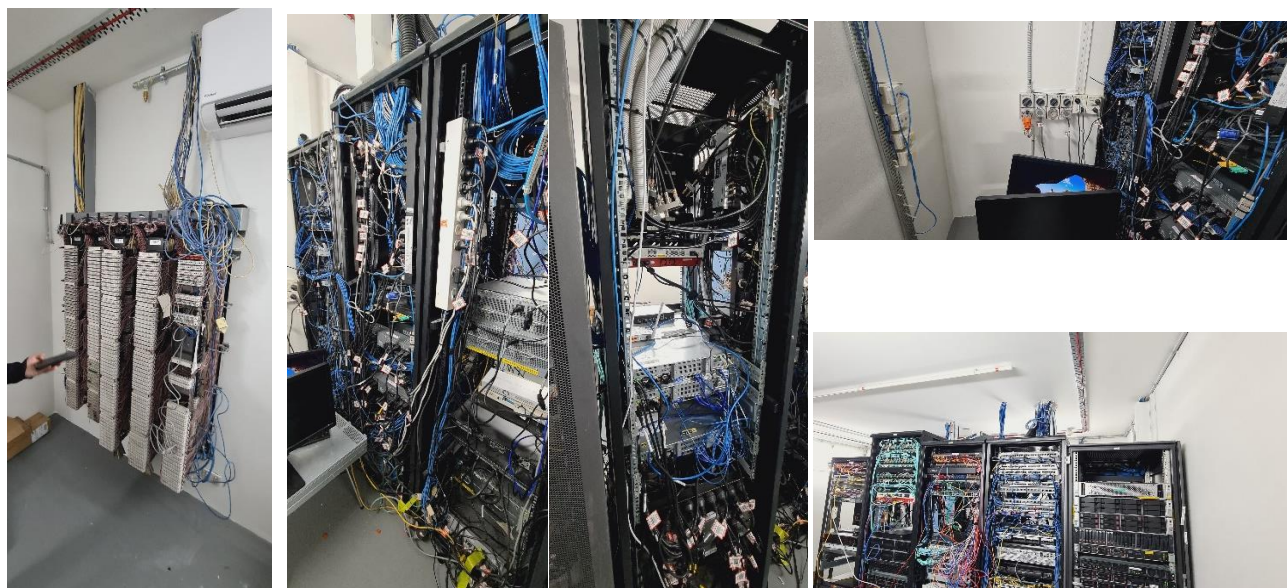
Figure 4-6: Building Distributor Room

The main building distributor room is located in the lower basement and serves as the central point of distribution for the entire building. The room currently houses 5 racks. The room and services could be retained in its current location for existing and future development needs however needs to be cleaned, repainted and finished internally to the current requirements of S009.

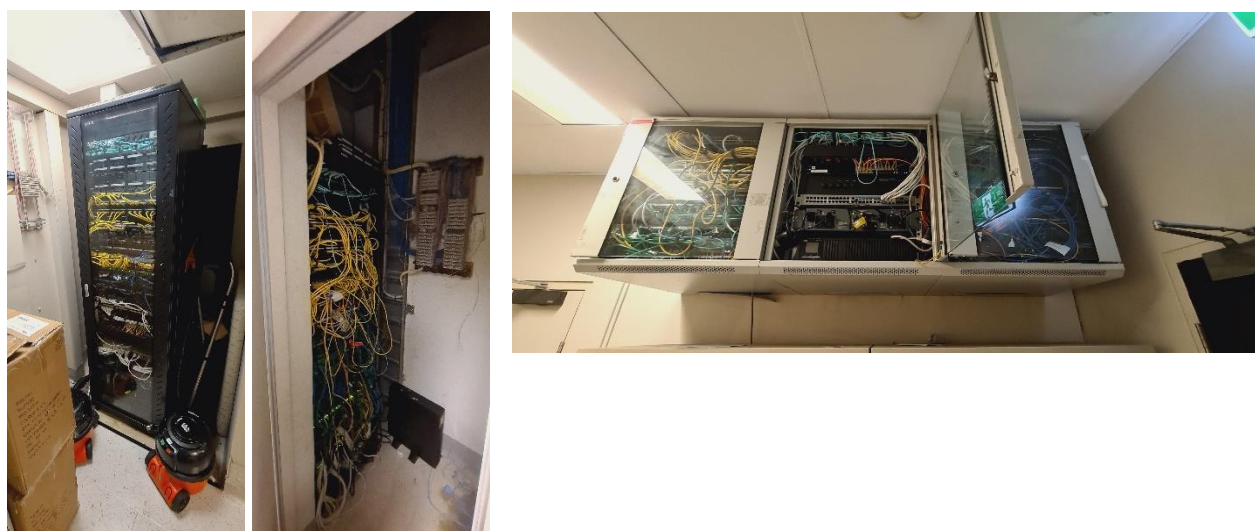
Figure 4-7: Floor Distributor Room

The floor distributor room is located on every level and serves as the central point of distribution on every floor. The room currently houses 1 rack. The space allocation for this room would need to be reviewed in conjunction with the new lift core arrangement for the new development. In some instances, the rack could be re-used for new works which would be dependent on its age and integrity. Spaces for specific use, for e.g. function spaces have their own small wall mounted racks. The suitability of reusing active gear in the current racks would have to be evaluated by the systems integrator which will be dependent on the technology being deployed for hotel communication infrastructure.

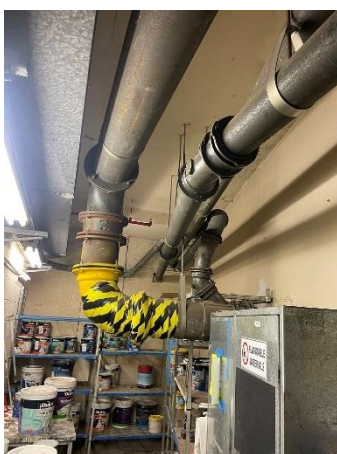
The existing sewer horizontal drainage and stack appears to be in poor condition and is currently sized to accommodate wastewater for the current building scheme. To accommodate the new building scheme, it is envisaged the existing mild steel sanitary drainage services pipework and stack risers would be undersized and should be replaced with new uPVC drainage pipework of adequate size.

Existing Mild Steel sewer drainage.

| Asset | Service | Recommendations |
|---|---|---|
| <b>Sanitary Drainage and sewer stack riser pipework</b> | Hydraulics | Replace to meet latest NCC Standards and to meet new increased demand |

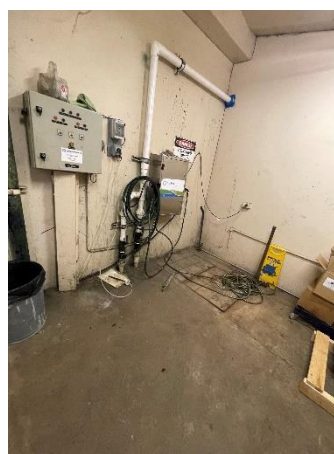
The condition of the existing sewer holding well and associated pumps located on Lower ground Basement is expected to need replacing due to being at it's end of life period. A new sewer holding well and associated pumps will be provided. The existing plantroom the sewer holding well is located within does not incorporate adequate ventilation for personnel to enter and work within. The ventilation to the room will be upgraded.

Existing sewer pump station.

| Asset | Service | Recommendations |
|---|---|---|
| <b>Sewer Holding Well</b> | Hydraulics | Replace to meet latest NCC Standards and to meet new increased demand |

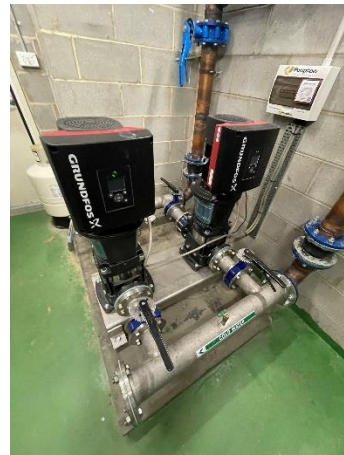
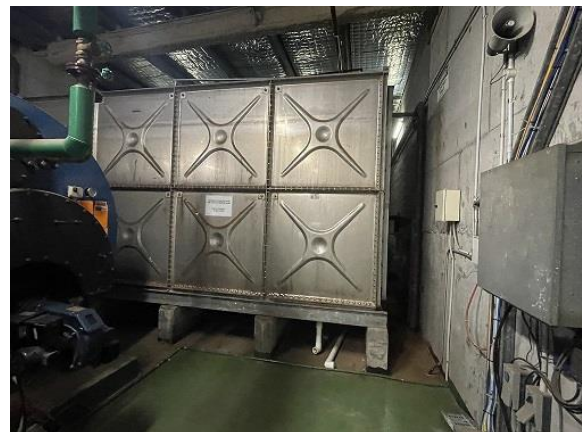
The current potable water services pipework appears to be in poor condition and is sized to cater for the current building scheme. New potable water services pipework should be provided that is adequately sized to cater for the new building scheme,

*Existing CW. transfer pumps.*

*Existing CW. booster pumps.*

*Existing incoming CW. service.*

*Existing Combined CW. & FH water storage tank.*

| Asset | Service | Recommendations |
|---|---|---|
| <b>Potable Water Pipework</b> | Hydraulics | Replace to meet latest NCC Standards and to meet new increased demand |

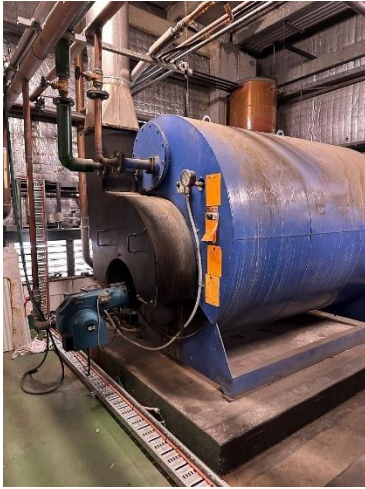
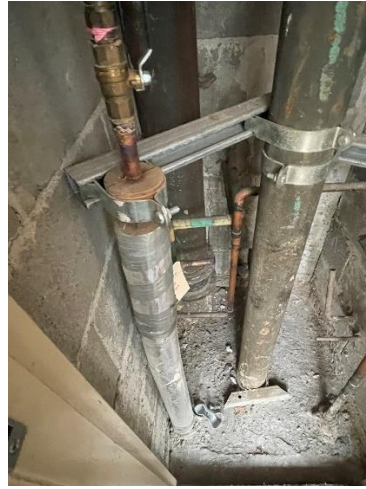
Currently no hot water temperature control devices in the form of tempering valves or thermostatic mixing valves are being utilised on the hot water system as required by the AS3500. New temperature control devices will be provided throughout the building to provide:

*Existing Domestoc HW boiler.*

*Existing Hot Water services pipework.*

| Asset | Service | Recommendations |
|---|---|---|
| <b>Domestic Hot Water Plant</b> | Hydraulics | Replace with heat pumps to meet latest NCC Standards and to meet new increased demand |
| <b>Hot Water Pipework</b> | Hydraulics | Replace to meet latest NCC Standards and to meet new increased demand |
