Attachment C

**Inspection Report
547-549 Crown Street, Surry Hills**

Council Investigation Officer Inspection and Recommendation Report; Clause 17(2) Part 8 of Schedule 5 of the Environmental Planning and Assessment Act 1979 (the Act)

Premises: 547-549 Crown Street, Surry Hills

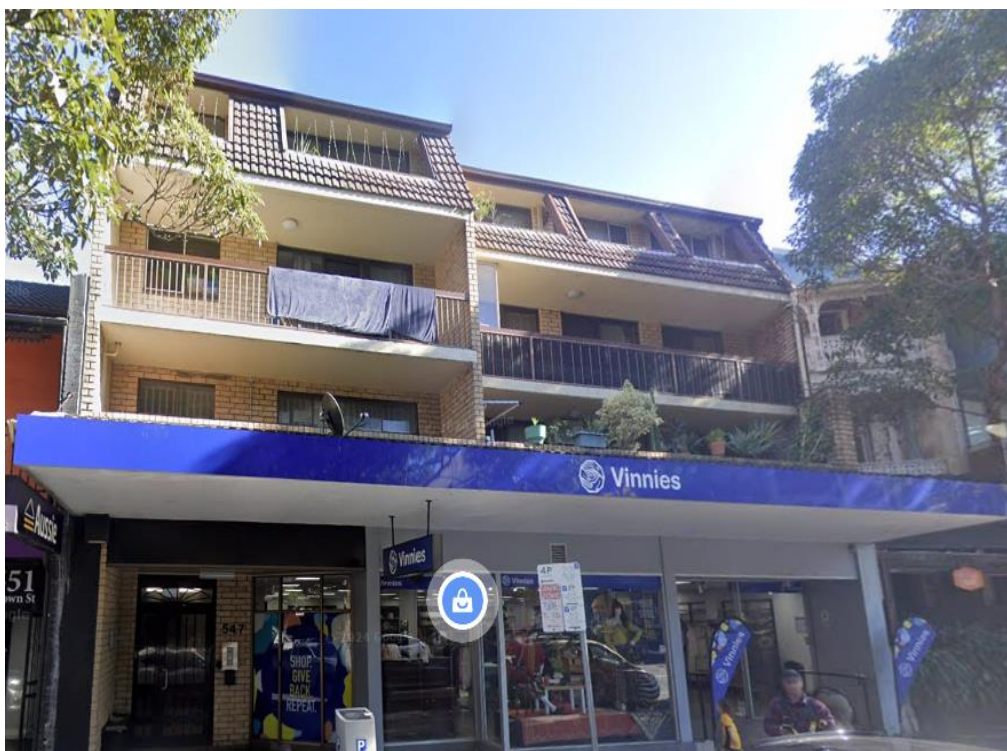
Figure 1: 547-549 Crown Street, Surry Hills, viewed from the east

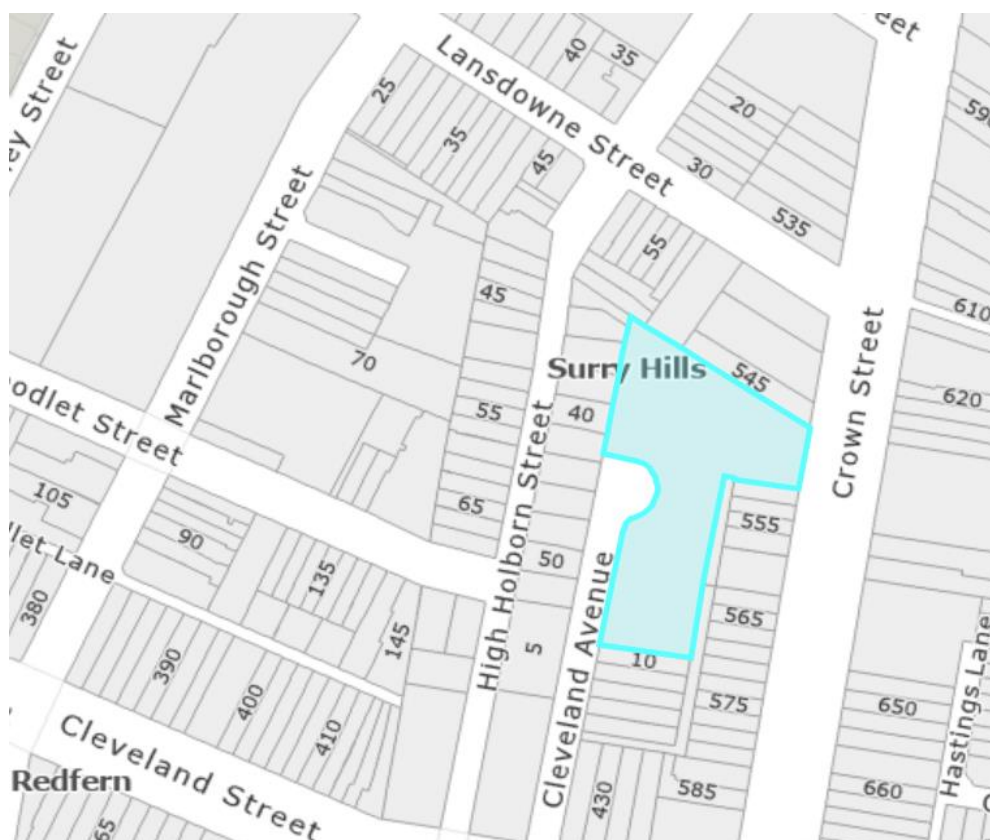
Figure 2: 547-549 Crown Street, Surry Hills

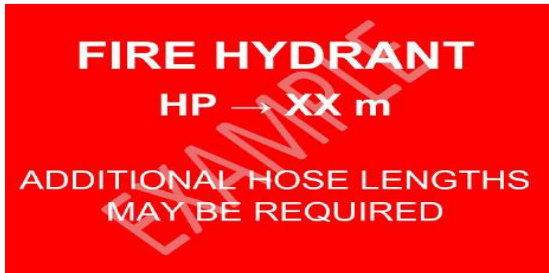
5.	<p>FRNSW recommend adjacent to the site plan is two signs indicating the direction and distance to the external fire hydrant at the premises (See Figure 2).</p> <p>One sign is to face the Crown Street entrance with the other sign facing the Cleveland Avenue entrance.</p>

<p>The City's inspection on 23 July 2025 found that the building lacked a site plan and fire hydrant signage that would assist firefighters in locating the fire safety measure in the case of a fire emergency at the premises.</p> <p>In response to this, the City issued a Proposed Fire Safety Order on 4 September 2025 requiring a suitable site plan and fire hydrant signage to be installed.</p>

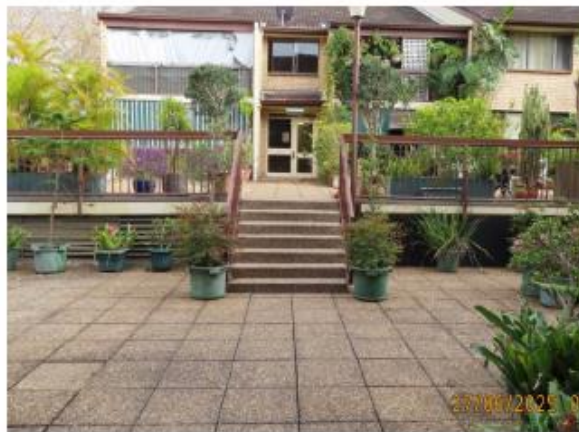
Figure 1

2. FRNSW observed hose lay coverage greater than the requirements of AS 2419.1-1994 to the northern unit blocks from the single attack fire hydrant on the podium level. The attack fire hydrant is located in a position remote from the two northern residential unit blocks and is not visible to firefighters responding to a fire when entering the property from Crown Street.

3. Due to the constraints of access and size of the site, FRNSW is of the opinion that an additional external attack hydrant in the central part of the podium between the entrance from Crown Street and Cleveland Avenue (Image 1) would be beneficial to firefighters in the case of a fire emergency at the premises.

- a. Review items 1 to 14 of this report and conduct an inspection.
- b. An additional external attack hydrant in the central part of the podium between the entrance from Crown Street and Cleveland Avenue.
- c. A site plan and additional signage in the central area of the podium level.
- d. Address any other deficiencies identified on "the premises".

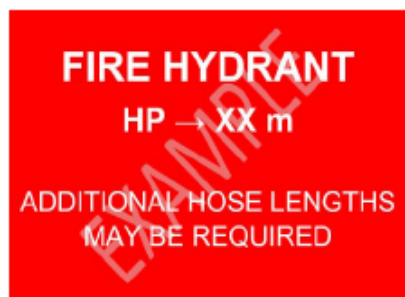
Figure 2

5. FRNSW recommend adjacent to the site plan is two signs indicating the direction and distance to the external fire hydrant at the premises (See Figure 2).

One sign is to face the Crown Street entrance with the other sign facing the Cleveland Avenue entrance.
