Attachment D

**Inspection Report
252-258 Sussex Street, Sydney**

Council Investigation Officer Inspection and Recommendation Report; Clause 17(2) Part 8 of Schedule 5 of the Environmental Planning and Assessment Act 1979 (the Act)

**Re: INSPECTION REPORT
YEHS HOTEL SYDNEY HARBOUR SUITES
252 SUSSEX STREET SYDNEY 2000 ("the premises")**

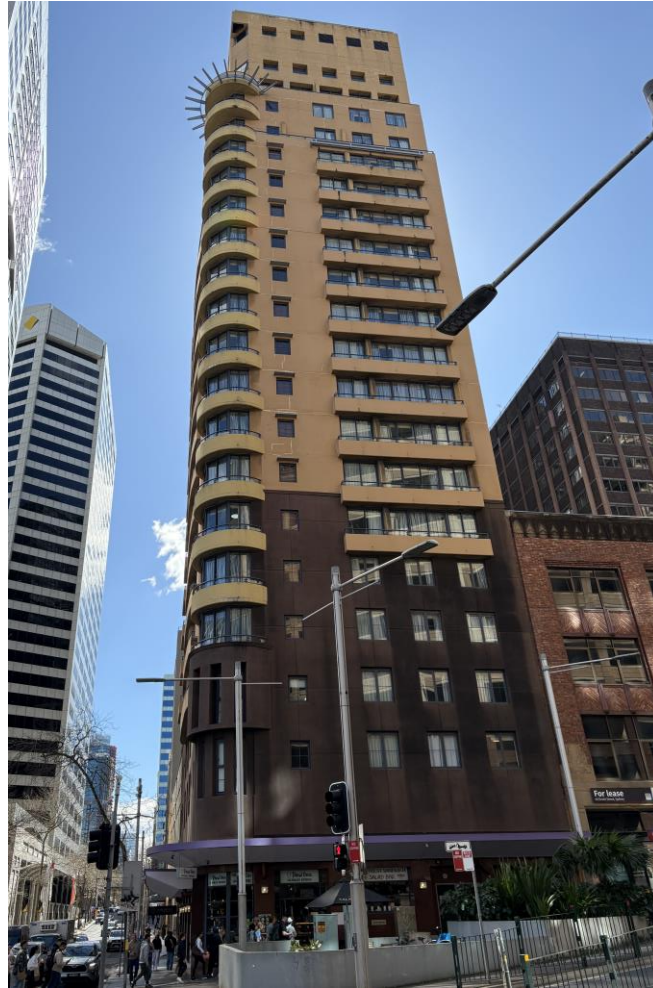
Figure 1: 252-258 Sussex Street, Sydney, viewed from the south-west
