Attachment B

**Inspection Report
144 Victoria Street, Potts Point ('Chili Blue
Backpackers')**

Council Investigation Officer Inspection and Recommendation Report; Clause 17(2) Part 8 of Schedule 5 of the Environmental Planning and Assessment Act 1979 (the Act)

**Re: INSPECTION REPORT
URBAN NOMADS
144 VICTORIA STREET POTTS POINT ("the premises")**

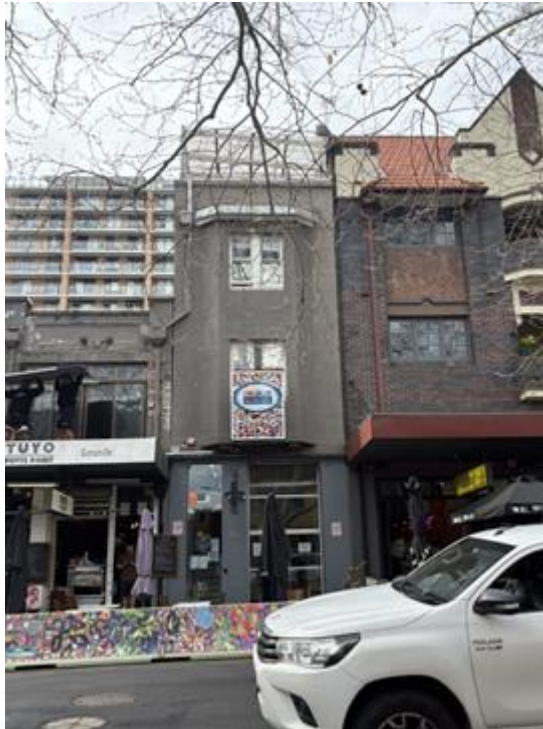
Figure 1: 144 Victoria Street, Potts Point viewed from the west
