# **Attachment C**

**Inspection Report  
547-549 Crown Street, Surry Hills**

# **Council Investigation Officer Inspection and Recommendation Report; Clause 17(2) Part 8 of Schedule 5 of the Environmental Planning and Assessment Act 1979 (the Act)**

**Re: INSPECTION REPORT  
RESIDENTIAL DWELLINGS  
547 CROWN STREET SURRY HILLS ("the premises")**

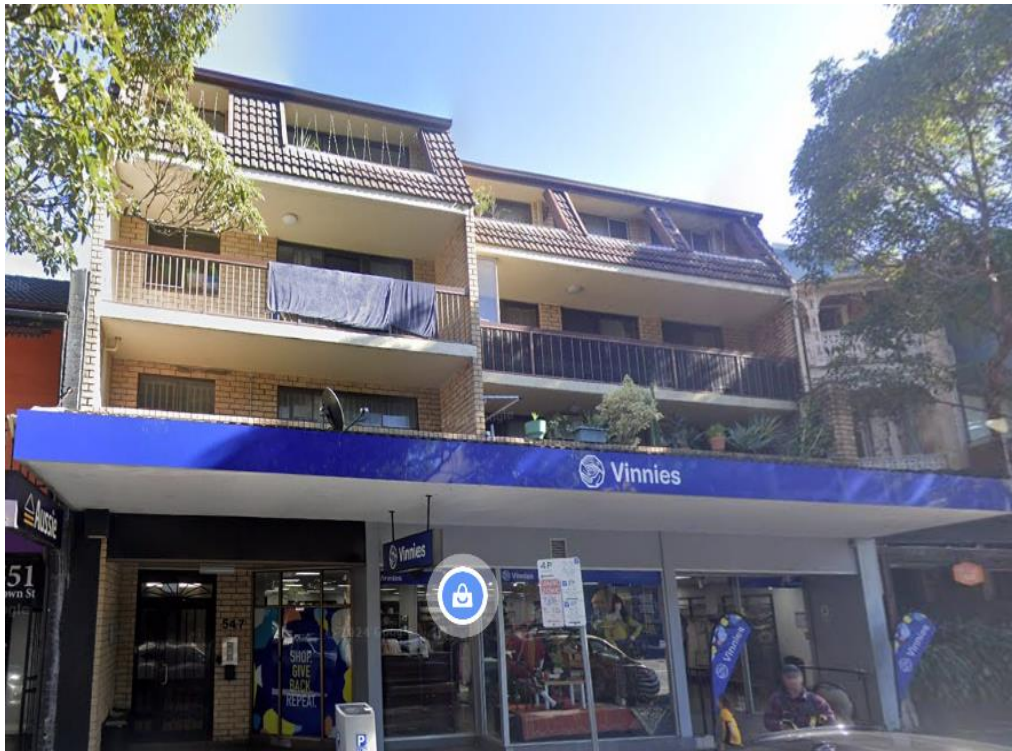
**Figure 1:** 547-549 Crown Street, Surry Hills, viewed from the east

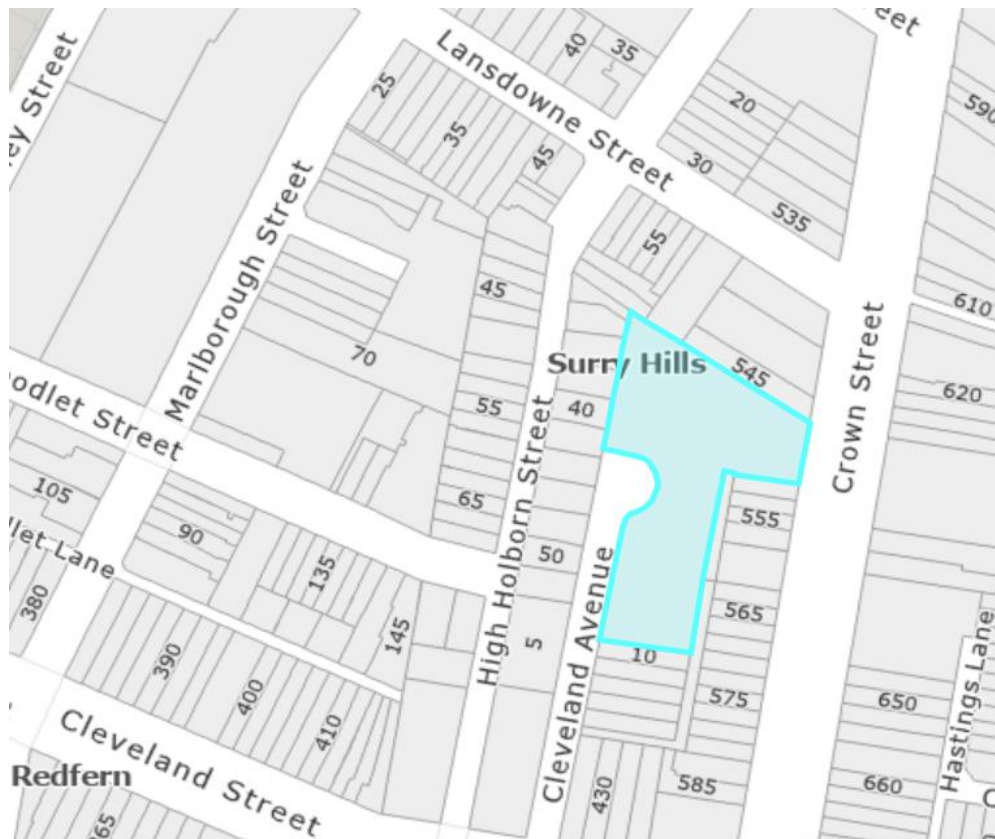
**Figure 2:** 547-549 Crown Street, Surry Hills
