**Inspection Report
679-695 Bourke Street, Surry Hills**

Council Investigation Officer Inspection and Recommendation Report; Clause 17(2) Part 8 of Schedule 5 of the Environmental Planning and Assessment Act 1979 (the Act)

Premises: 679-695 Bourke Street, Surry Hills

**Re: INSPECTION REPORT
679 BOURKE STREET
SURRY HILLS ("the premises")**

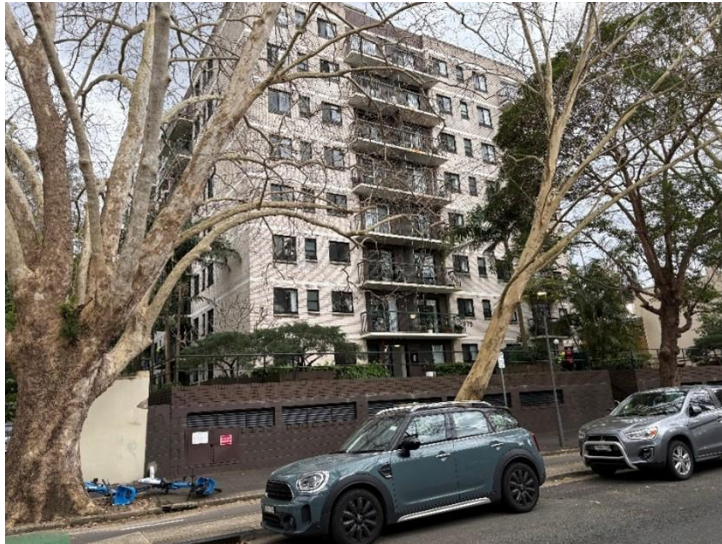
Figure 1: 679-695 Bourke Street, Surry Hills facing west from Bourke Street
