Attachment D

Scope of Works: Vestibule Dome

Attachment D – Scope of Works: Vestibule Dome

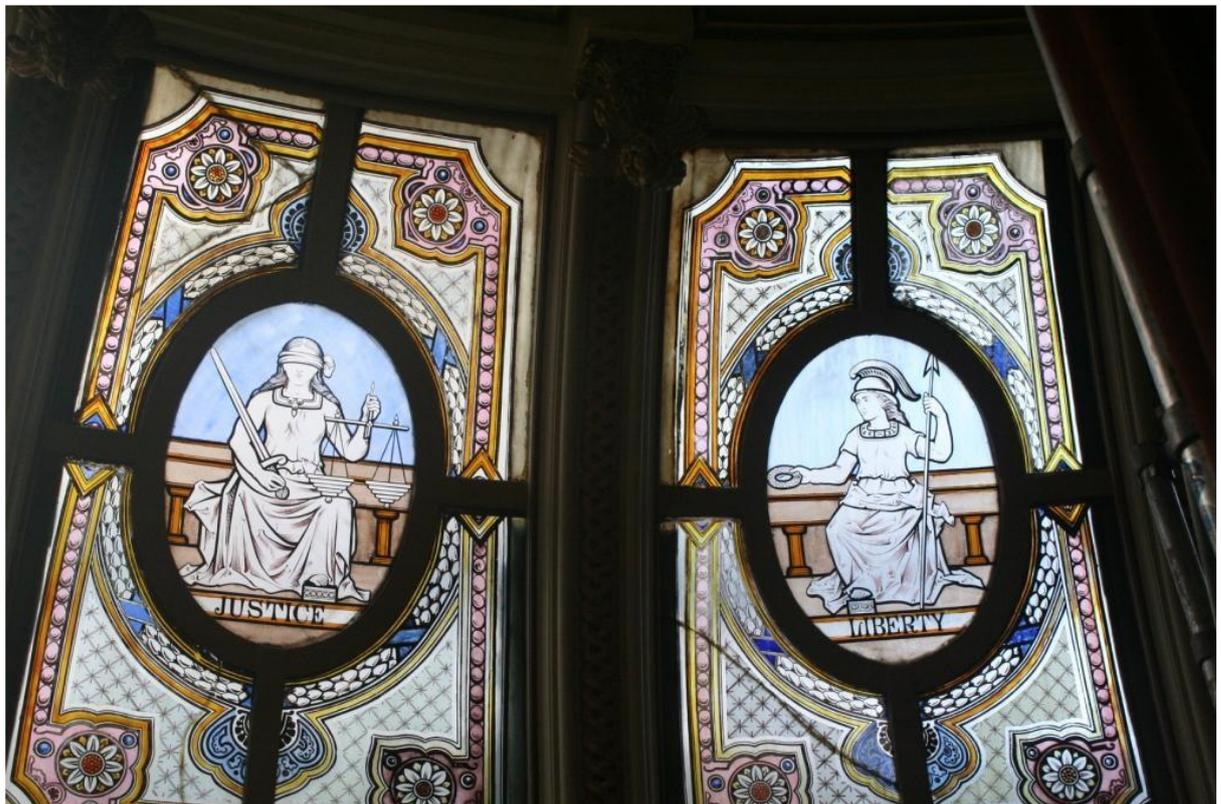
Image at "Justice" and "Liberty" bays

Internal view after cleaning of the exterior of the glass panels and removal of the upper portion of the wide lead overflashing over the curved rib in the centre of the image. On the central rib, the lower portion of the overflashing remains in place and overlaps the glass panels on both sides of the rib by about 40mm thereby obscuring the beige coloured vertical margin and reducing the translucent area of glass in each bay by about 10%
