Attachment A

General Scope of Works and Program

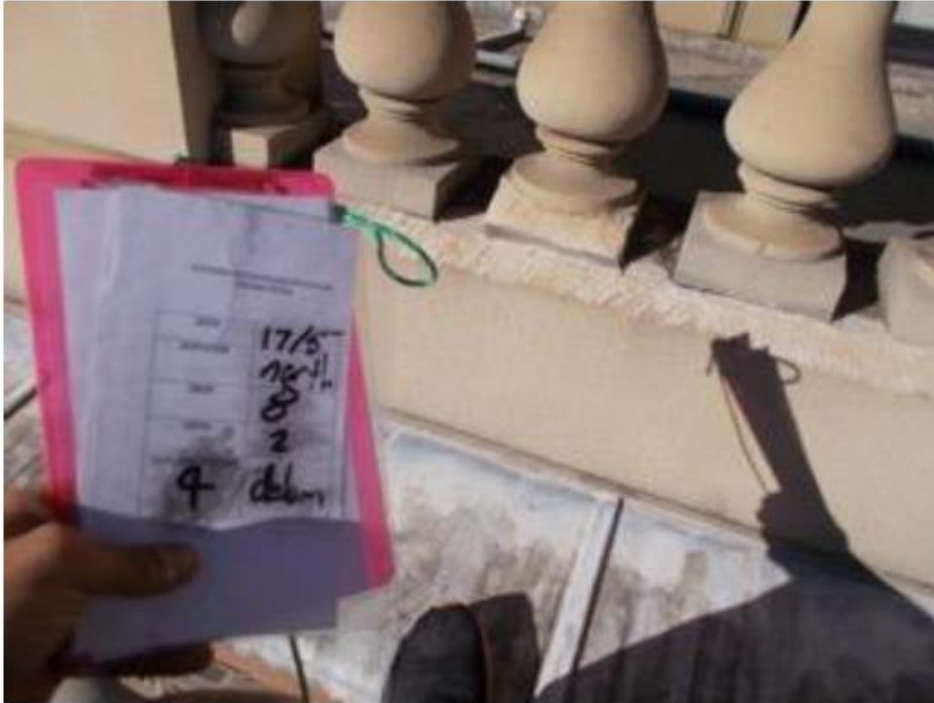
Level 2: deterioration at base of sandstone balustrade

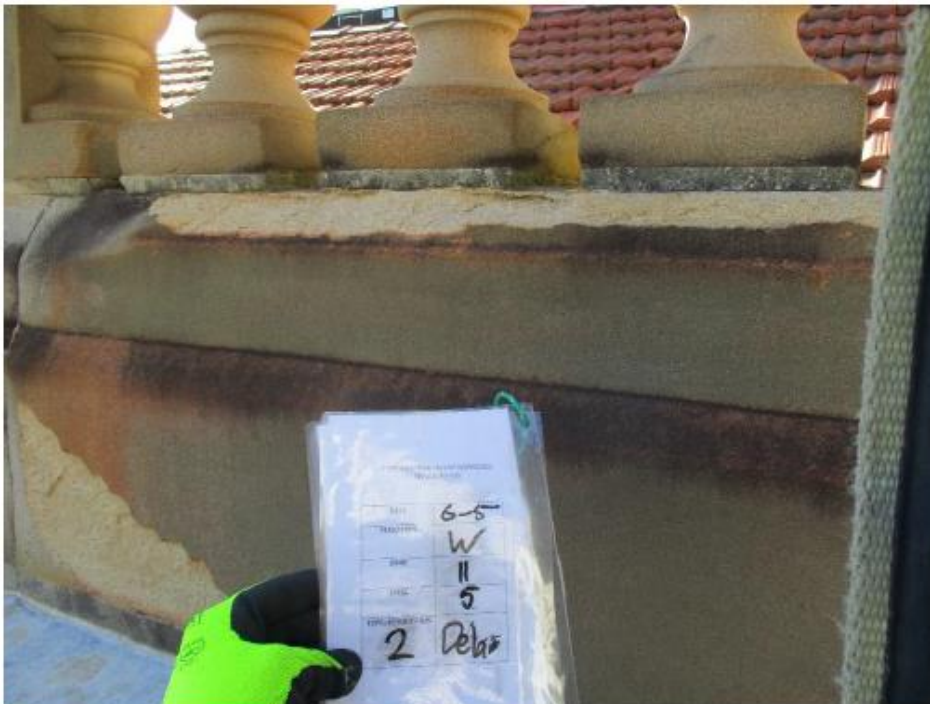
Level 5: deterioration at base of sandstone balustrades

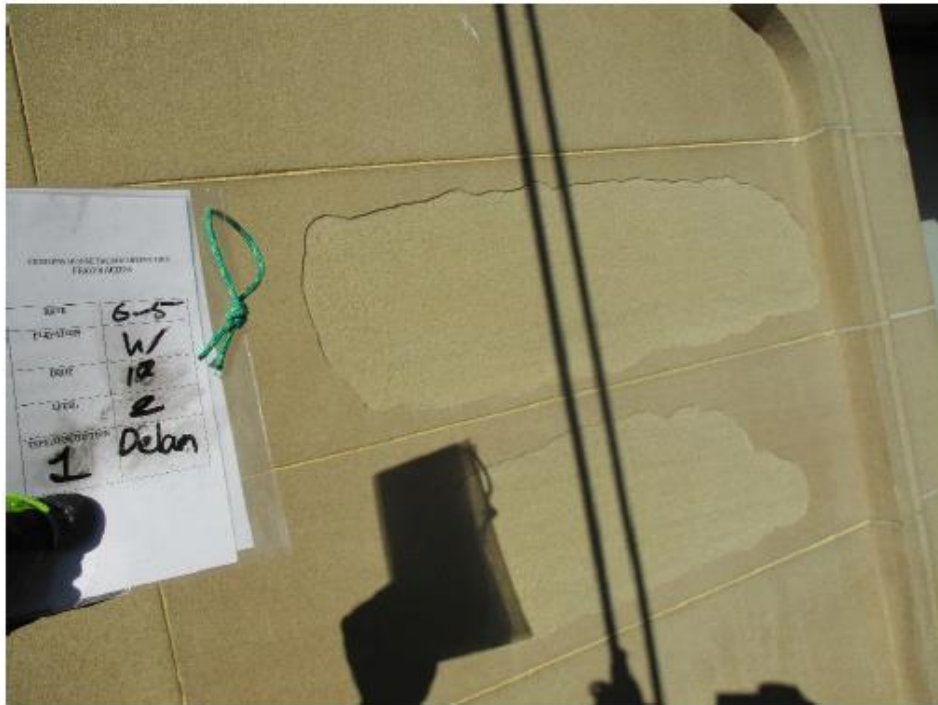
Level 2: weathering of sandstone wall

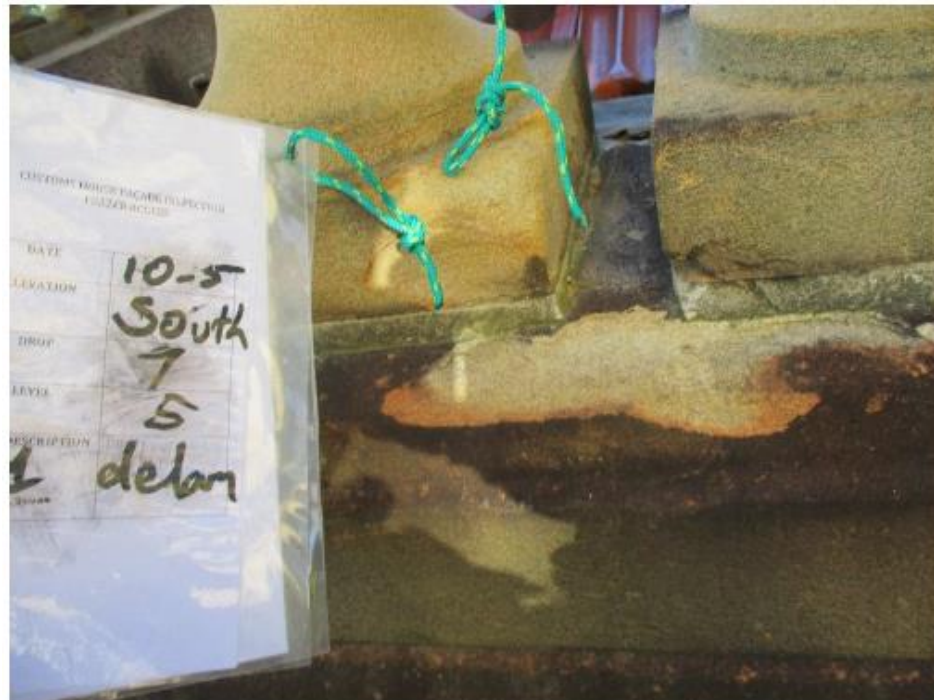
Level 5: sandstone deterioration at base of balustrades

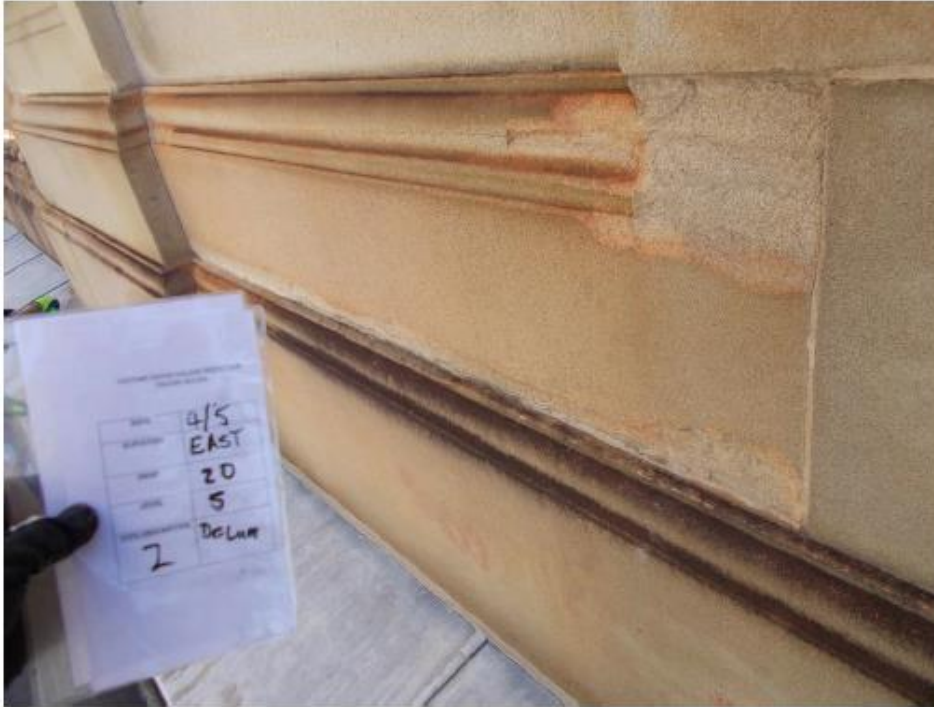
Level 5: deterioration of sandstone wall
