CONSERVATION MANAGEMENT PLAN

171-173 VICTORIA STREET, POTTS POINT

2 JUNE 2020
P0005011
PREPARED FOR OAKSTAND

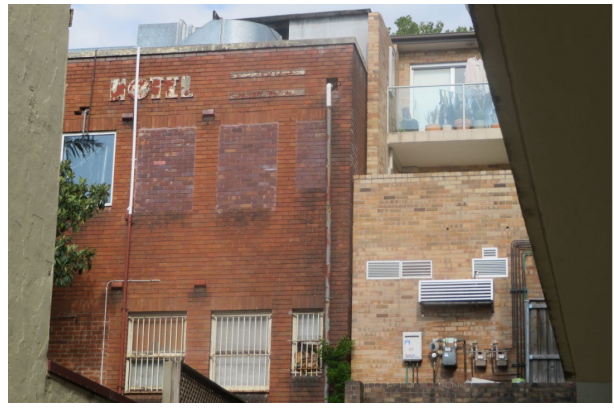
Figure 19 – View of the rear of the subject hotel from No. 100 Brougham Street carpark. Note remnant Hotel sign and infilled windows.

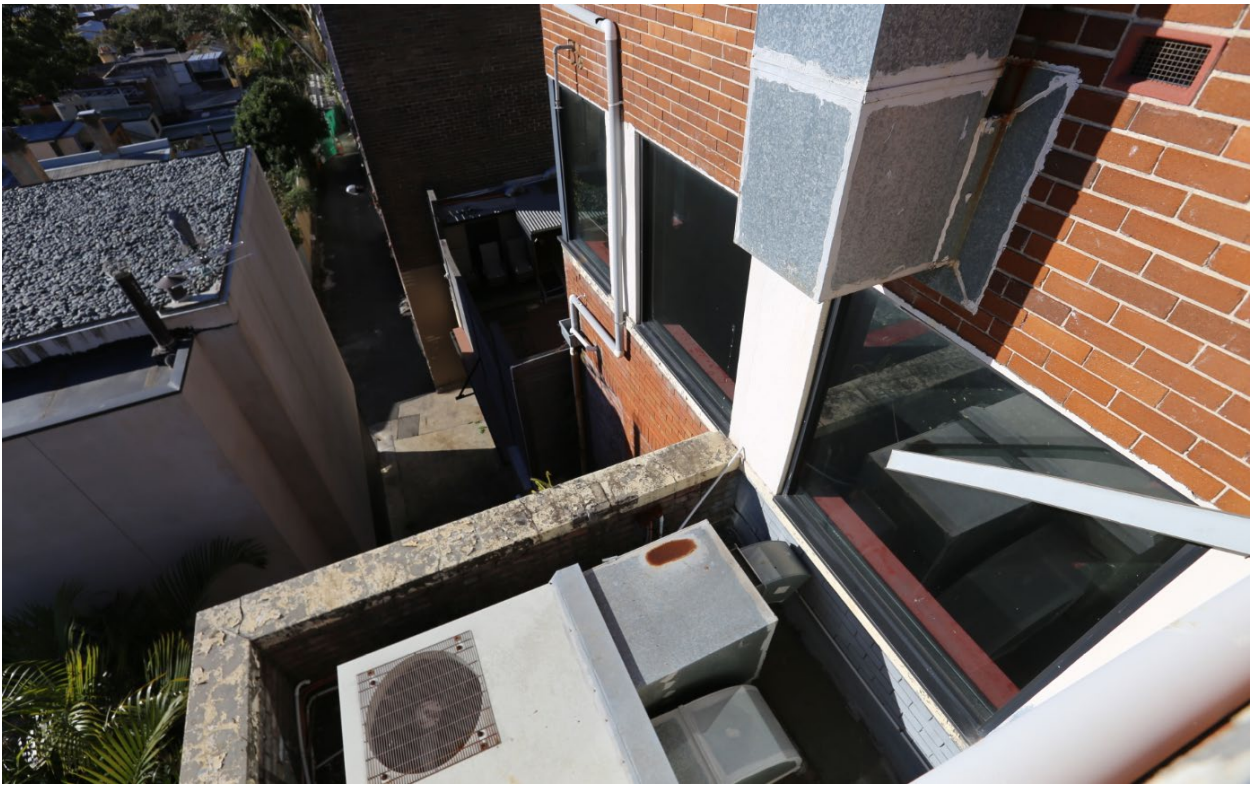
Figure 21 – View of the rear (western) façade of the subject Hotel. View from within the subject site. Note areas of infilled windows on the ground floor. Windows on the second floor were constructed in 1997 as part of the balcony infill.

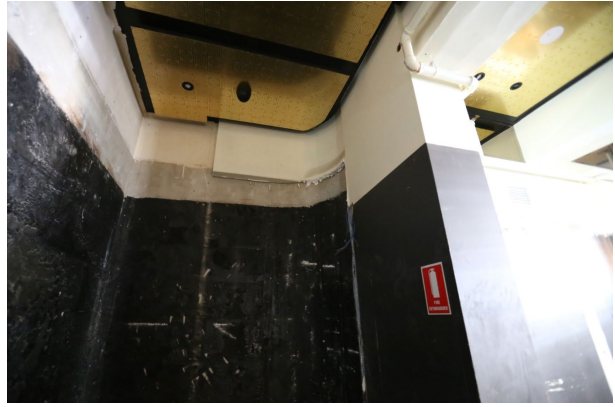
Figure 56 – View south within the games room. Replaced doors/entrance with louvers for ventilation.

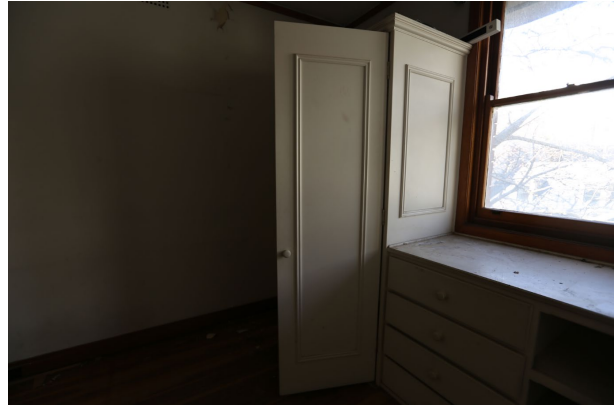
Figure 108 – View west into room in the north-west corner. Damaged ceiling and contemporary wardrobe.
