Heritage Committee Report

Date: 12 March 2021
Development Application: D/2020/1071 and D/2020/1072
Site: 58-76, 82-106, and 110-122 Oxford Street, Darlinghurst
Applicant: TOGA Projects Services
Committee Members:
Scott Robertson, Robertson & Hindmarsh
Hari Gohil, Shreeji Consultant
Otto Cserhalmi, OCP Architects

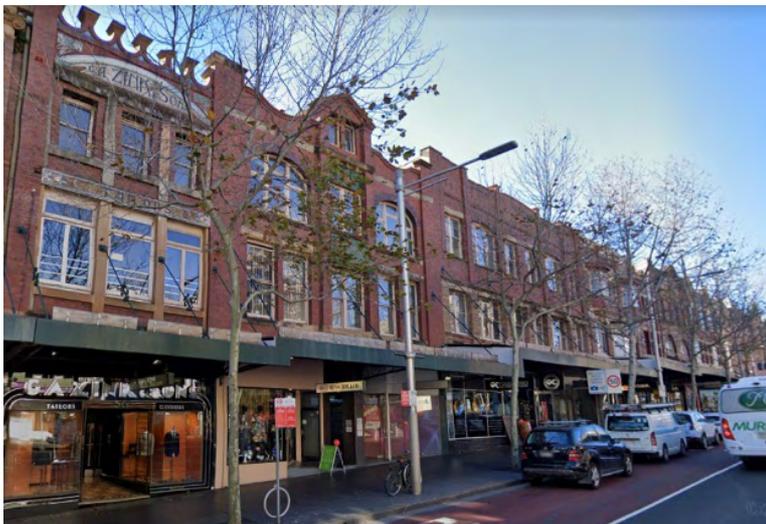
Figure 1 - Exterior view of group 1 buildings at 56-76 Oxford Street, showing buildings at the western end of the group. Source: Google Streetview.

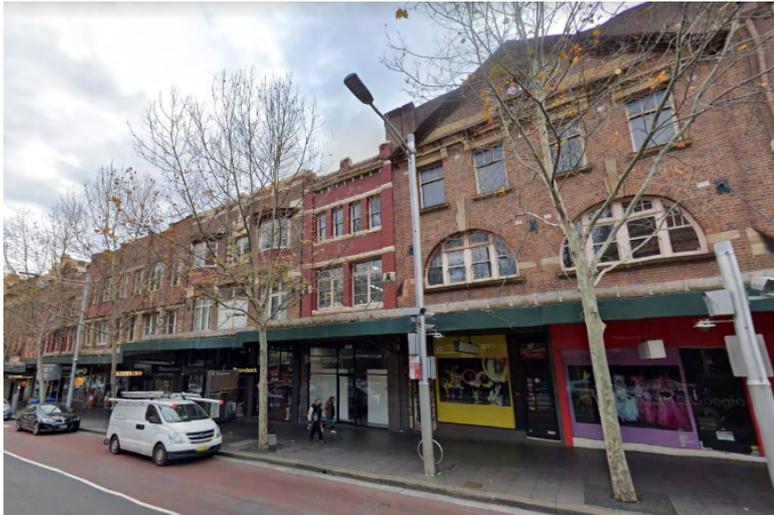
Figure 2 - Exterior view of group 1 buildings at 56-76 Oxford Street, showing the buildings at the eastern end of the group. Source: Google Streetview.

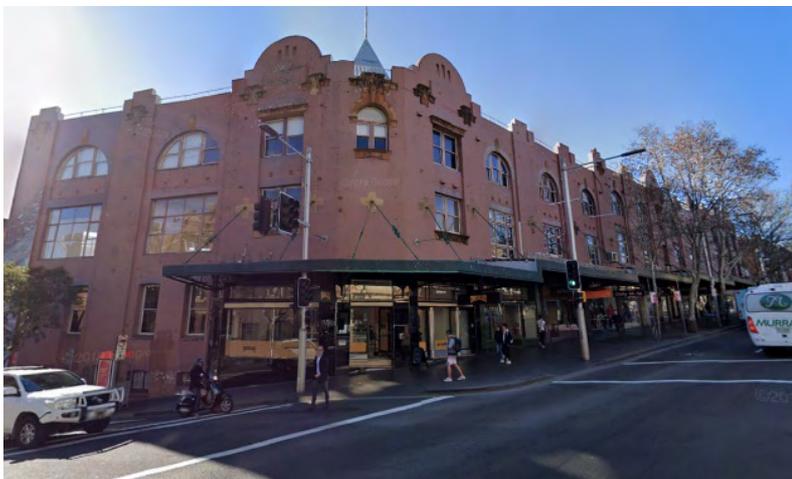
Figure 3 - Exterior view of group 2 building at 82-106 Oxford Street, showing the Oxford and Crown Street facades. Source: Google Streetview

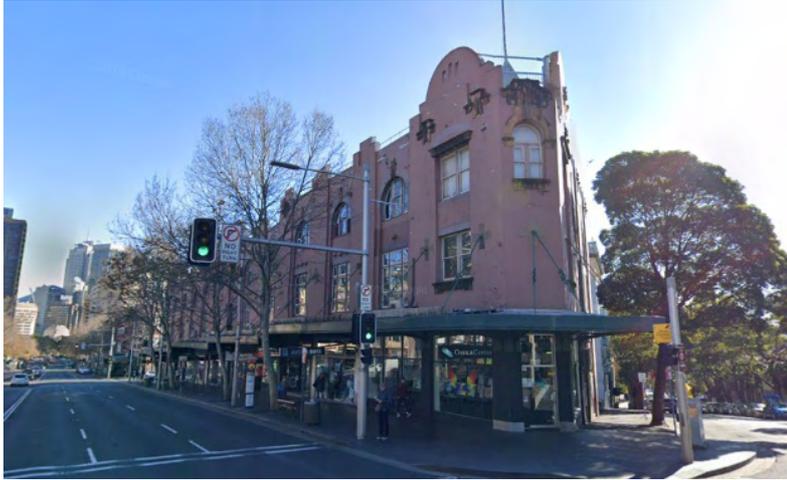
Figure 4 - Exterior view of group 2 building at 82-106 Oxford Street, showing the building façade at the corner of Oxford and Palmer Street. Source: Google Streetview

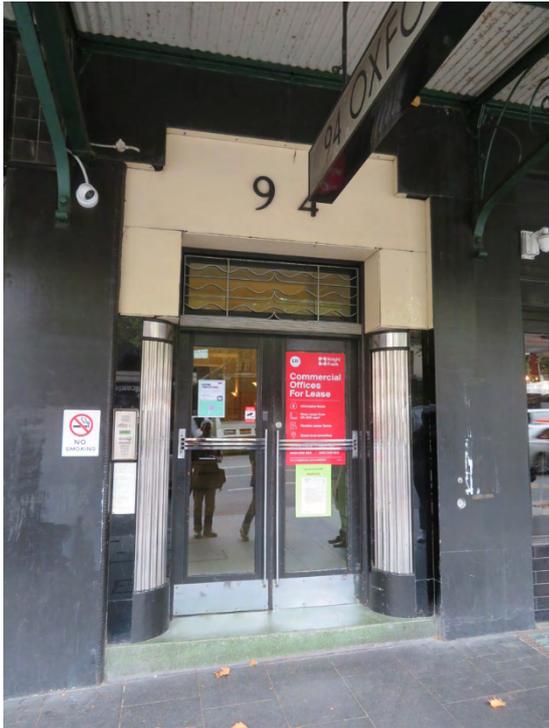
Figure 5 – View of entrance to 94 Oxford Street.

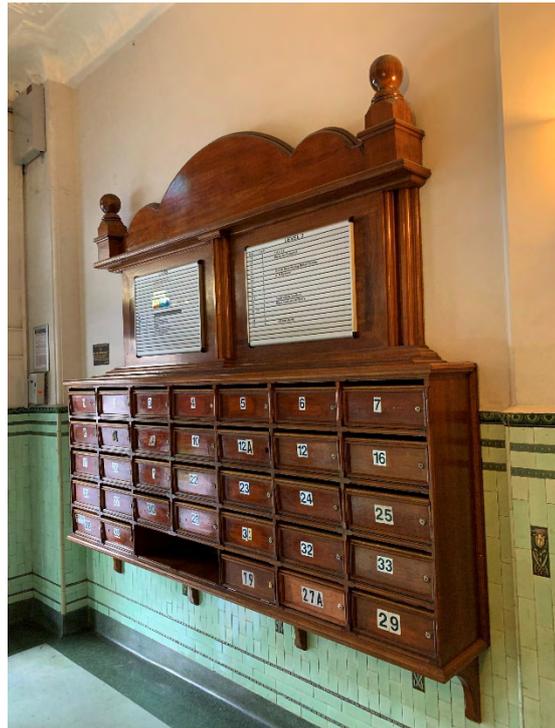
Figure 6 – View early tiles and timber letterboxes within entrance foyer of 94 Oxford Street.

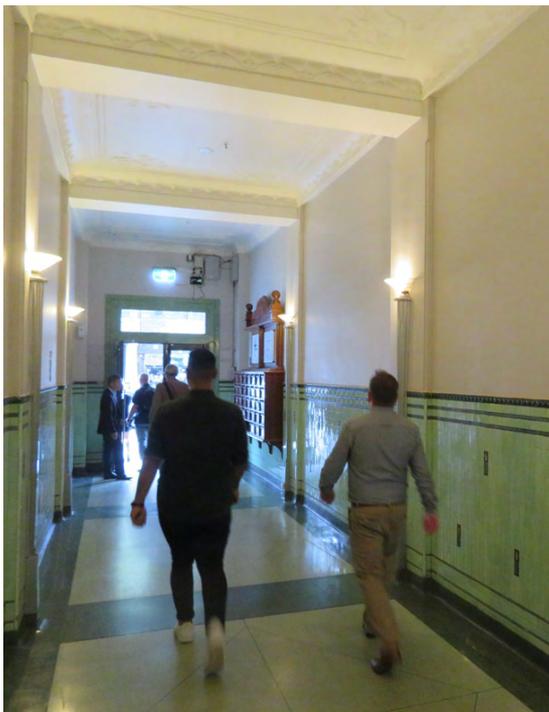
Figure 7 – View of entrance foyer at 94 Oxford Street showing tiled dado, terrazzo floors, pressed metal ceilings and Inter War lighting.

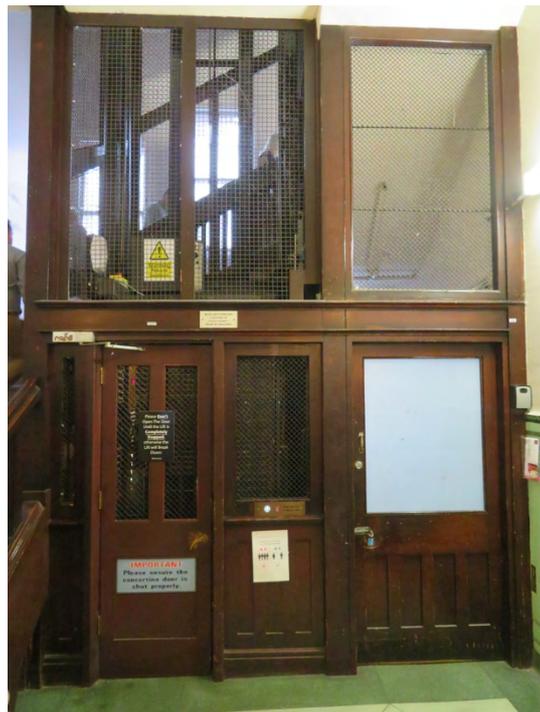
Figure 8 – View of lift and staircase at 94 Oxford Street.

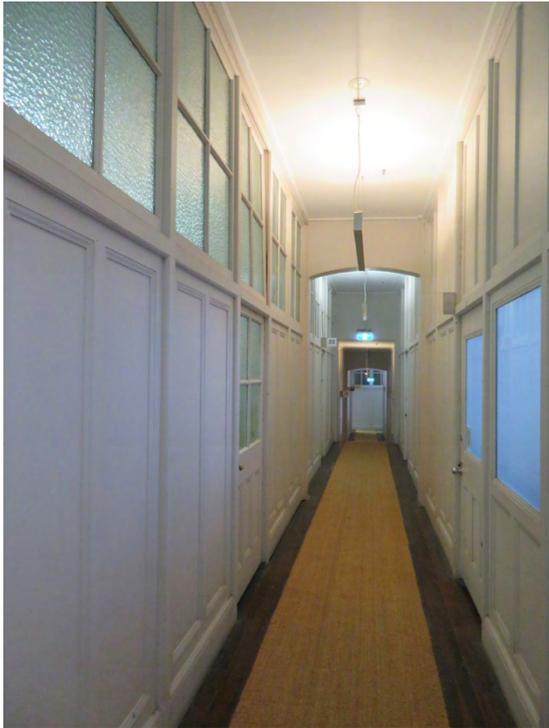
Figure 9 – View of typical corridor in upper floor of building.

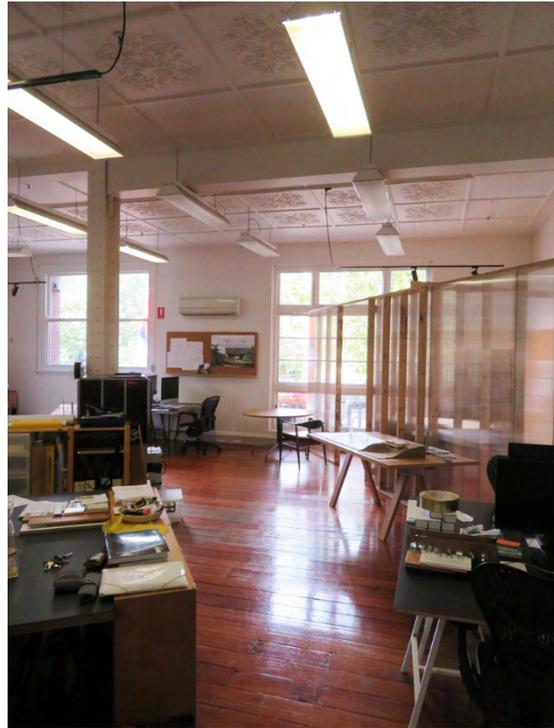
Figure 10 – View of existing office space within 94 Oxford Street.

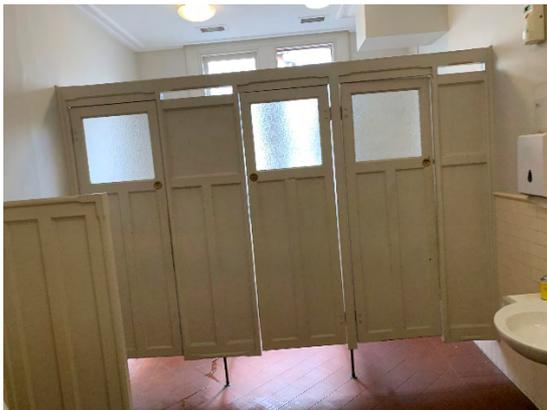
Figure 11 – Early bathroom partitions on second floor of 94 Oxford Street.

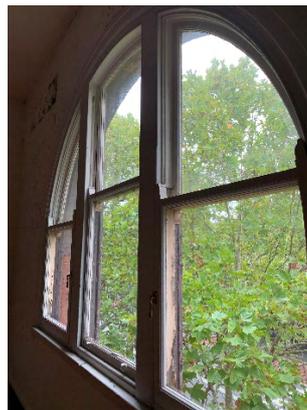
Figure 12 – Typical second floor window on north wall of 94 Oxford Street.

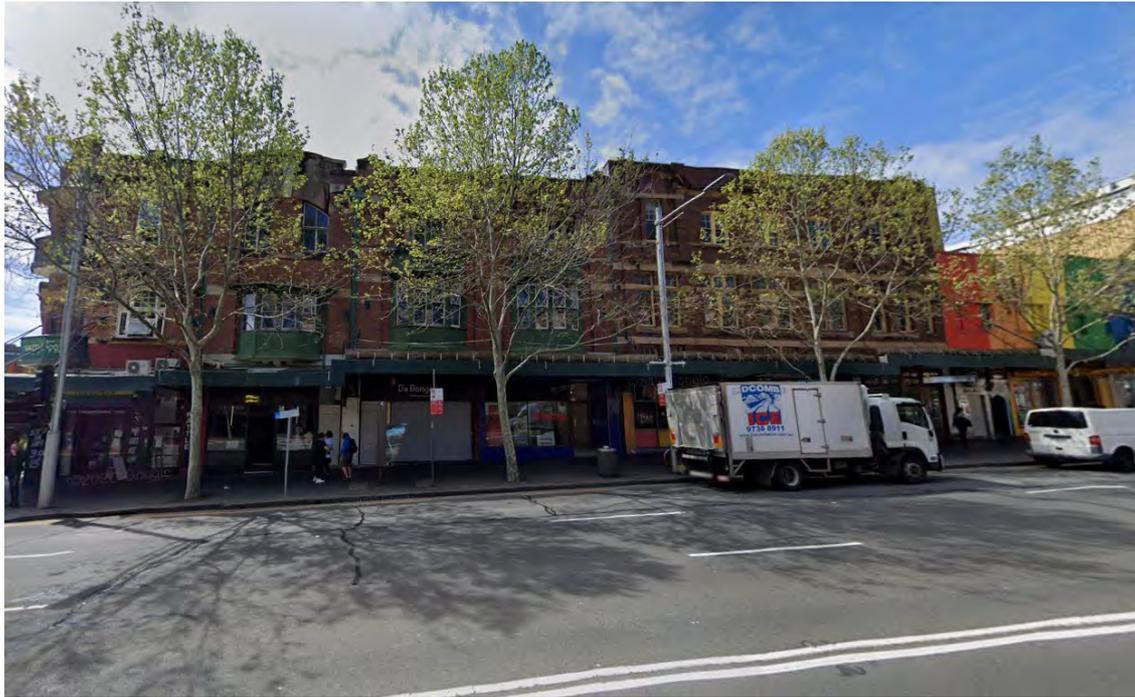
Figure 13 – View of Group 3 buildings (Source: Google Streetview).
