# **Attachment E**

## HERITAGE COMMITTEE REPORT

**Date:** 12 March 2021  
**Development Application:** D/2020/1071 and D/2020/1072  
**Site:** 58-76, 82-106, and 110-122 Oxford Street, Darlinghurst  
**Applicant:** TOGA Projects Services  
**Committee Members:**  
Scott Robertson, Robertson & Hindmarsh  
Hari Gohil, Shreeji Consultant  
Otto Cserhalmi, OCP Architects

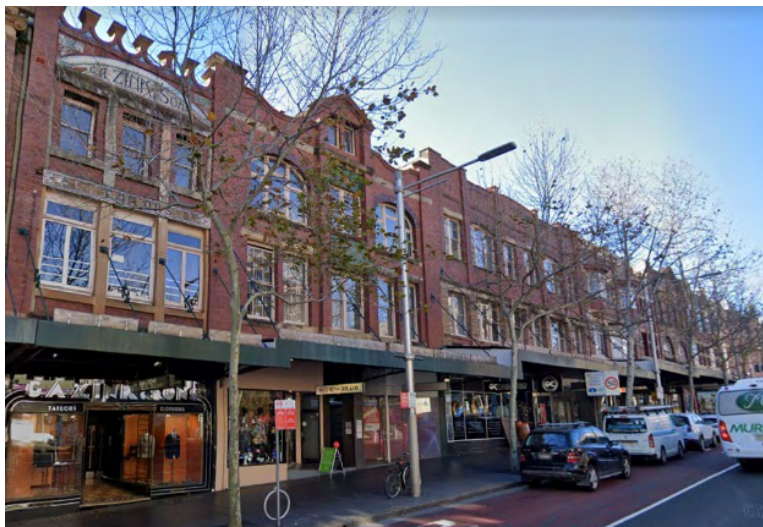
*Figure 1 - Exterior view of group 1 buildings at 56-76 Oxford Street, showing buildings at the western end of the group. Source: Google Streetview.*

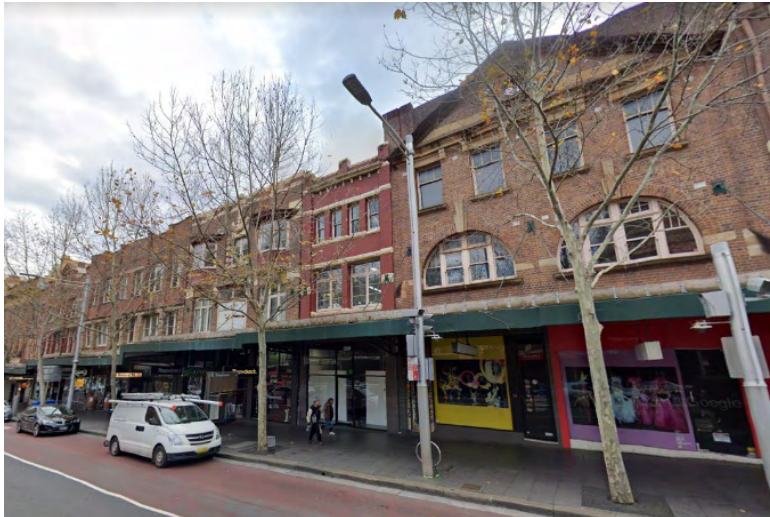
*Figure 2 - Exterior view of group 1 buildings at 56-76 Oxford Street, showing the buildings at the eastern end of the group. Source: Google Streetview.*

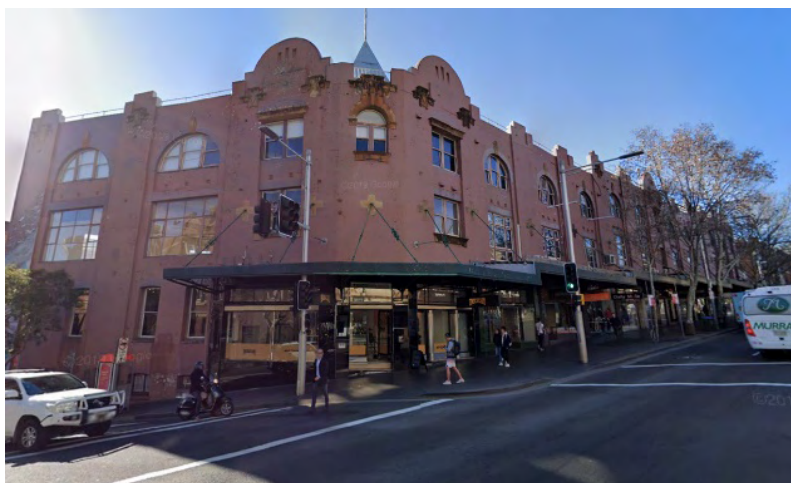
*Figure 3 - Exterior view of group 2 building at 82-106 Oxford Street, showing the Oxford and Crown Street facades. Source: Google Streetview*

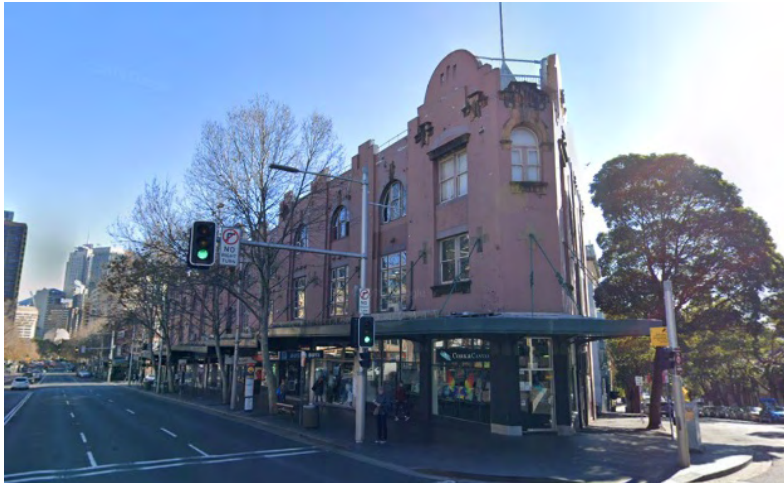
*Figure 4 - Exterior view of group 2 building at 82-106 Oxford Street, showing the building façade at the corner of Oxford and Palmer Street. Source: Google Streetview*

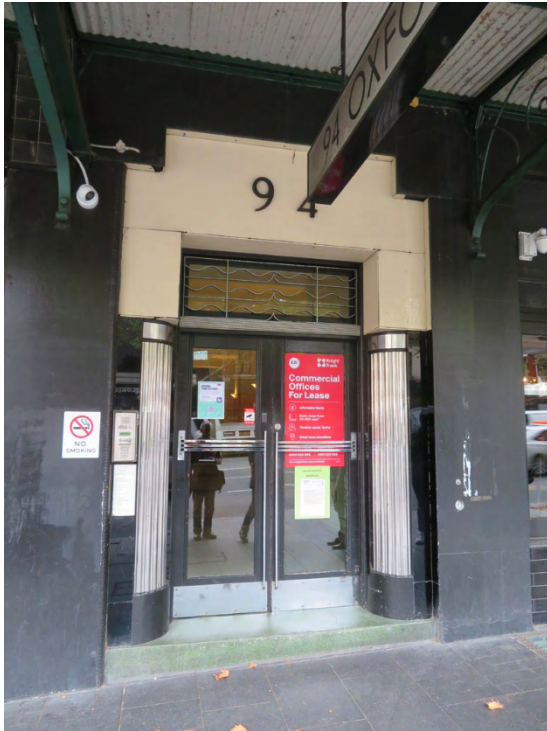
Figure 5 – View of entrance to 94 Oxford Street.

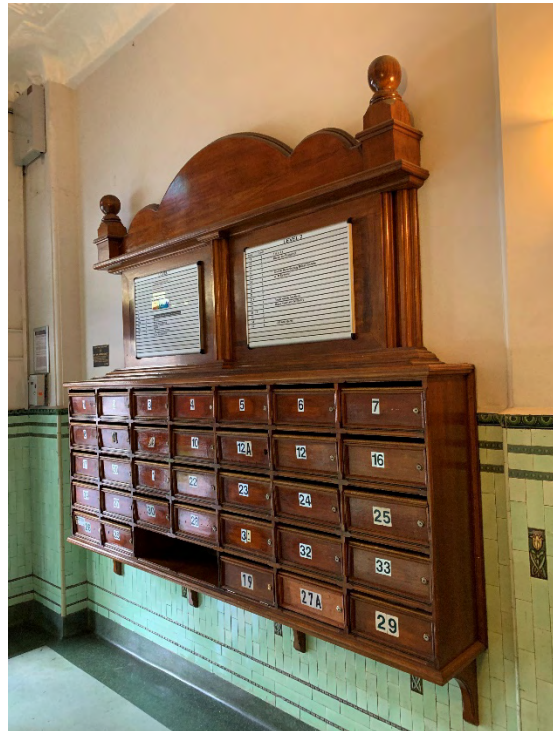
Figure 6 – View early tiles and timber letterboxes within entrance foyer of 94 Oxford Street.

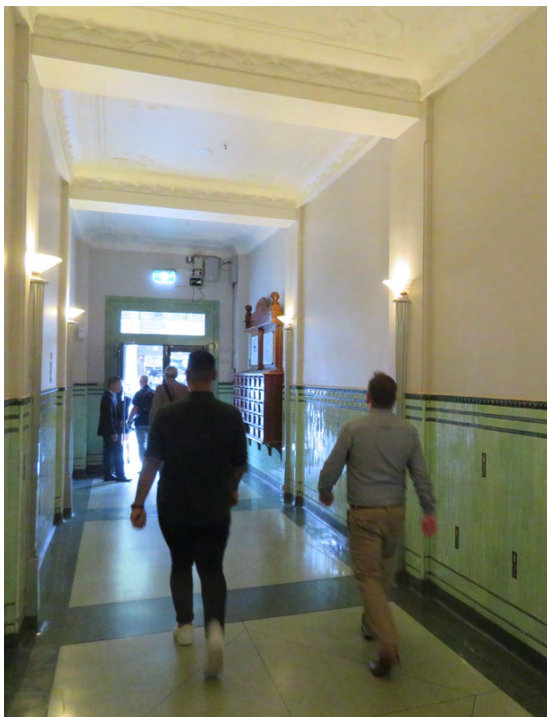
Figure 7 – View of entrance foyer at 94 Oxford Street showing tiled dado, terrazzo floors, pressed metal ceilings and Inter War lighting.

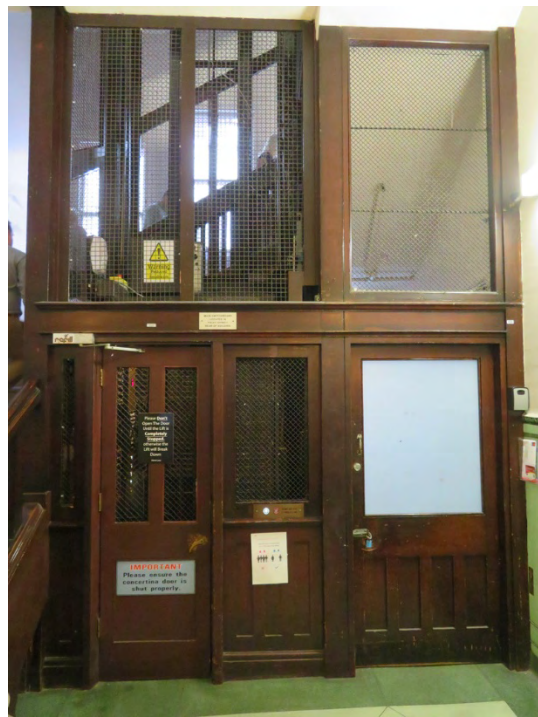
Figure 8 – View of lift and staircase at 94 Oxford Street.

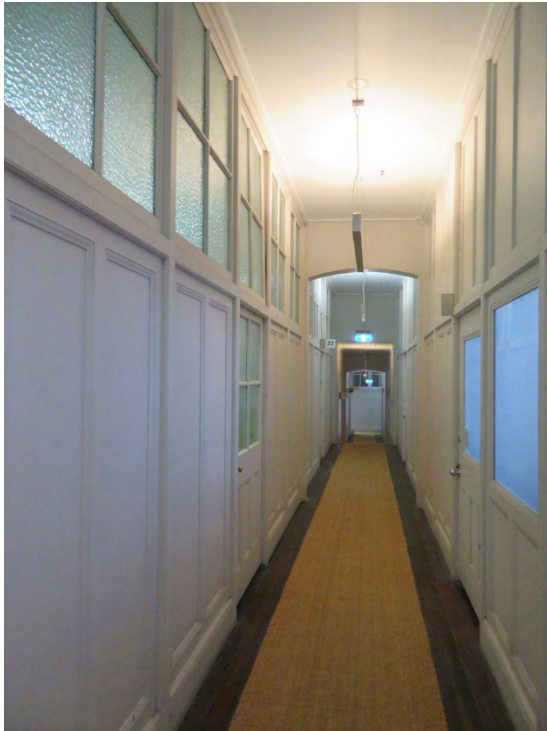
Figure 9 – View of typical corridor in upper floor of building.

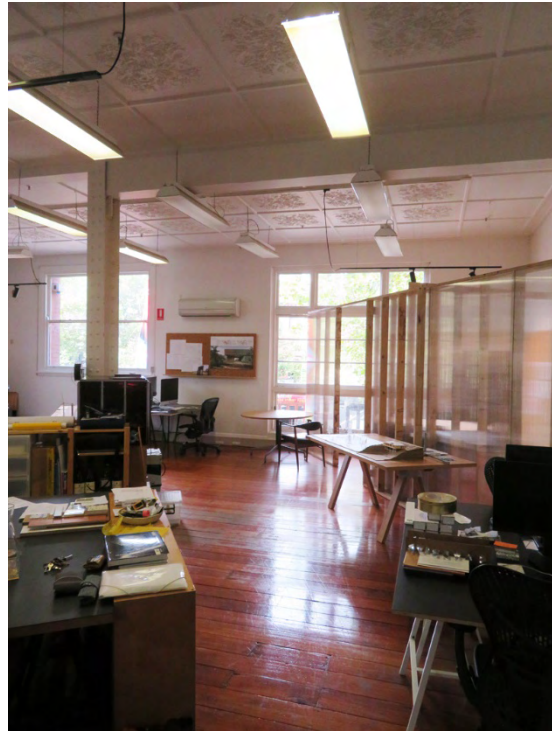
Figure 10 – View of existing office space within 94 Oxford Street.

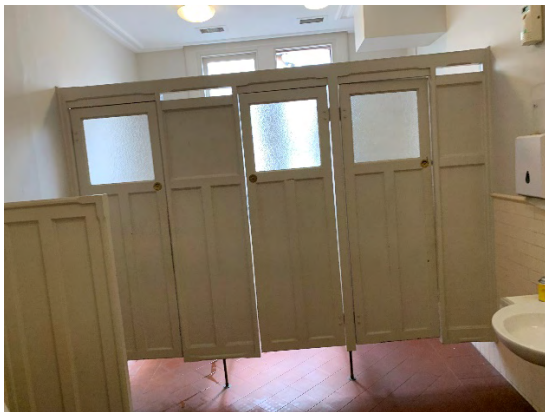
Figure 11 – Early bathroom partitions on second floor of 94 Oxford Street.

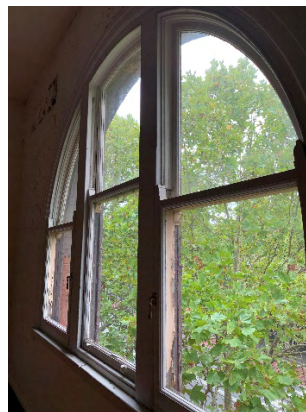
Figure 12 – Typical second floor window on north wall of 94 Oxford Street.

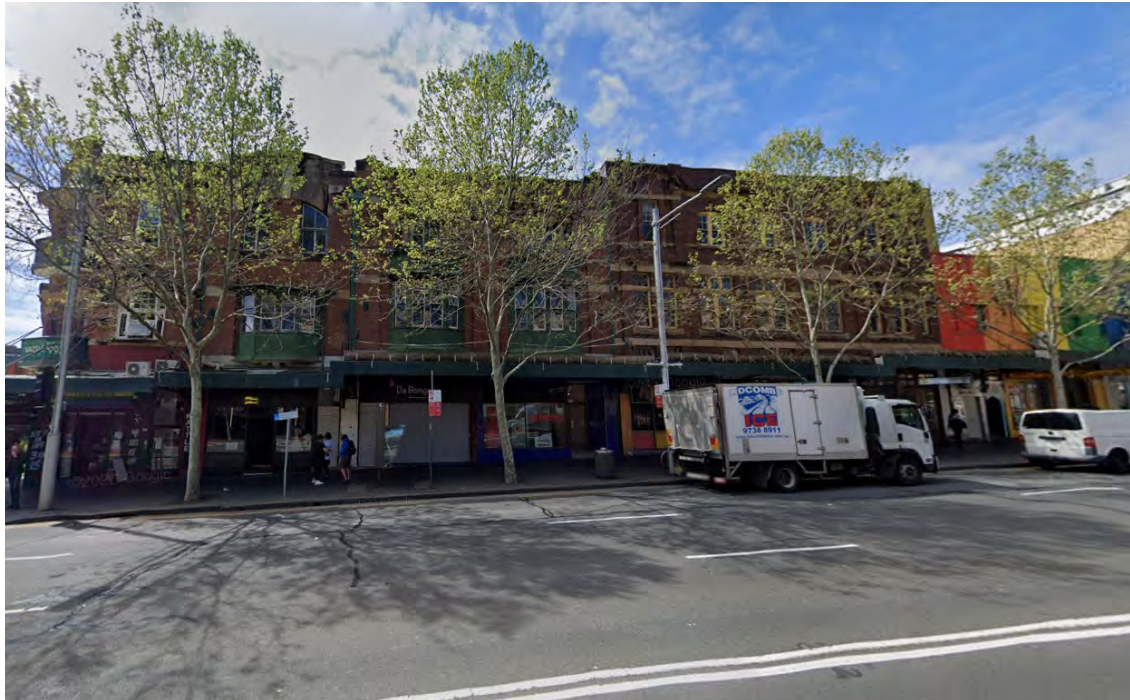
Figure 13 – View of Group 3 buildings (Source: Google Streetview).
