HERITAGE COMMITTEE REPORT

Date: 12 March 2021
Development Application: D/2020/1071 and D/2020/1072
Site: 58-76, 82-106, and 110-122 Oxford Street, Darlinghurst
Applicant: TOGA Projects Services
Committee Members:
Scott Robertson, Robertson & Hindmarsh
Hari Gohil, Shreeji Consultant
Otto Cserhalmi, OCP Architects

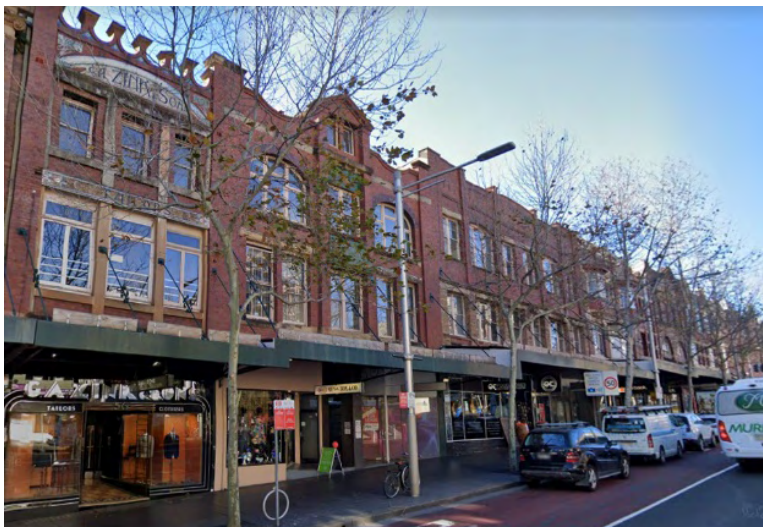
The Foley Street elevation has suffered more change than the Oxford Street facades. Apart from detail modifications noted below, the brick wall surfaces have been painted and intrusive service pipes, downpipes and air conditioning units have been installed in various locations. Many windows have been replaced and balcony openings cut into the walls of buildings. The roofs of the buildings have been re-sheeted.

Figure 1 - Exterior view of group 1 buildings at 56-76 Oxford Street, showing buildings at the western end of the group. Source: Google Streetview.

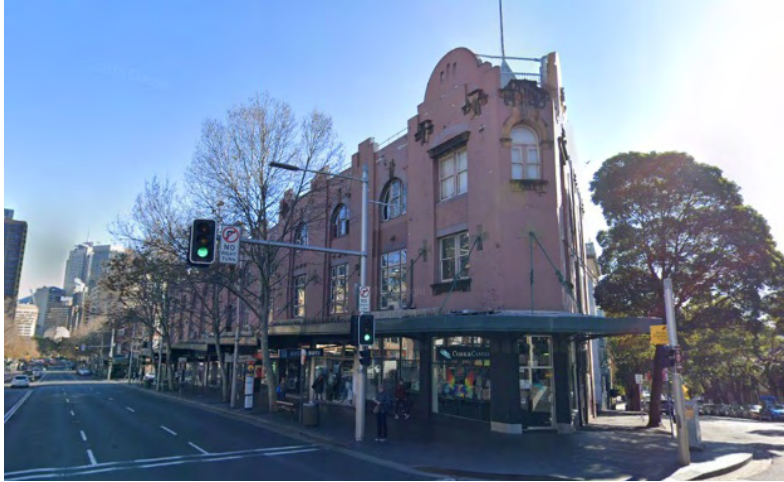
Figure 4 - Exterior view of group 2 building at 82-106 Oxford Street, showing the building façade at the corner of Oxford and Palmer Street. Source: Google Streetview

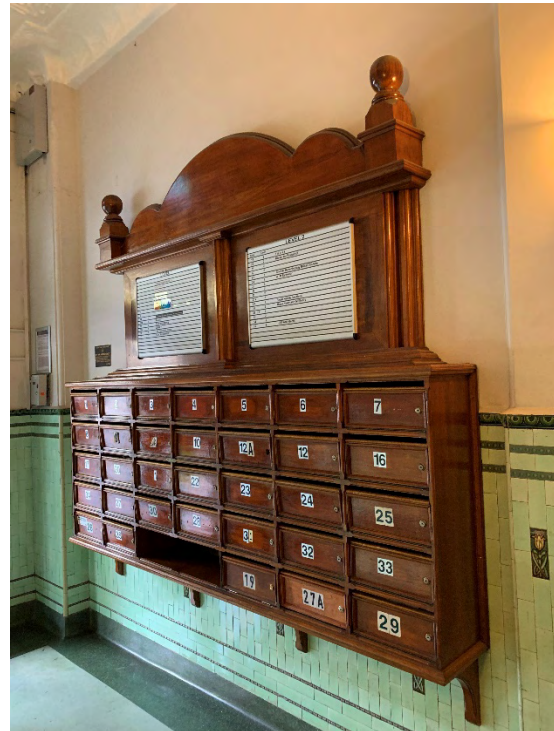
Figure 6 – View early tiles and timber letterboxes within entrance foyer of 94 Oxford Street.

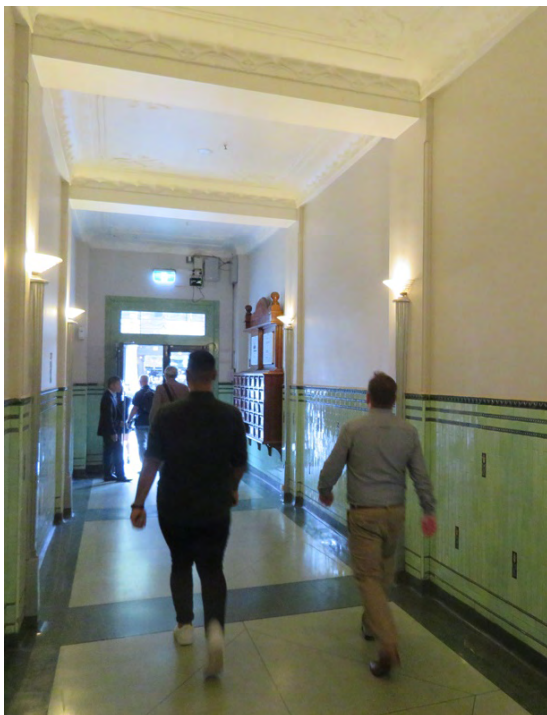
The entrance foyer dates from the date of construction of the building and still retains all its interior finishes (terrazzo floor finish – probably dating from the Inter-war refurbishment), original Art Nouveau-pattern wall tiles forming a wainscot – dating from the construction of the building), and original decorative plaster ceilings. The length of the foyer is punctuated by engaged piers which contain (Monel?) metal fluted half-column supports to glass wall sconce light fittings (dating from the Inter-war refurbishment). At the Foley Street (north) end of the foyer the original lift and concrete stairs with timber newel posts and balustrade still remain.

Figure 7 – View of entrance foyer at 94 Oxford Street showing tiled dado, terrazzo floors, pressed metal ceilings and Inter War lighting.

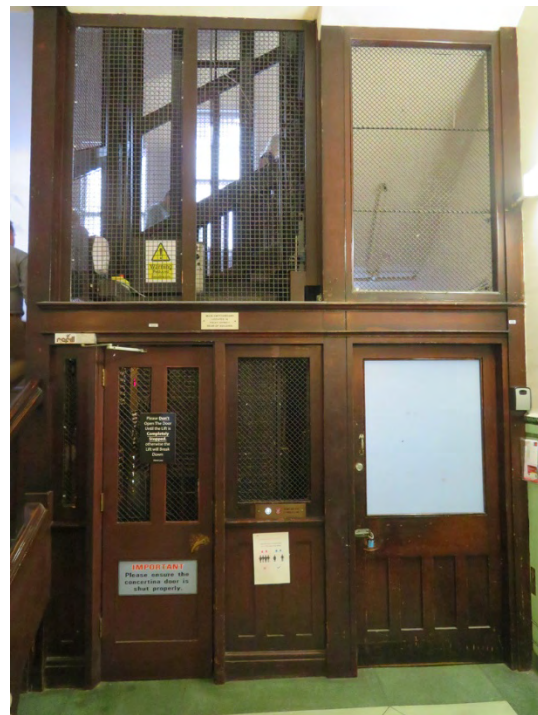
Figure 8 – View of lift and staircase at 94 Oxford Street.
