<h2>Heritage Committee Report</h2>

Date: 12 March 2021
Development Application: D/2020/1071 and D/2020/1072
Site: 58-76, 82-106, and 110-122 Oxford Street, Darlinghurst
Applicant: TOGA Projects Services
Committee Members:
Scott Robertson, Robertson & Hindmarsh
Hari Gohil, Shreeji Consultant
Otto Cserhalmi, OCP Architects

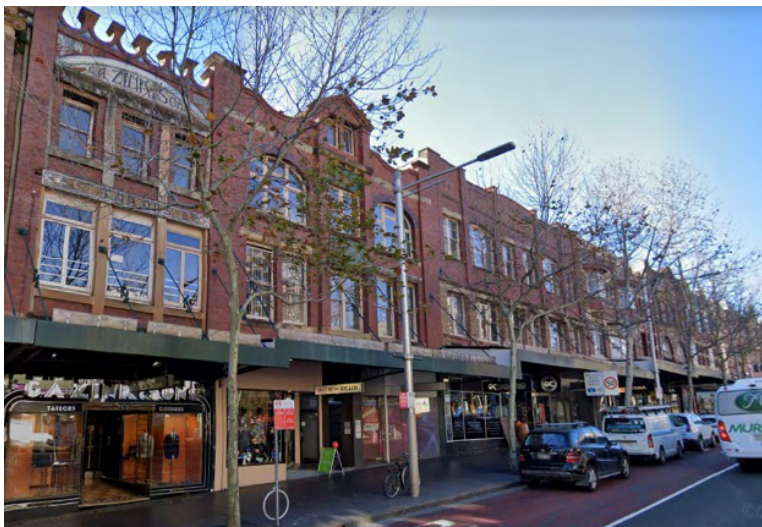
All of the buildings in this group have been subjected to a relatively high level of internal modification. Surviving shop interiors have been altered while first and second floor levels were extensively remodelled by South Sydney Council during the first half of the 1990s to form a series of professional suites accessed by a lift, stairs and common passageways. There is no visible evidence of early uses or original building elements such as stairs, lavatories, door joinery and skirting boards on the first and second floors.

The Foley Street elevation has suffered more change than the Oxford Street facades. Apart from detail modifications noted below, the brick wall surfaces have been painted and intrusive service pipes, downpipes and air conditioning units have been installed in various locations. Many windows have been replaced and balcony openings cut into the walls of buildings. The roofs of the buildings have been re-sheeted.

Figure 1 - Exterior view of group 1 buildings at 56-76 Oxford Street, showing buildings at the western end of the group. Source: Google Streetview.

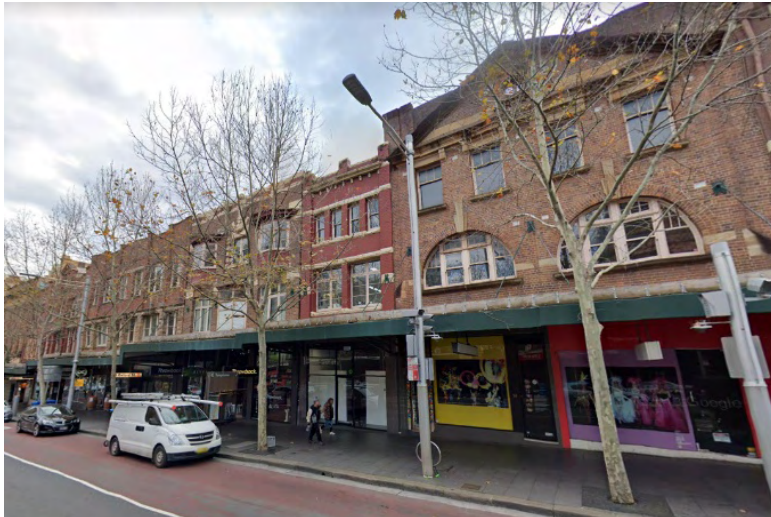
Figure 2 - Exterior view of group 1 buildings at 56-76 Oxford Street, showing the buildings at the eastern end of the group. Source: Google Streetview.

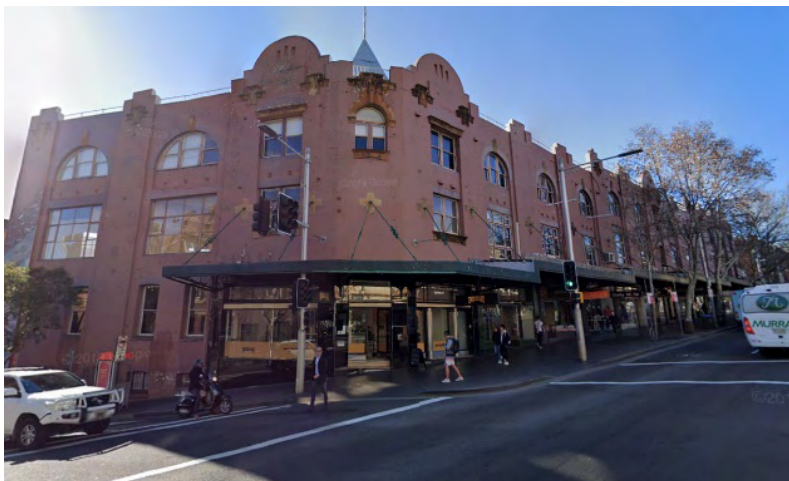
The Oxford Street façade is symmetrically organised but steps to follow the fall along the street. The design of the façade, as well as the facades facing Crown and Palmer Streets, generally conforms to the characteristics of the Federation Free Style. Fenestration of the first and second floor levels consists of bays of square headed window openings at first floor level with arched openings above, divided by wide piers that step at parapet level. The central bay, above the principal entrance to the upper levels of the buildings, contains narrow windows and a raised semi-circular parapet (reminiscent of the Cape Dutch architecture of South Africa). The central bay is echoed at either end of the façade by similar though larger design elements, above which rise steeply pitched pyramidal roofs covered with corrugated steel sheeting. The western and eastern facades of the building are similar in general detail to the Oxford Street façade. However, windows in the first floor level of the Crown Street façade appear to have been replaced with different sashes, disrupting the building's appearance to some extent.

Figure 3 - Exterior view of group 2 building at 82-106 Oxford Street, showing the Oxford and Crown Street facades. Source: Google Streetview

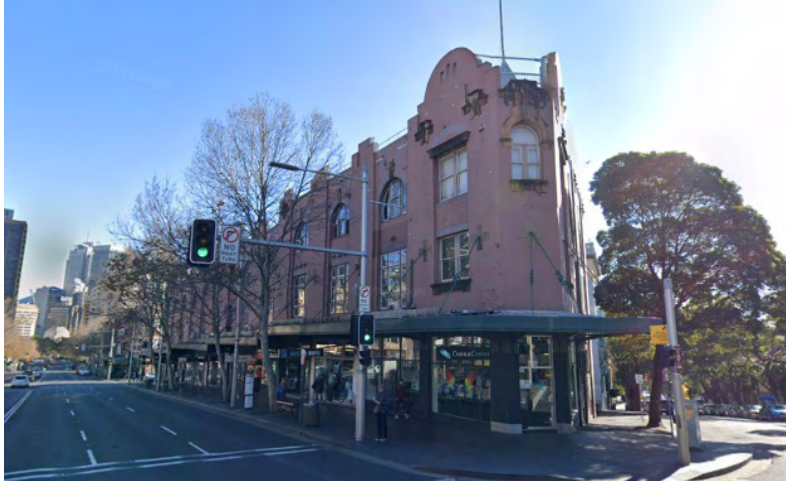
Figure 4 - Exterior view of group 2 building at 82-106 Oxford Street, showing the building façade at the corner of Oxford and Palmer Street. Source: Google Streetview

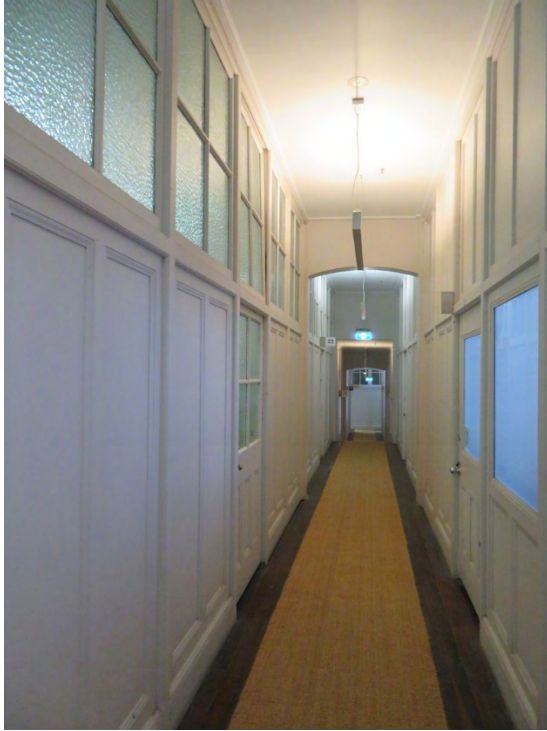
Figure 9 – View of typical corridor in upper floor of building.

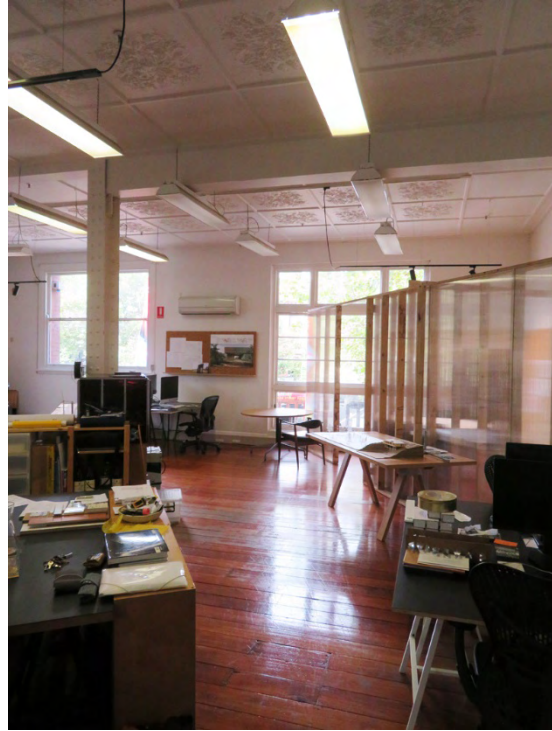
The commercial office floors (first & second floors) are remarkably intact with their Kauri timber floor boards, pressed metal and decorative plaster ceilings, masonry dividing walls and Edwardian period timber partitions defining the corridor. The toilets also contain the original toilet cubicle walls and timber cubicle doors but the fixtures have been replaced with modern fixtures and the floor re-tiled in sympathetic modern tiling. The staircase rises up to the trafficable roof level and the stair can be fire-isolated by sliding fire doors which are either original or an early addition to the building.

Figure 10 – View of existing office space within 94 Oxford Street.

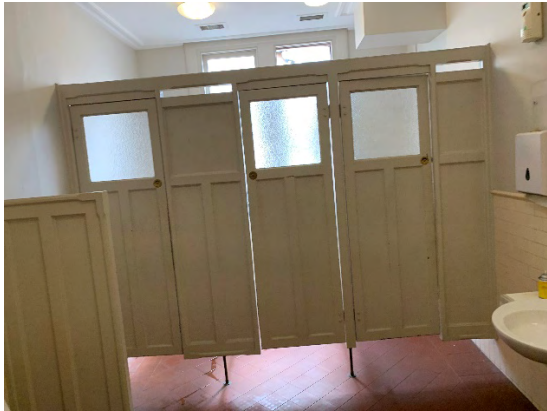
Figure 11 – Early bathroom partitions on second floor of 94 Oxford Street.

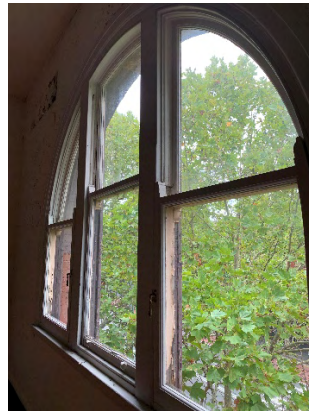
Figure 12 – Typical second floor window on north wall of 94 Oxford Street.
