# **Attachment A**

**Location Plan and Site Photographs**

# Glebe Street Playground

Glebe and Mitchell Streets, Glebe

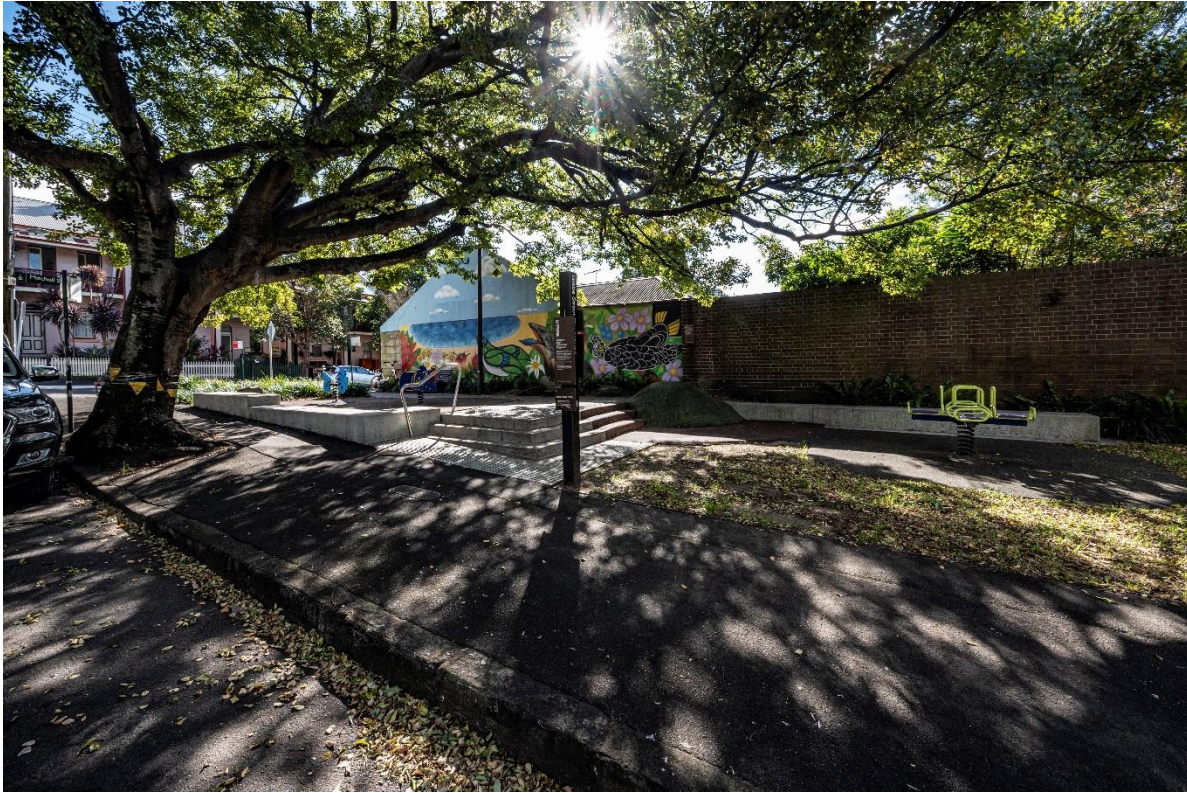
Existing playground in the park, looking north from Glebe Street. Play equipment is at the end of its useful life and soft fall is worn and separating at edges. Playground is well shaded from the existing tree. Small area of turf in poor condition.

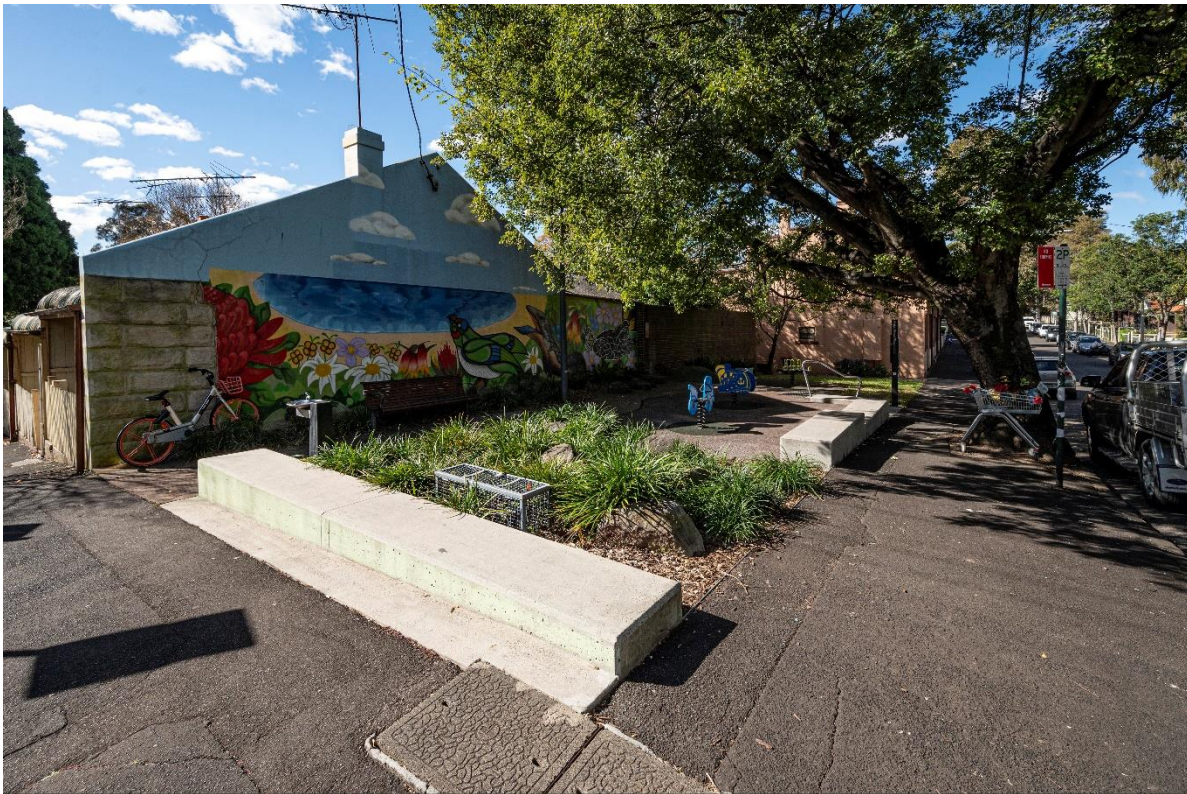
Looking east from Mitchell Street. Play equipment is at the end of its useful life and soft fall is worn and separating at edges. Planting areas are in reasonable condition. There is no paved access from Glebe Street. Low boundary walls are currently too low to be used comfortably as seating. There is one bench.
