Draft Conservation Management Plan

Former Hinchcliff Wool Store, 5-7 Young Street,
Sydney

November 2012

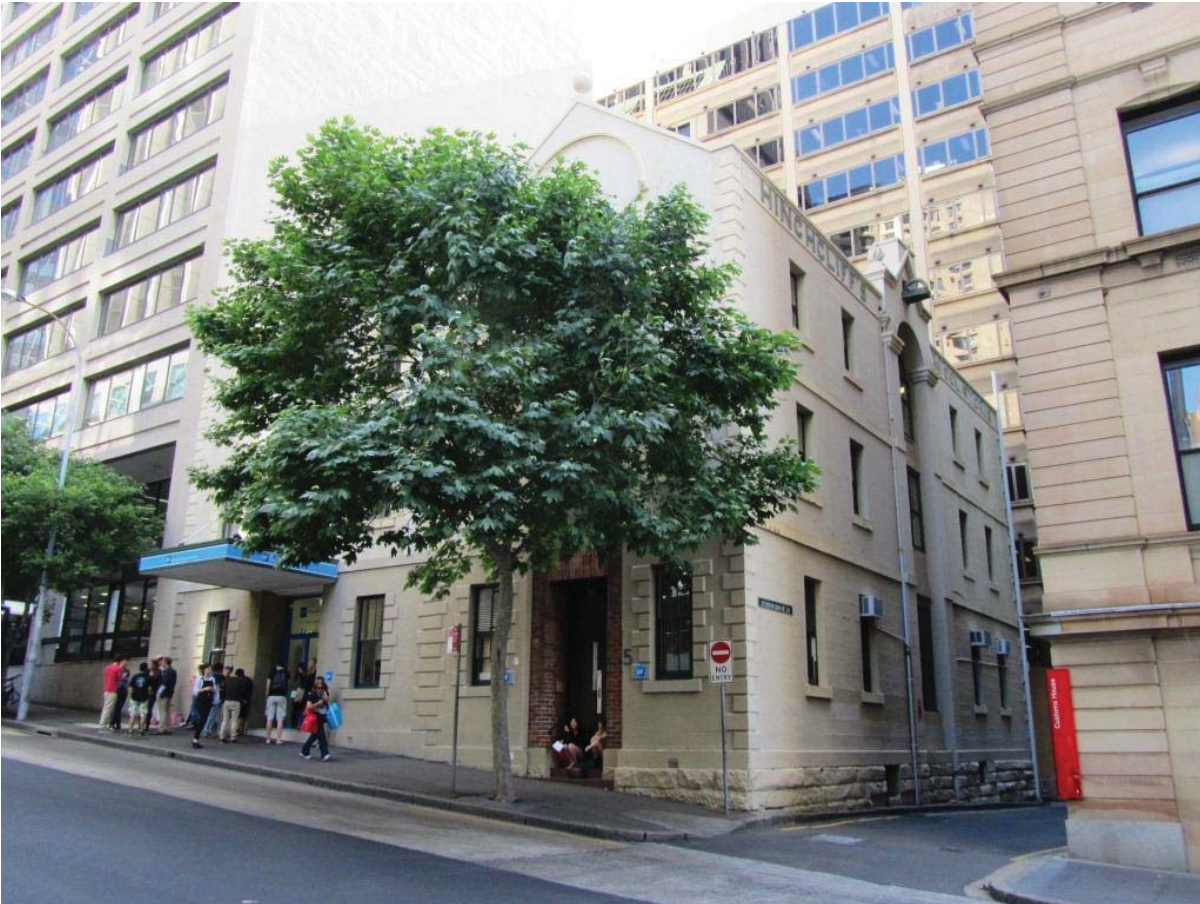
FIGURE 4 – THE SUBJECT SITE

VIEW OF THE PRINCIPAL EASTERN AND NORTHERN ELEVATIONS. ACCESS IS VIA THE EASTERN/ YOUNG STREET ELEVATION.

Overall the building is in good condition with some minor deterioration of sandstone and some damp evident. The facades have been modified in conjunction with contemporary access and uses. Remnant industrial features survive including signage and remnant cat head pulleys.

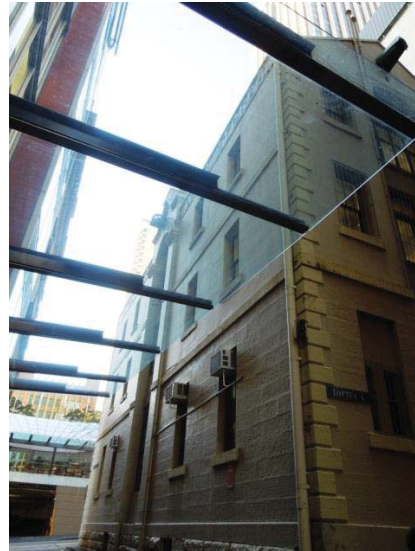
THE NORTHERN ELEVATION AS VIEWED FROM CUSTOMS HOUSE AND LOFTUS LANES (VIEW EAST TO YOUNG STREET)

Rising damp is evident in the lower sandstone courses. Downpipes and rainwater heads appear to be in good condition, including some recent replacements. Three air-conditioning units are fixed to the façade. The former sheep effigy which stood on the northern elevation parapet as a symbol of the former building use has been lost.

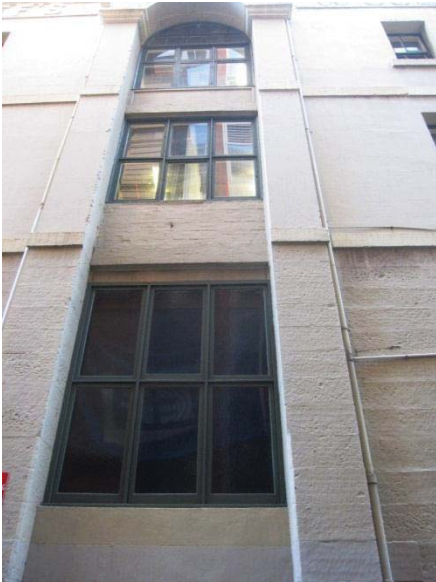
FIGURE 10 – DETAIL VIEWS OF THE NORTHERN FAÇADE

THE MODIFIED CENTRAL LOADING BAY

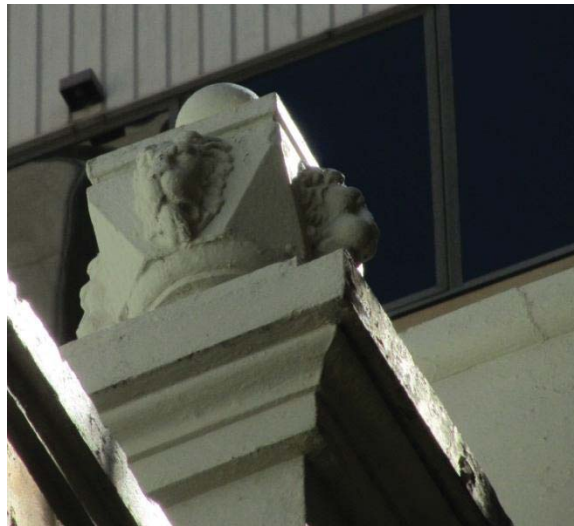
DECORATIVE LION HEAD AND BALL FINIALS TO THE NORTHERN FAÇADE PARAPET

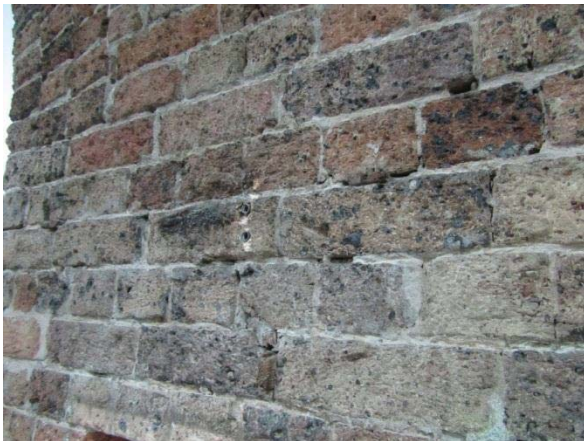
FIGURE 18 – CONDITION OF FABRIC – DETAIL VIEWS OF BRICK AND STONE FINISHES

In recent years there has been some minor upgrading for fire services, with sprinkler system installed throughout. It is understood that the school has leased the former chapel until 2015; however the space remains disused. Some salt activity and damp is evident in the northern stone wall particularly at the western end and in the vicinity of the former loading dock. Otherwise the stone is in good condition, with lime mortar and limited cement patching. The masonry section below the central window has been infilled (likely brick) and the original loading doors removed. Damp is also evident in the southern sandstock brick wall, at the western end. The surface of the brick is rough and in poor condition and may have been sandblasted or picked in conjunction with the removal of later render (as part of documented refurbishment works to the Chapel). Some loss of mortar is noted.

DETAIL OF THE SANDSTOCK BRICK WALL SHOWING DEGRADED SURFACE

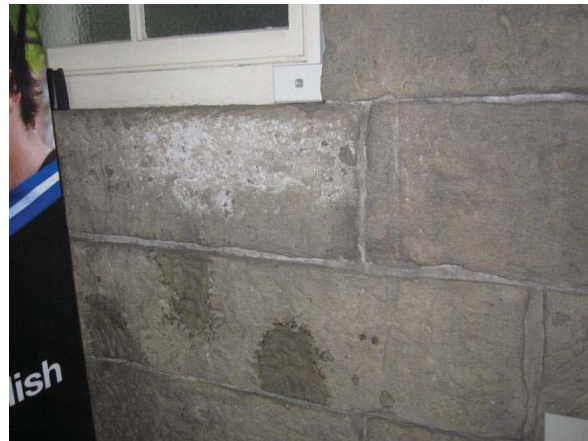
DETAIL OF THE NORTHERN WALL SANDSTONE SHOWING EVIDENCE OF SALT ACTIVITY AND CEMENT PATCHING

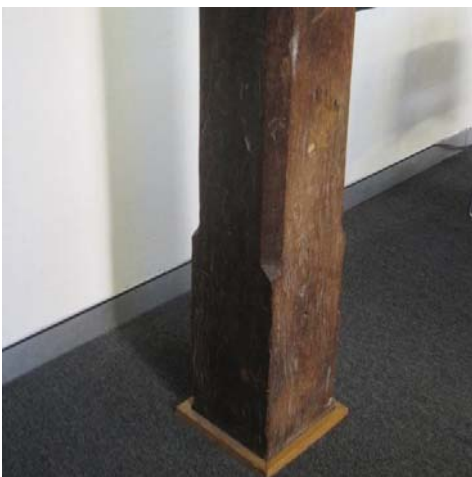
DETAIL OF THE STOP CHAMFERED BASE TO ONE OF THE HARDWOOD POSTS

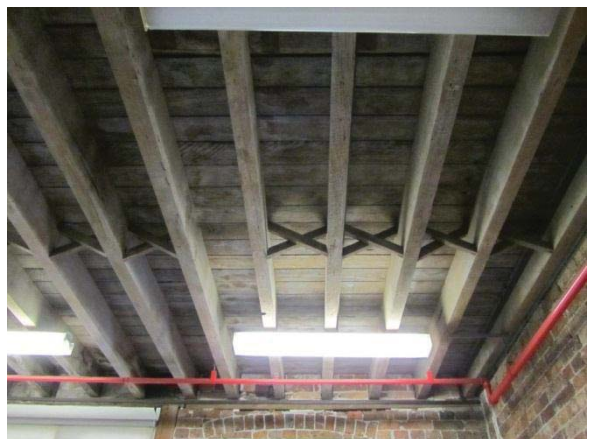
VIEW OF THE EXPOSED FLOOR JOISTS AND REMNANT HERRINGBONE TRUSSES (NORTHERN STORE)

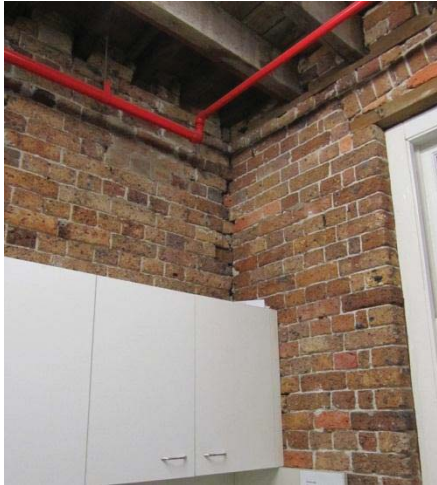
FIGURE 22 – CONDITION OF FABRIC - DETAIL OF DAMAGED/ FAILED BRICKWORK

Overall the condition of the fabric is good. There is some damage and failure of brickwork in the central wall at the western end and some movement is indicated at the juncture of the western elevation and central wall (refer Figure 22 below) and structural assessment has been recommended.

CRACKED BRICKWORK, MISSING MORTAR AND OPEN JOINT INDICATES MOVEMENT IN THE WESTERN ELEVATION AT THE JUNCTURE OF THE CENTRAL WALL (NORTH STORE)

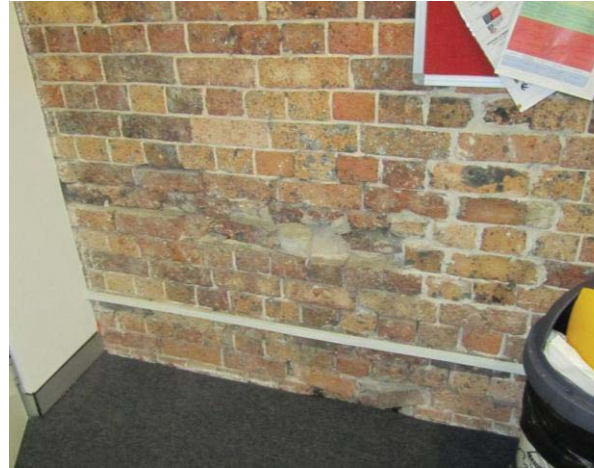
DETAIL OF FAILED AND DAMAGED BRICKWORK AT THE WESTERN END OF THE CENTRAL WALL (NORTH STORE)

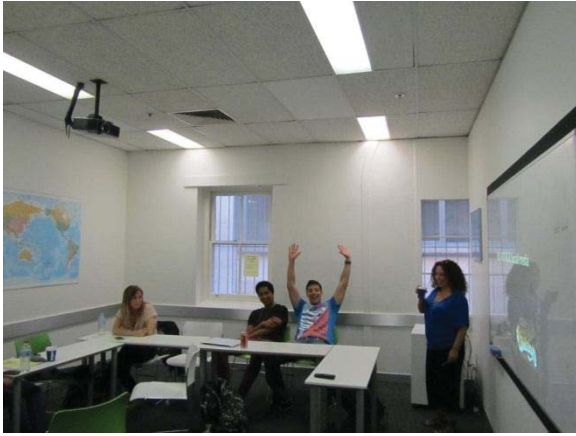
CLASSROOM AT THE SOUTHWESTERN CORNER OVERLOOKING LOFTUS LANE. THE CENTRAL ARCHED WINDOW/ FORMER LOADING BAY HAS BEEN PARTIALLY INFILLED REPLACED WITH A SMALLER WINDOW (RIGHT), BISECTED BY THE CLASSROOM PARTITIONING

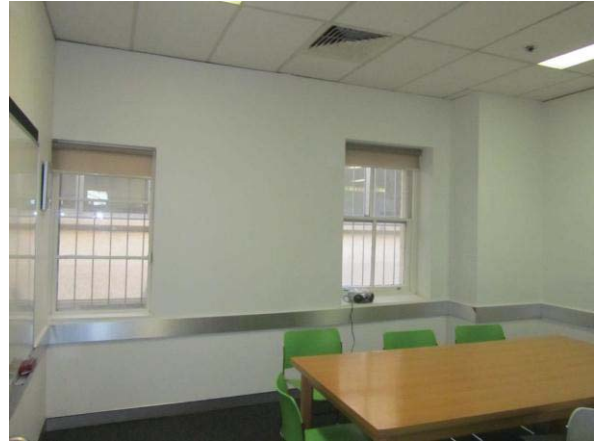
CLASSROOM AT THE WESTERN END OF THE SOUTHERN STORE. THE CENTRAL ARCHED WINDOW/ FORMER LOADING BAY HAS BEEN PARTIALLY INFILLED AND REPLACED WITH A SMALLER WINDOW (LEFT), AND BISECTED BY THE CLASSROOM PARTITIONING

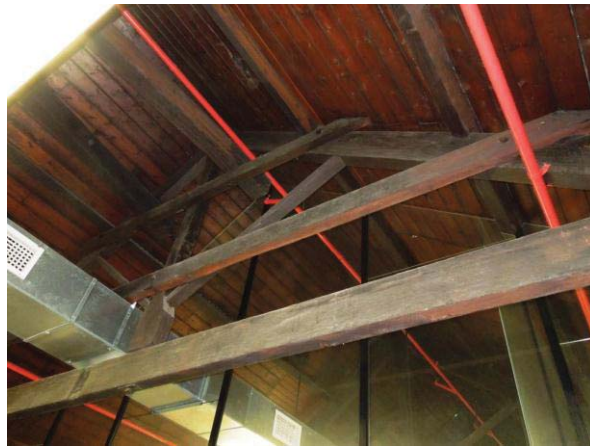
THE KING POST TRUSS ROOF, REINFORCED IN ASSOCIATION WITH THE EXTANT FAÇADE PULLEYS

Overall the condition of the fabric is good. The eastern wall of the northern store has steel brackets securing the gable to the brick structure and the brickwork of the arched window is similarly reinforced (refer Figure 25). The central arch in the central wall has failing mortar and missing joints (refer Figure 26). Overall the condition of the brick surface is noted as poor, having been aggressively cleaned to remove render consistent with the first floor. The new door opening in the central wall off the stair hall necessitated removal of one of the brick piers and some structural assessment may be required. Windows to the western elevation have been modified including replacement of timber frames with steel casement and partial infill of the central former loading bay.

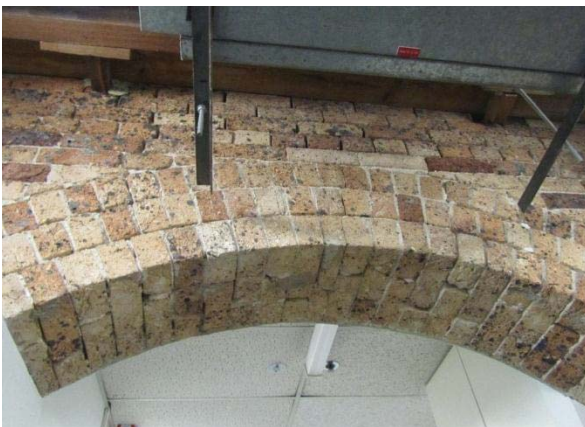
FIGURE 26 – CONDITION OF FABRIC

THE CENTRAL ARCH BETWEEN THE STORES HAS MISSING MORTAR AND JOINTS AND REQUIRES SOME ASSESSMENT

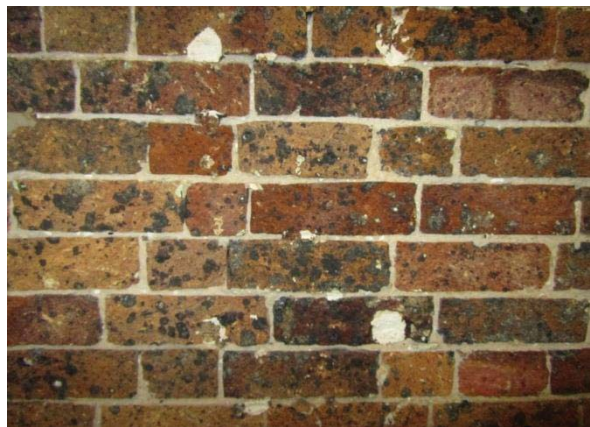
DETAIL OF THE SANDSTOCK BRICK WHICH HAS BEEN DAMAGED IN CONJUNCTION WITH THE REMOVAL OF RENDER AND FINISHES
