CONSERVATION MANAGEMENT PLAN

FOLEY BROS WAREHOUSE & OFFICE TOWER
230-232 & 234-238 SUSSEX STREET
SYDNEY NSW 2000

APRIL 2015

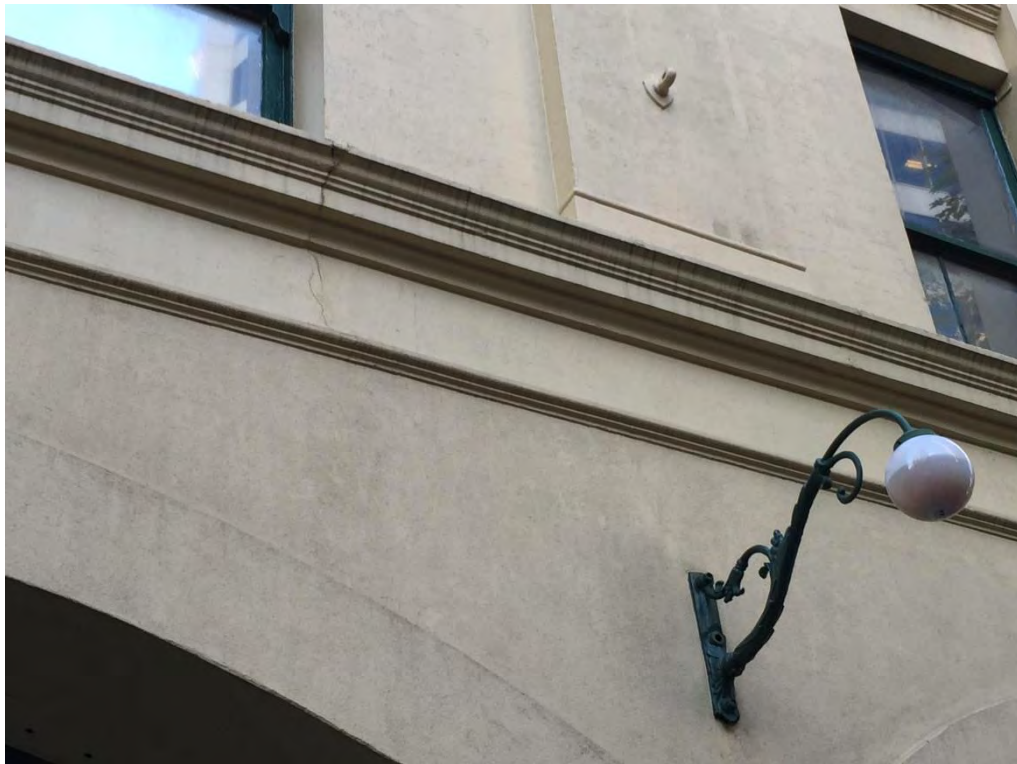
Figure 47 – ‘Period’ bracketed luminaires and original awning anchors. NBRSPartners, April 2015.

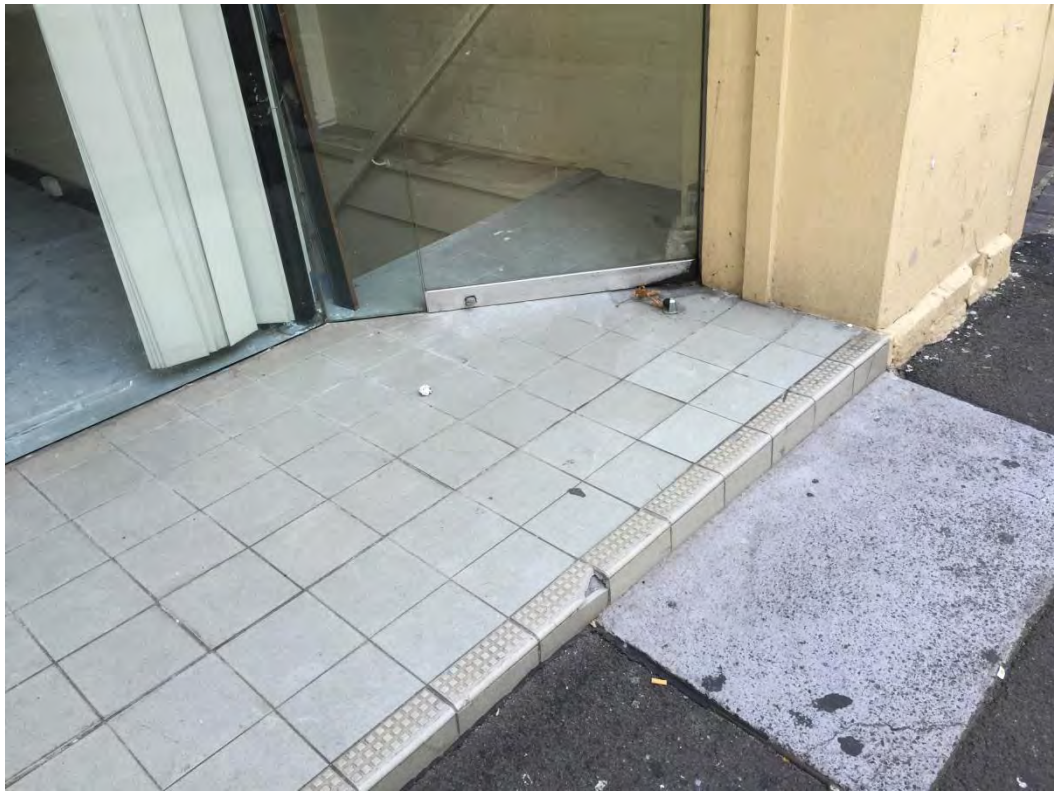
Figure 55 – Altered threshold to infill openings of ground floor. NBRSPartners, April 2015.

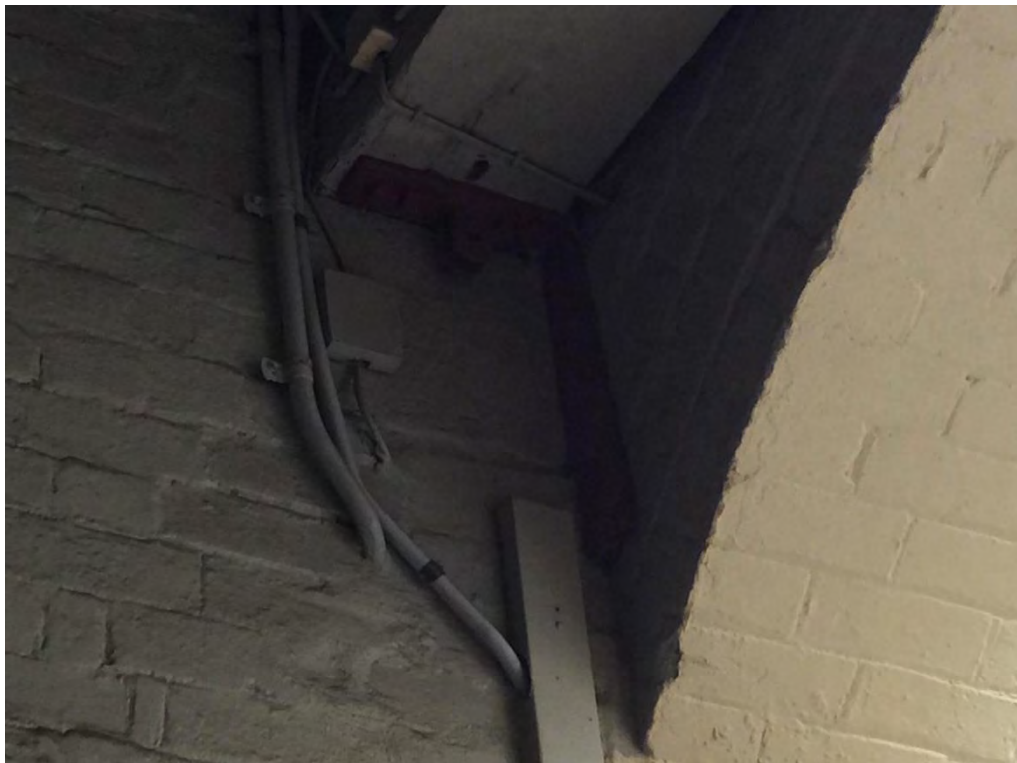
Figure 56 – Pivot brackets as evidence of original cartway gates. NBRSPartners, April 2015.

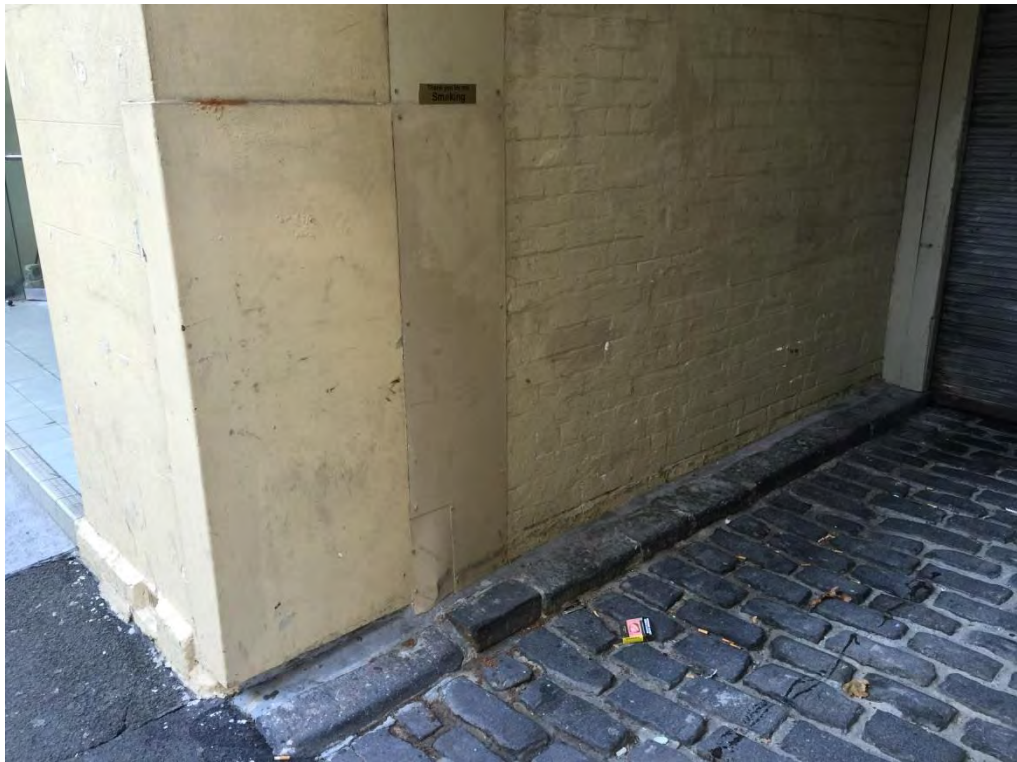
Figure 57 – Curb and setts of cartway paving. NBRSPartners, April 2015.

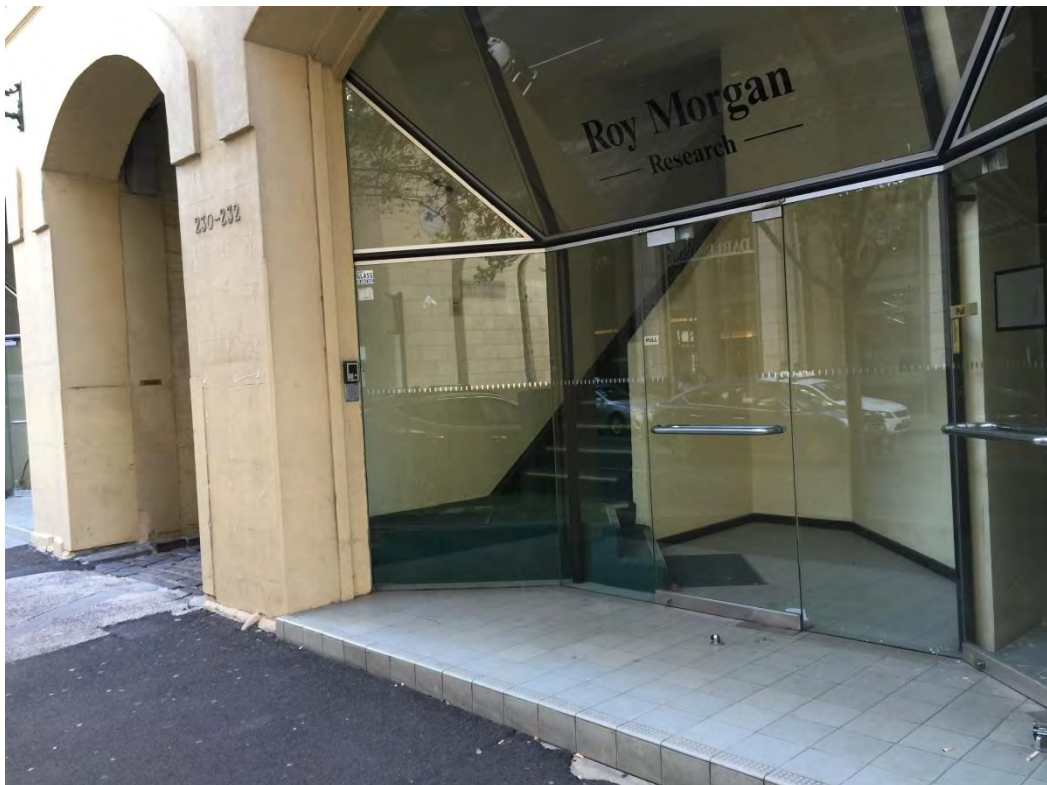
Figure 58 – Ground floor façade opening infill. NBRSPartners, April 2015.

In addition to the ground floor glazed infills, a service core and stair has been inserted into the space above space G06 and the cartway (Y01). It appears the floor framing through this core has remained. Arches in the brick wall between the northern and southern sections on the first and second floors have been broken through to create a more open plan and access on these floors.

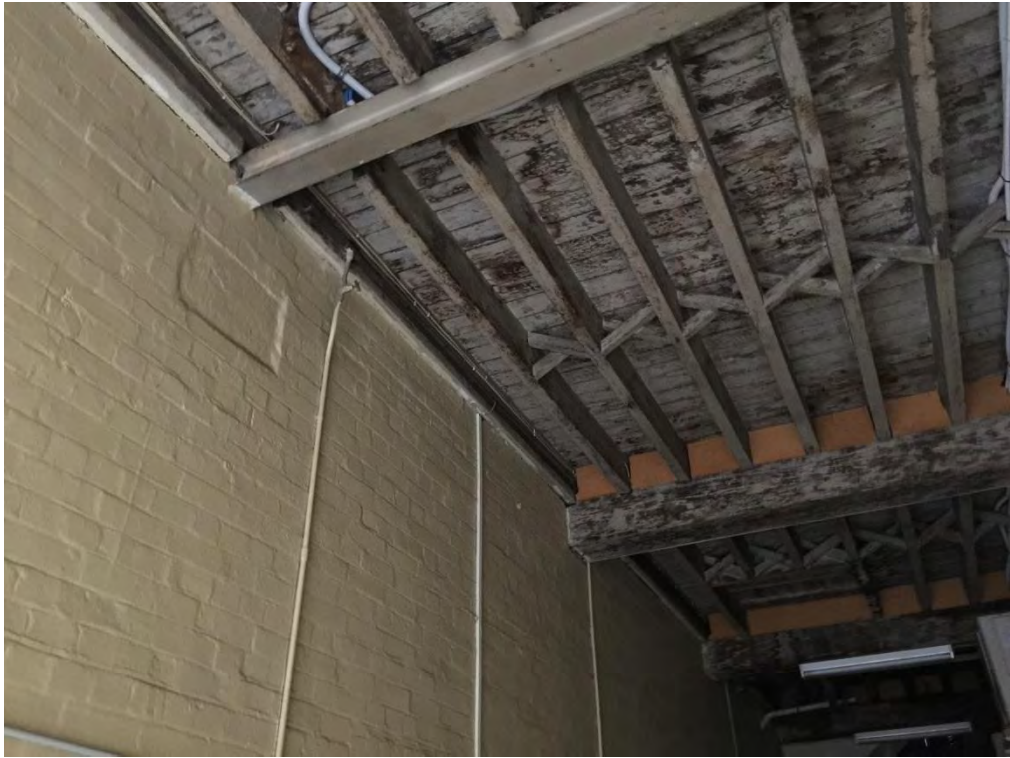
*Figure 71 – Steel beam in place of timber beam borne in wall of Cartway (Y01)
NBRS+Partners, April 2015.*

- The fibre-cement clad 'link' galleries at first floor (F06 and F08) including their steel beams;
- Steel beam replacement of section of beam at eastern end of cartway (Y01) and space G06;

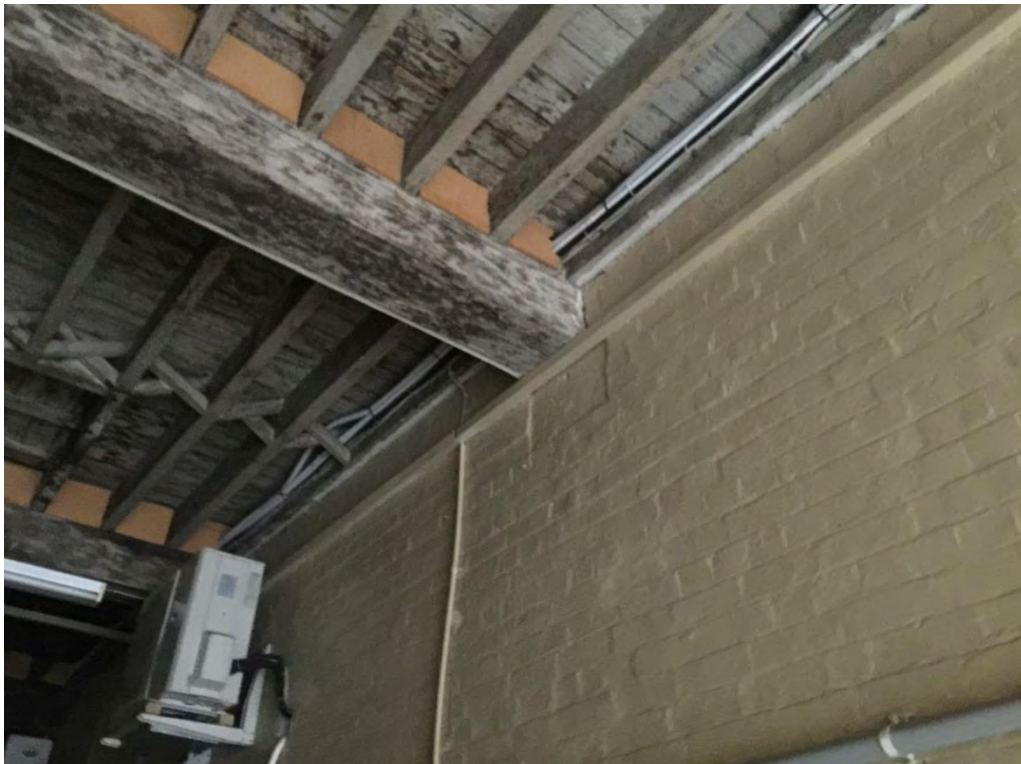
*Figure 72 – Timber beam borne on stone block in wall of Cartway (Y01)
NBRS+Partners, April 2015.*

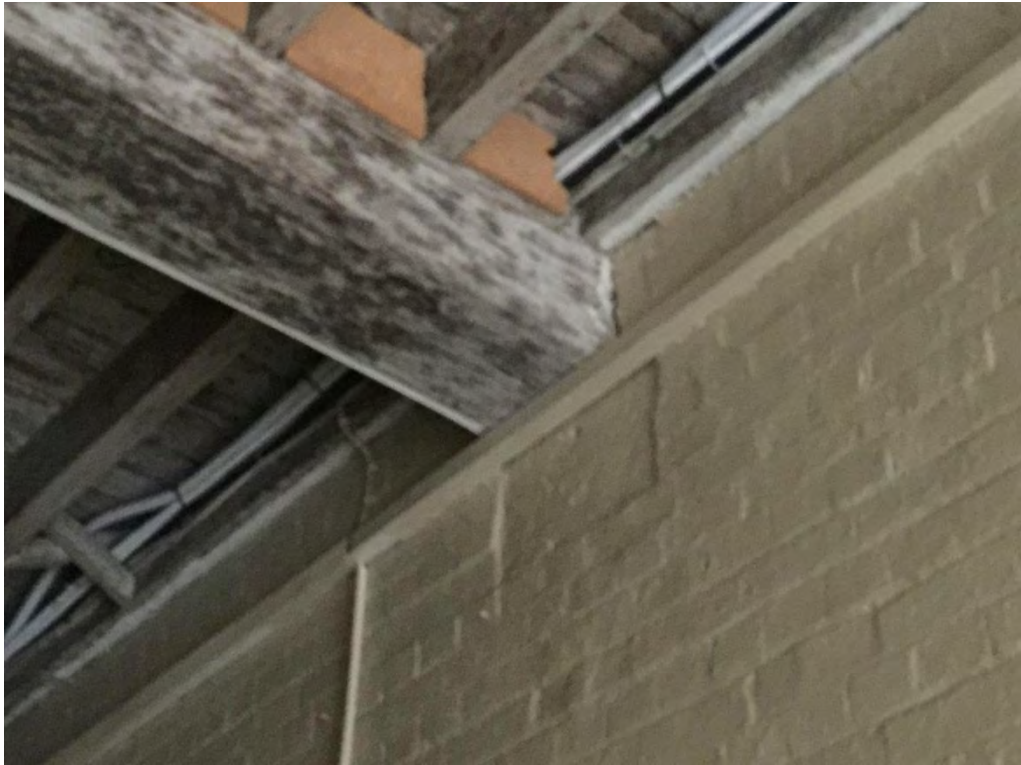
*Figure 73 – Timber beam borne on stone block in wall of Cartway (Y01)
NBRS+Partners, April 2015.*

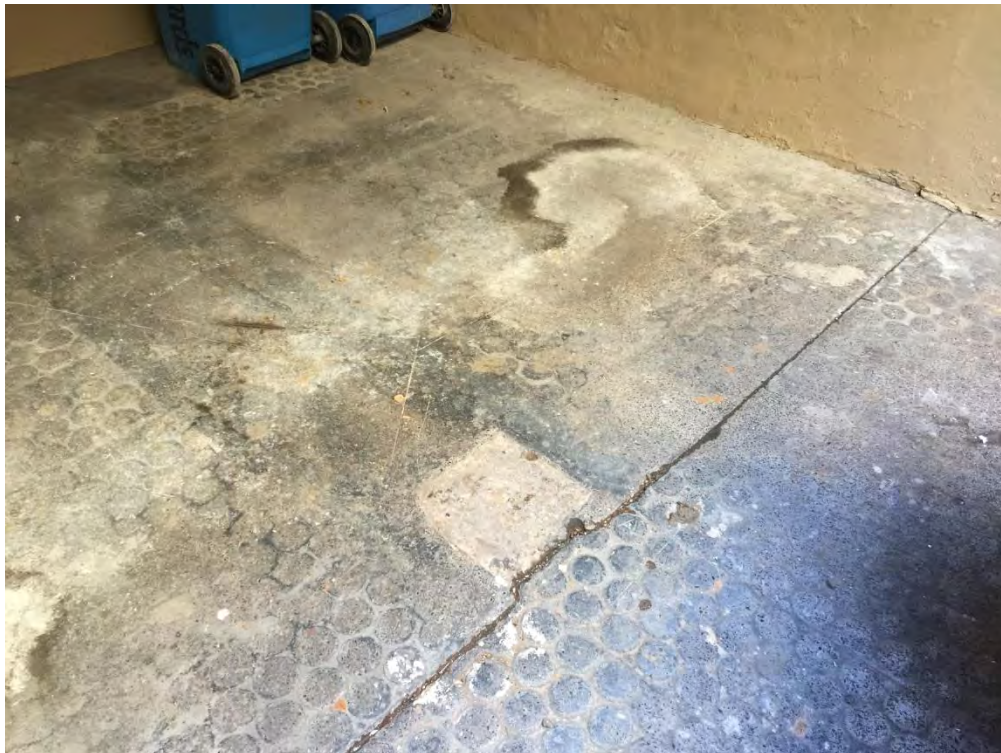
Figure 80 – One of five sandstone block footings for posts evident in floor of yard (Y02). NBRSPartners, April 2015.

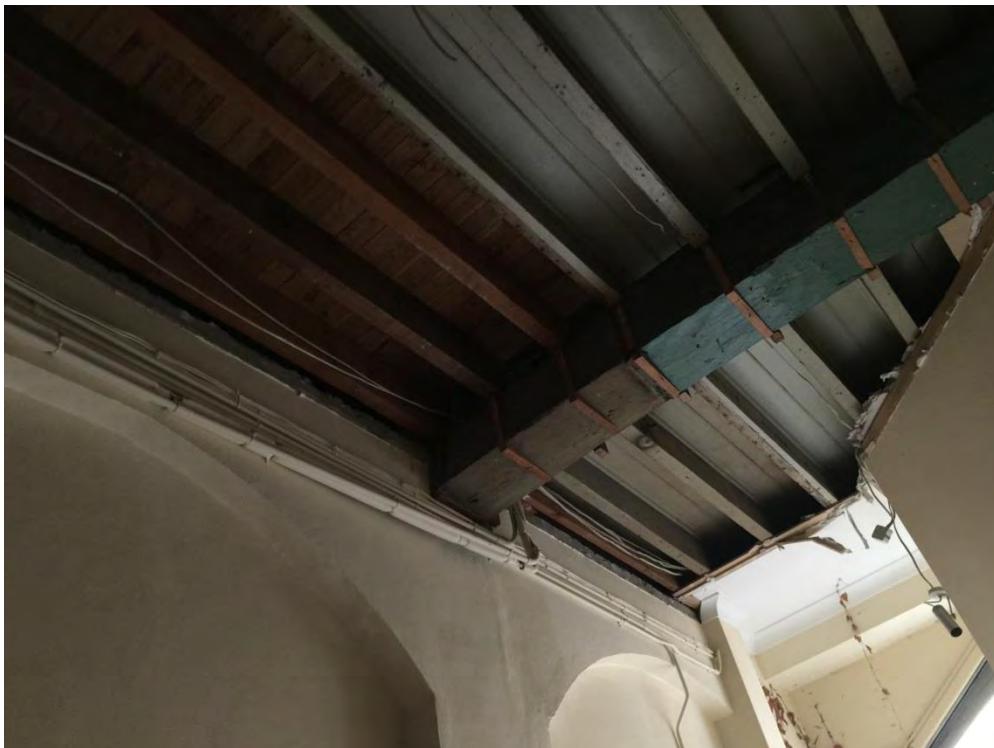
Figure 90 – South-western corner of space G06 showing original matchboard lining. NBRSPartners, April 2015.

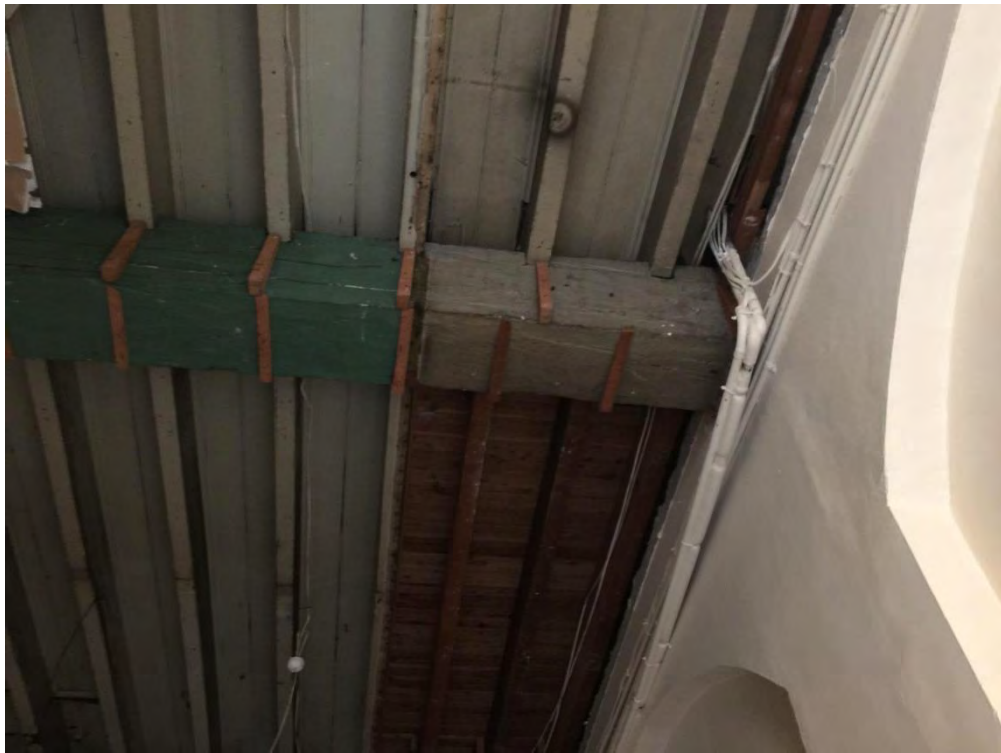
Figure 91 – South-western corner of space G06 showing original matchboard lining. NBRSPartners, April 2015.

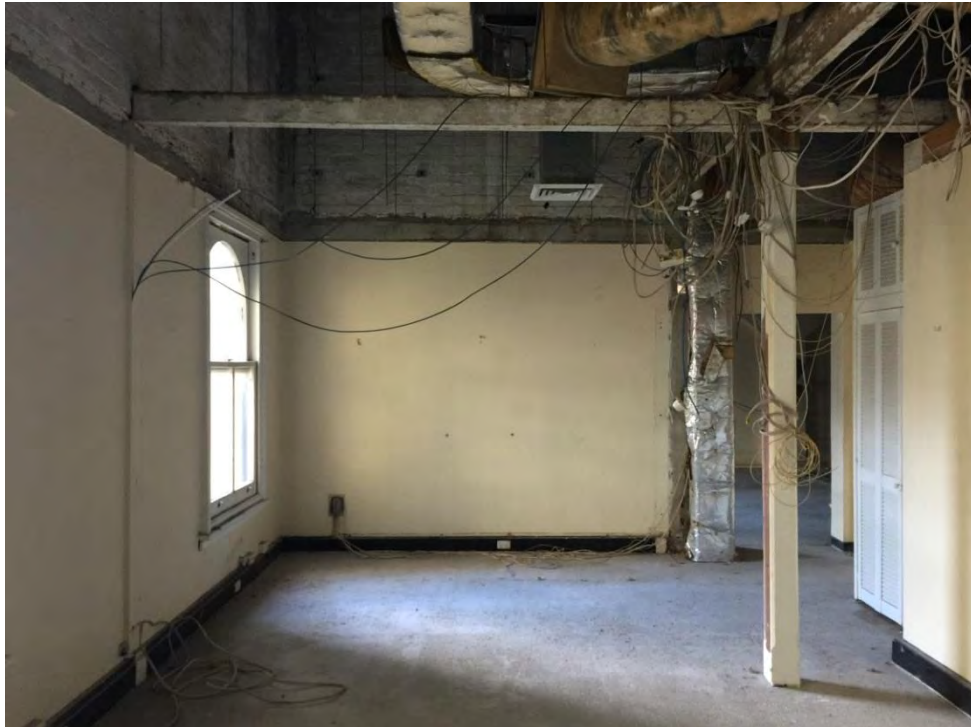
Figure 93 – Western section of space S02 showing timber post, beam and truss structure. NBRSPartners, April 2015.

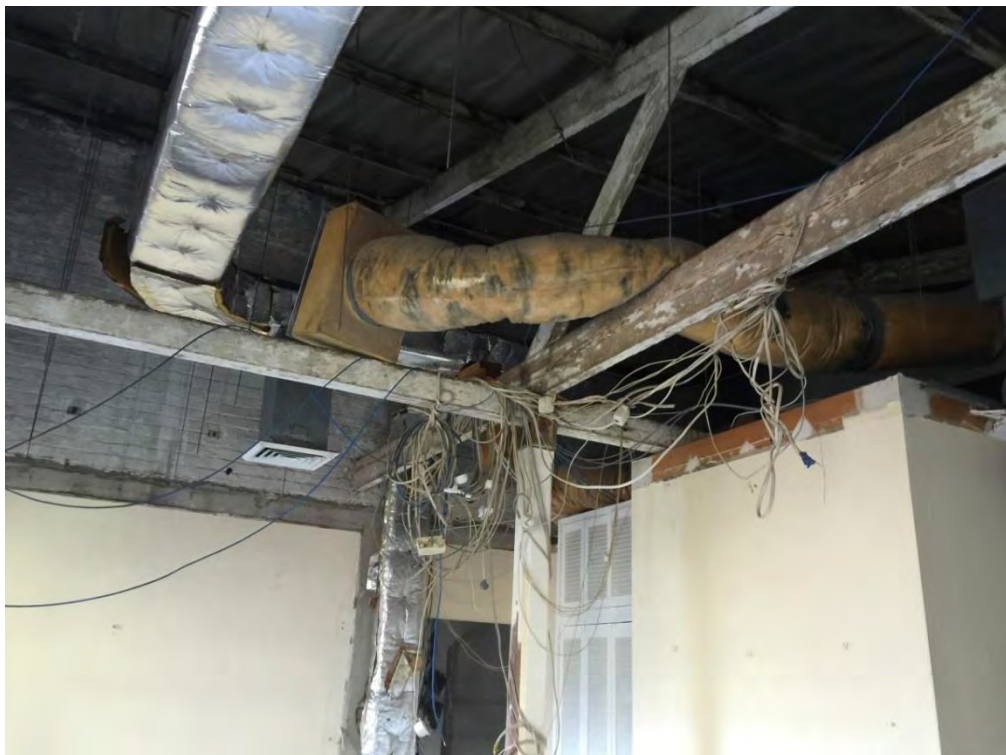
Figure 94 – Western section of space S02 showing timber post, beam and truss structure. Recent studwork walls to stair and service core at right. NBRSPartners, April 2015.

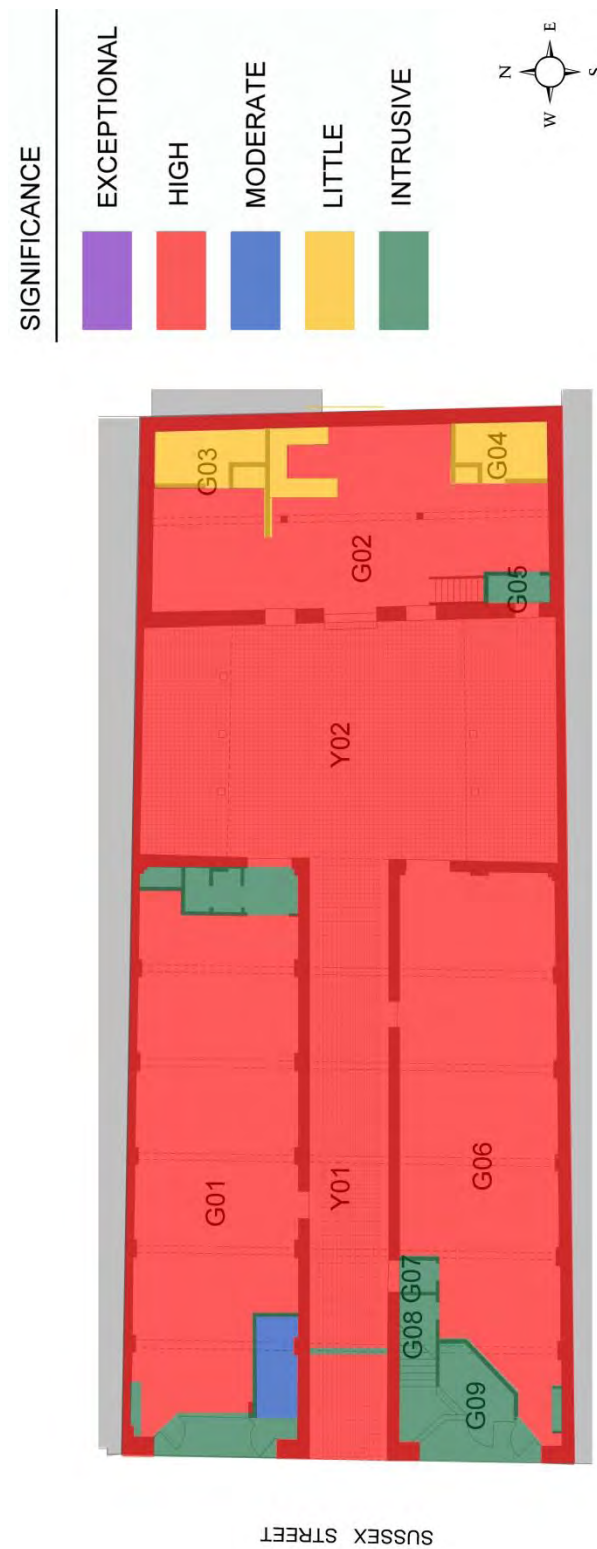
Figure 100 – Relative Degrees of Significance – Ground Plan. NBRSPartners, 2015.
