Phase 1 Assessment

174 - 176a George Street, Sydney

178 - 186 George Street & 33 - 35 Pitt Street, Sydney

Plates

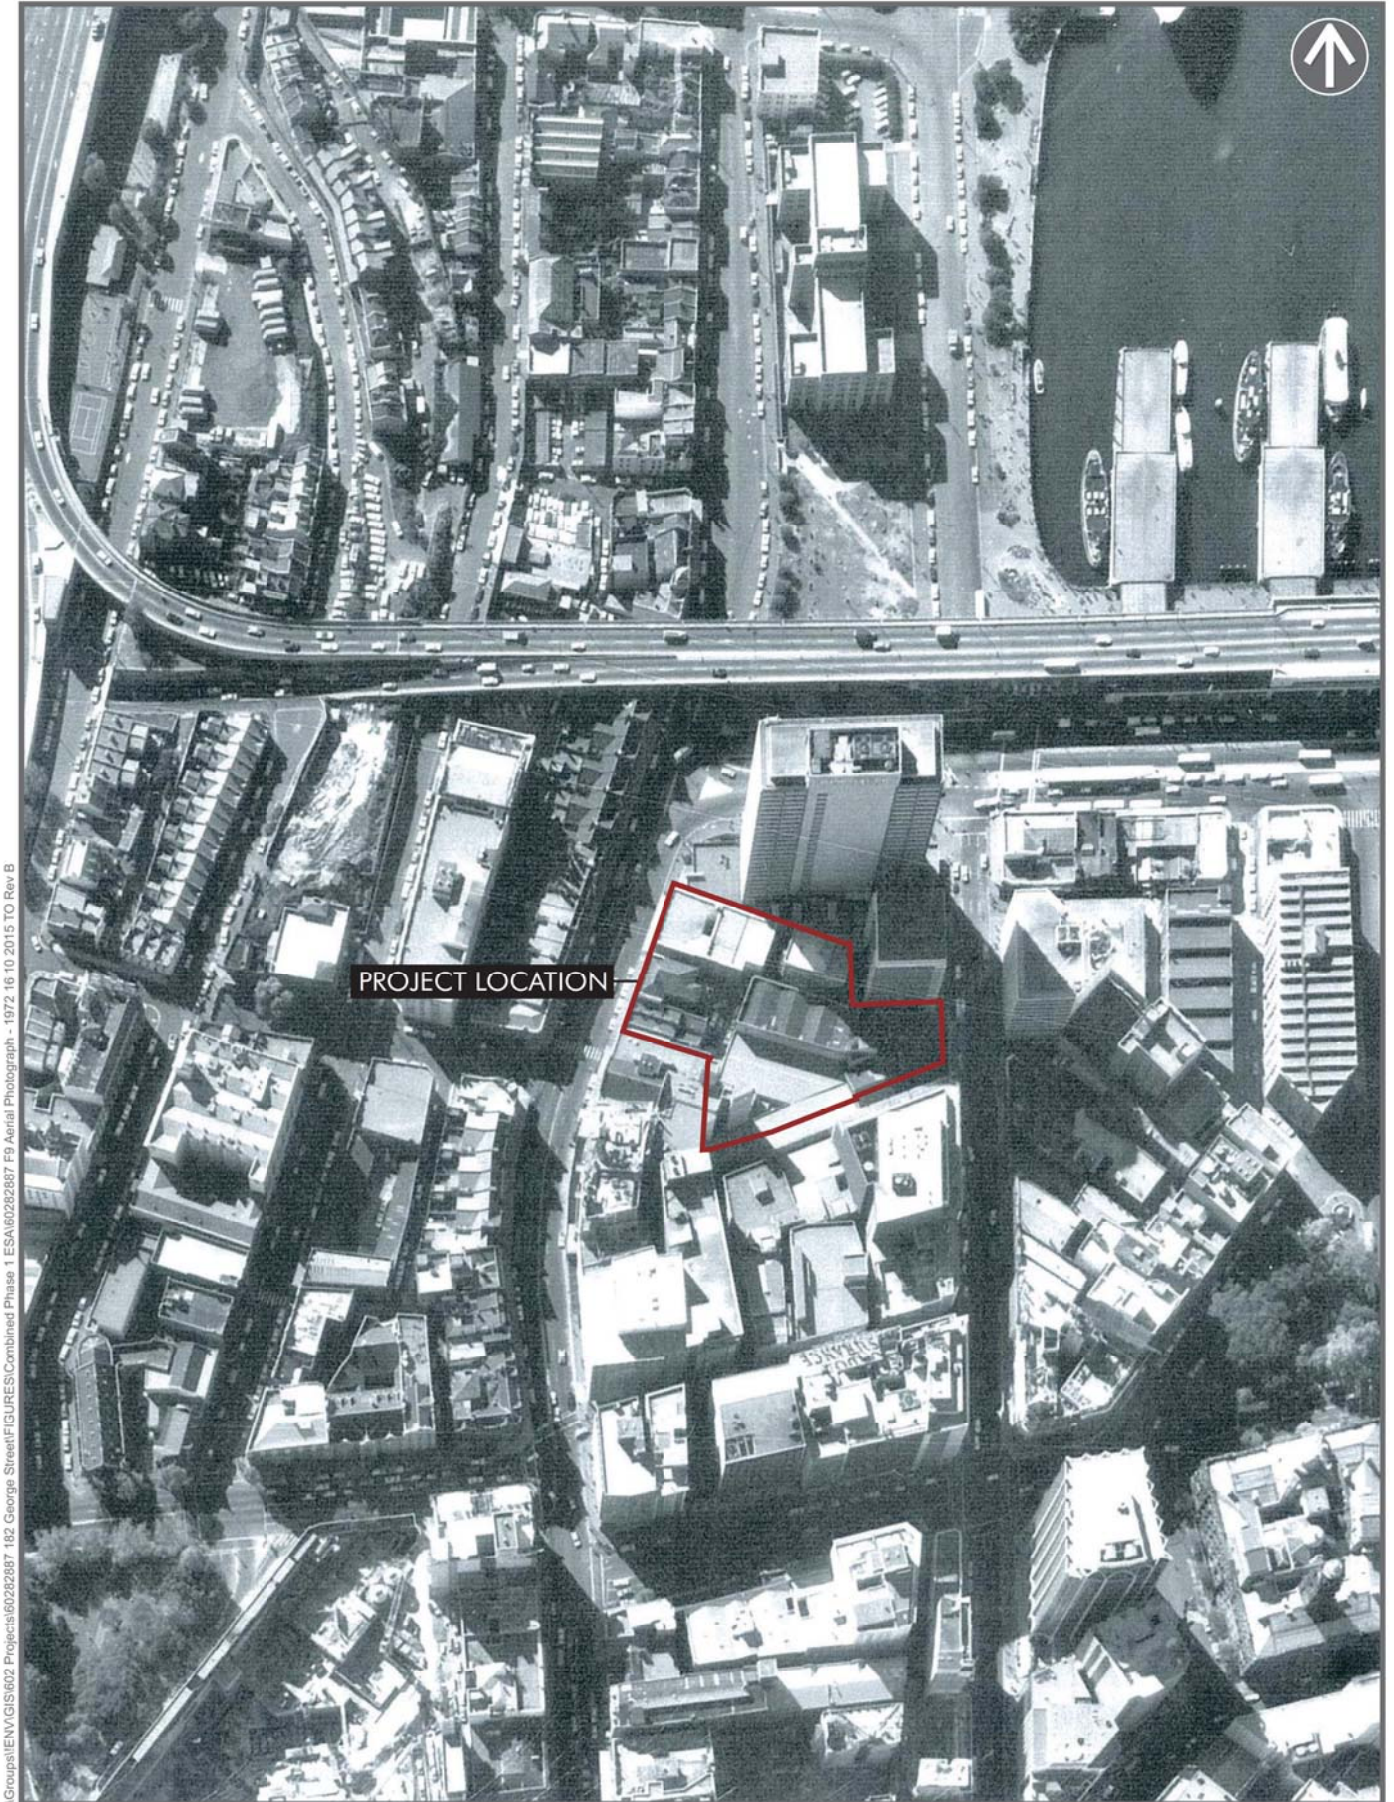
FIGURE 9

AERIAL PHOTOGRAPH - 1972

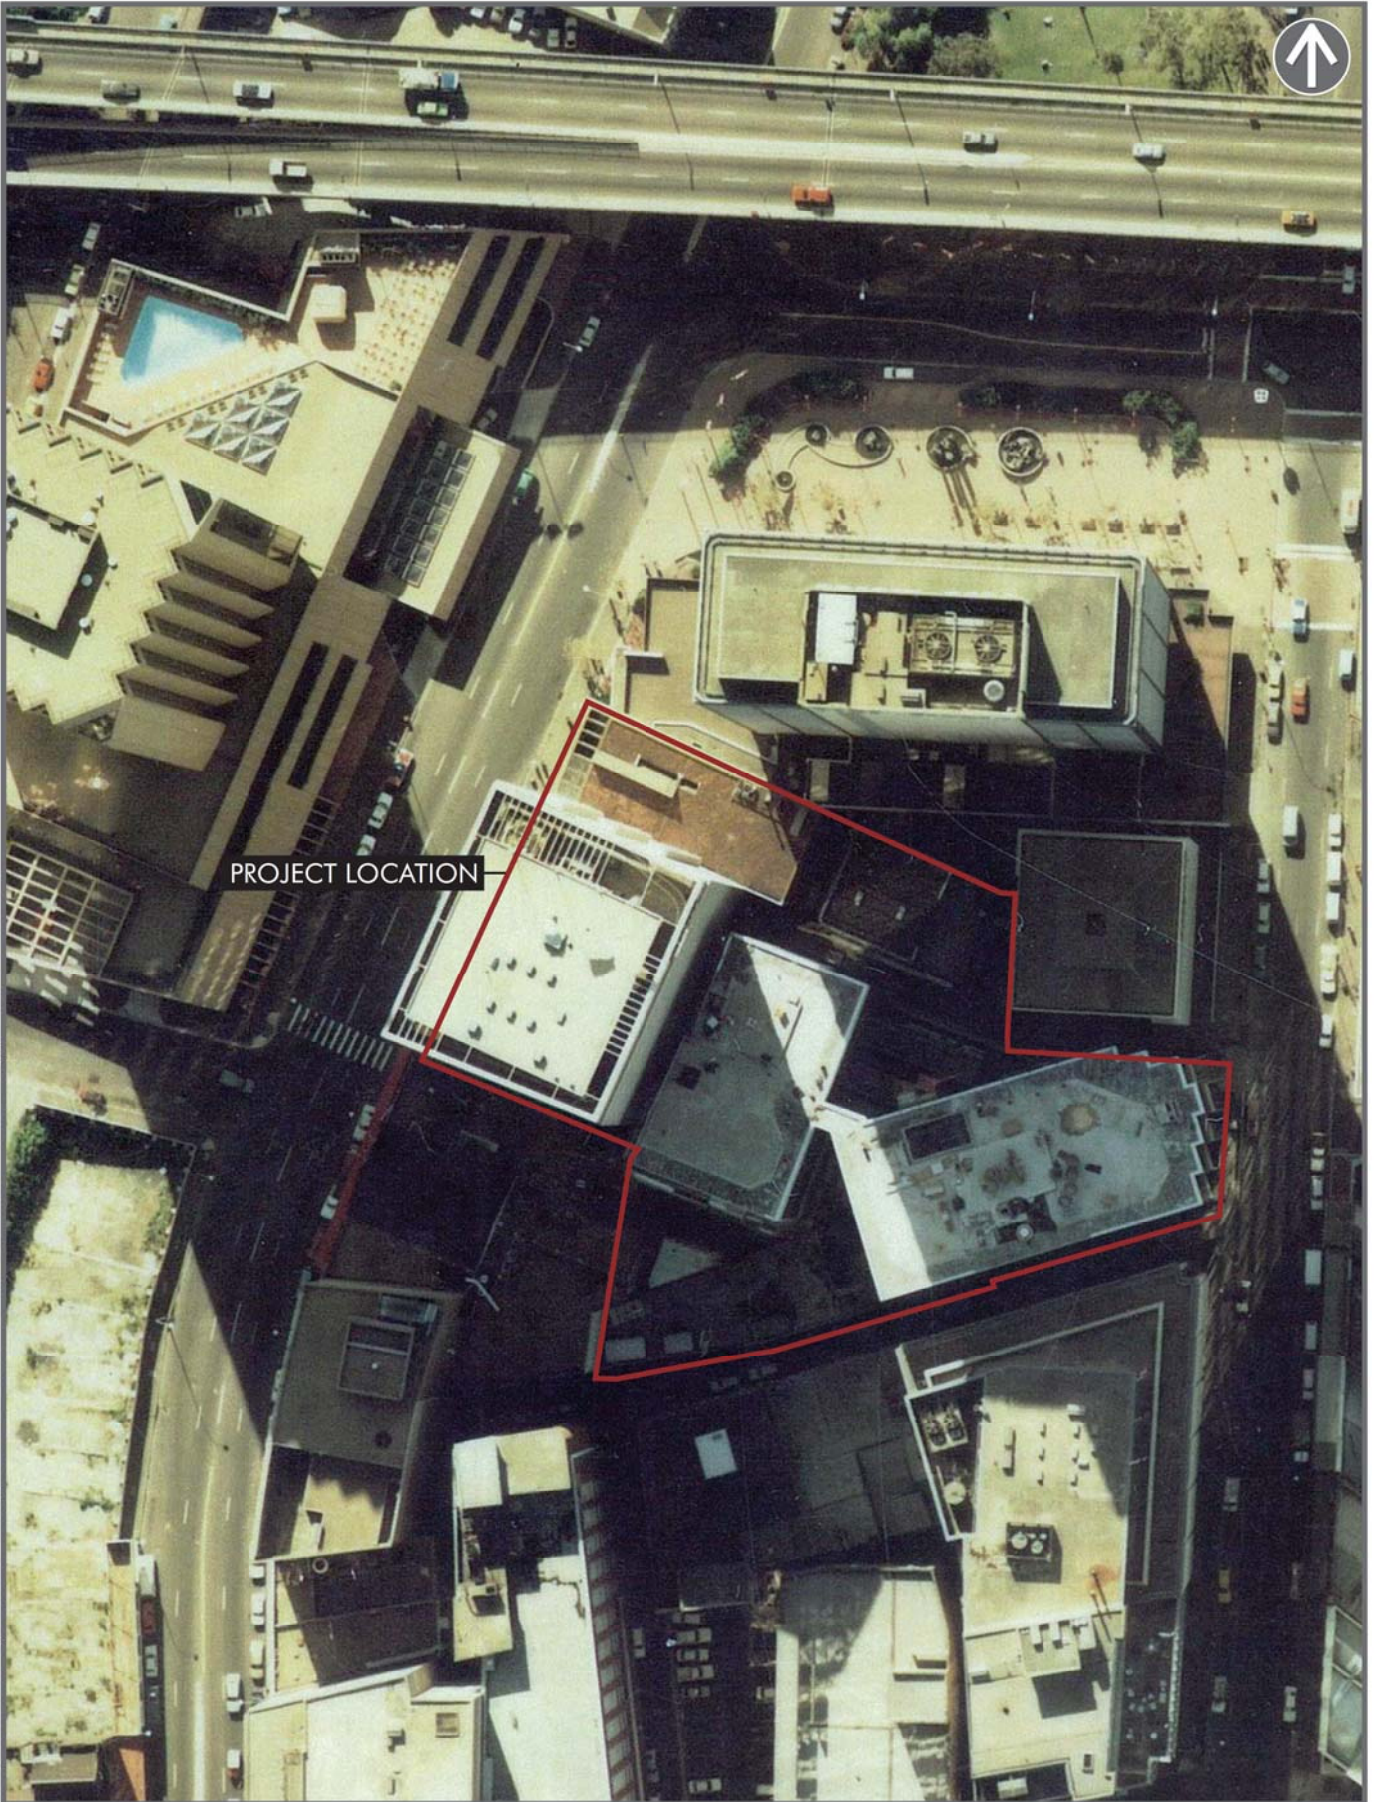
FIGURE 10

AERIAL PHOTOGRAPH - 1983

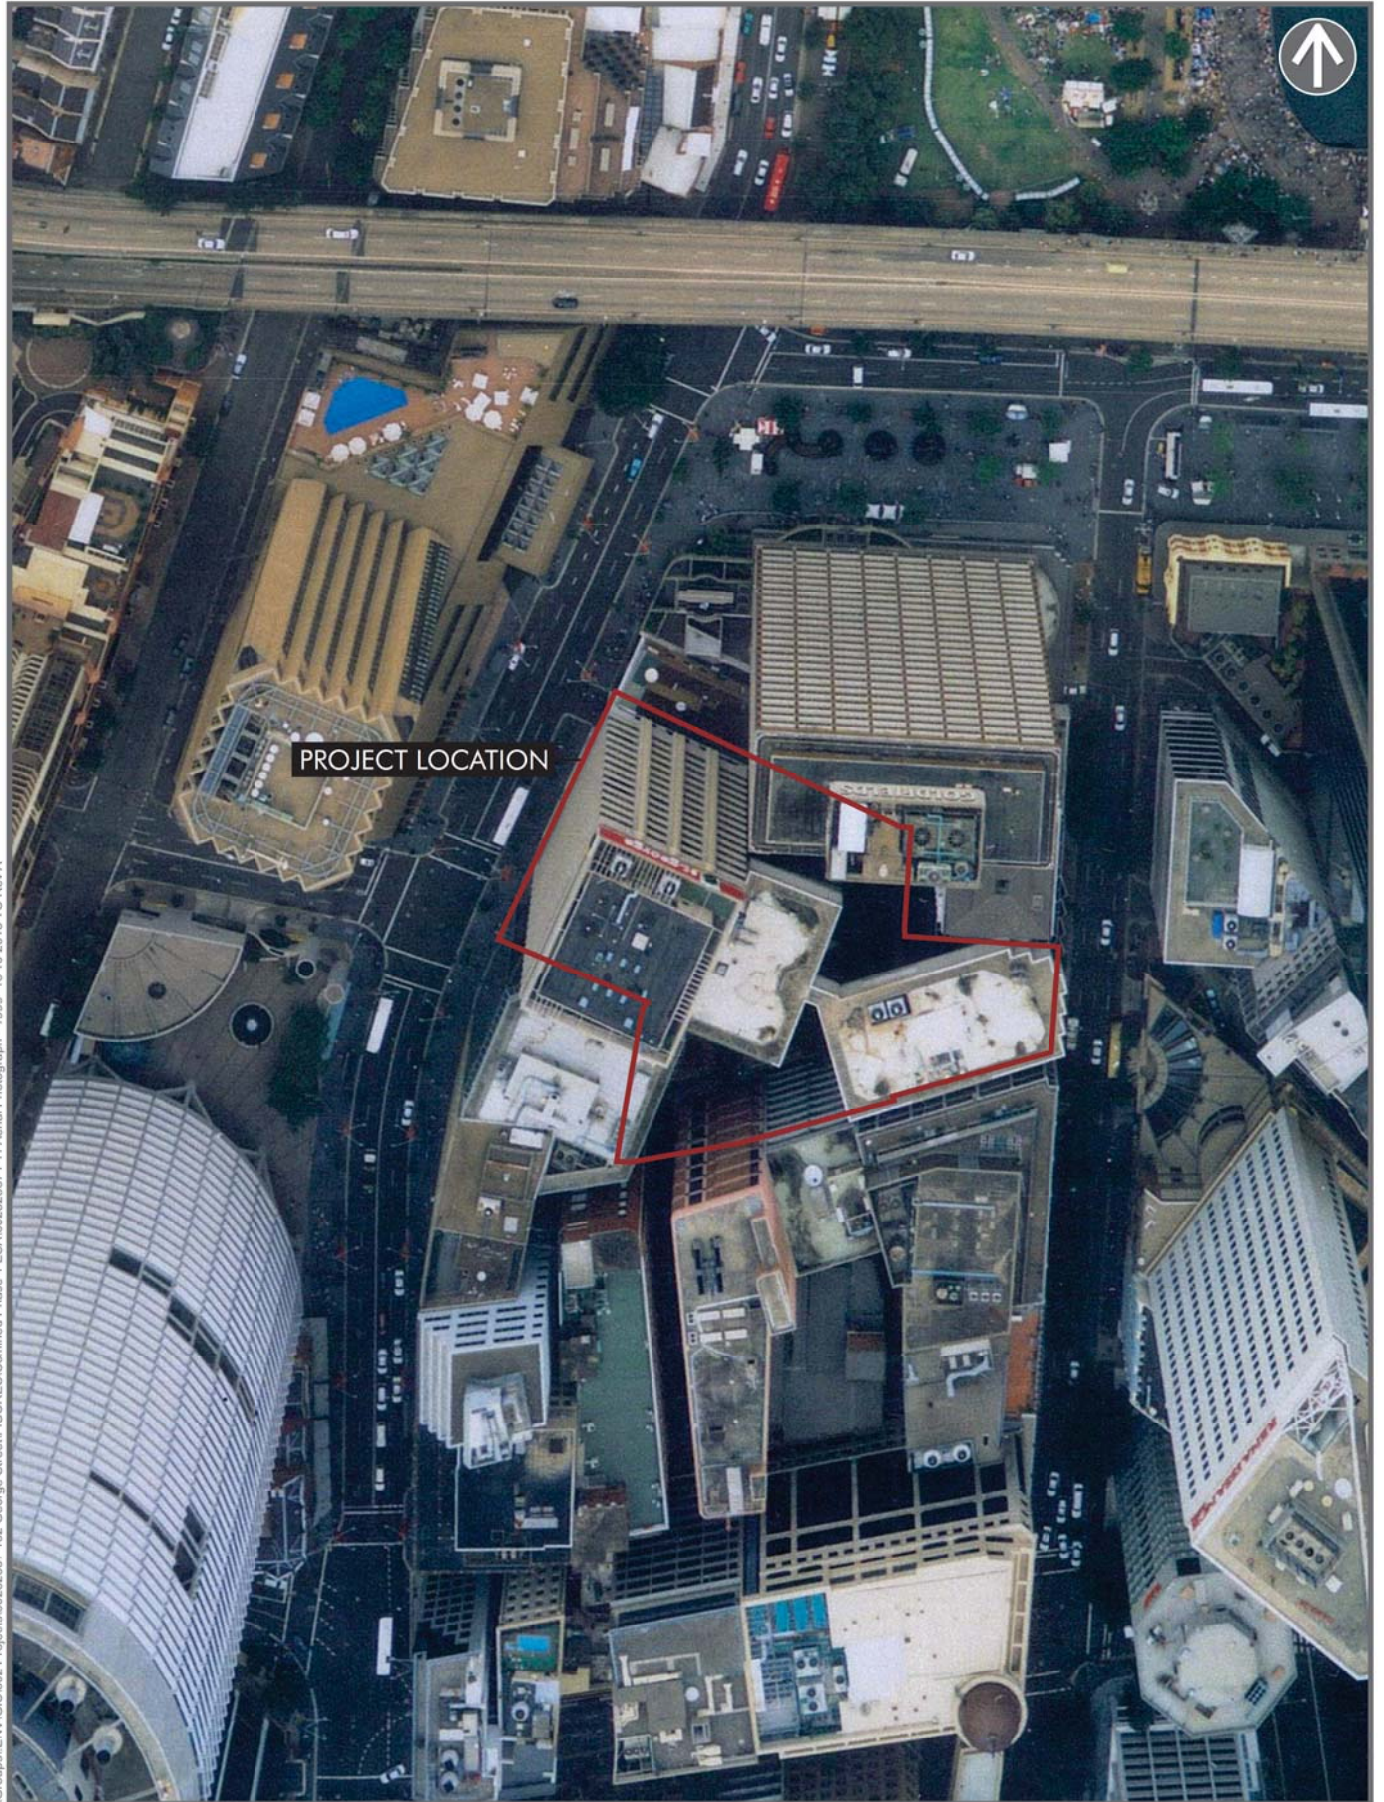
FIGURE 11

AERIAL PHOTOGRAPH - 1999

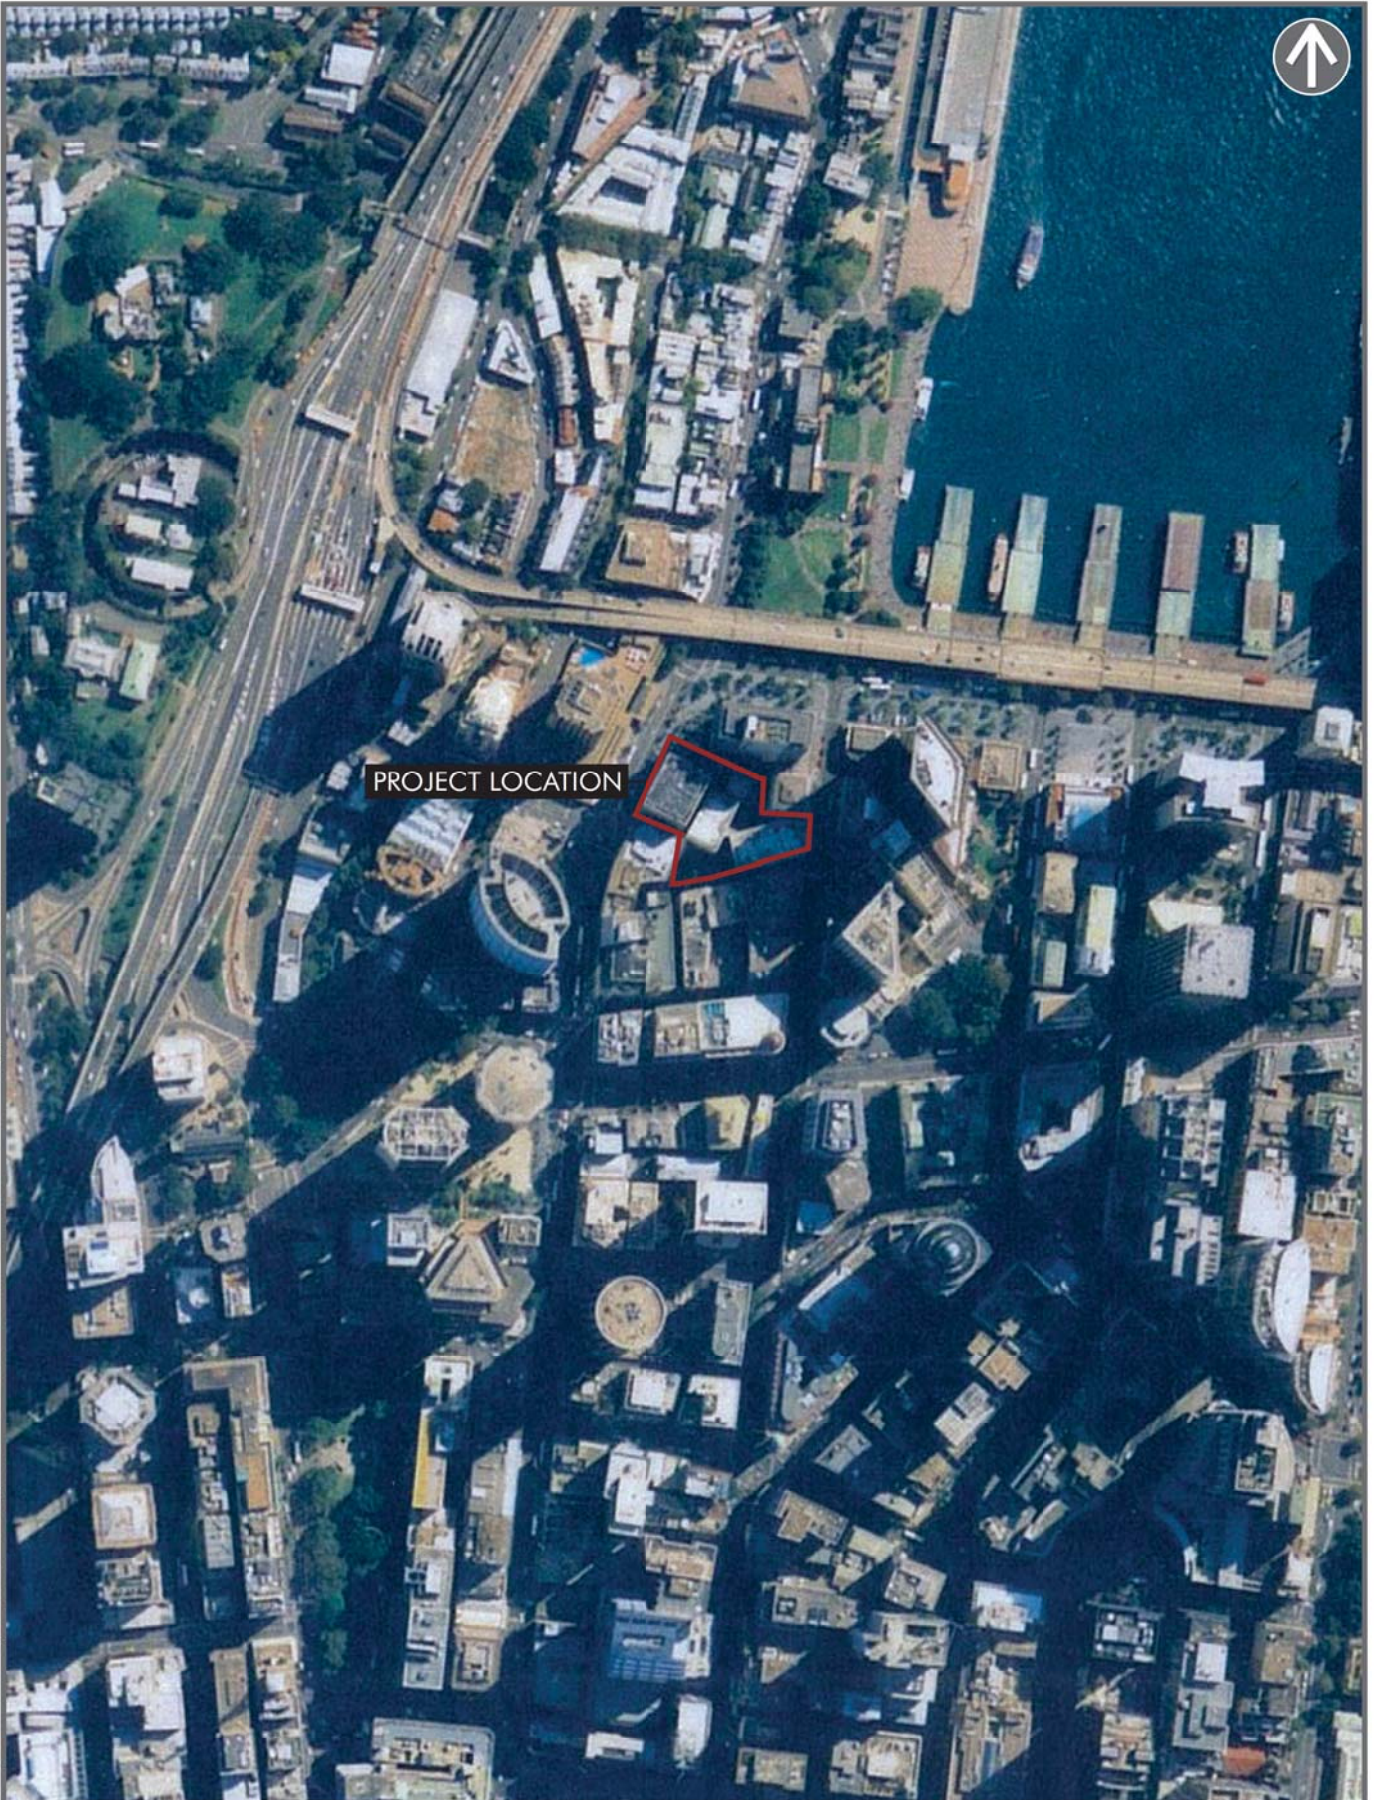
FIGURE 12

AERIAL PHOTOGRAPH - 2002

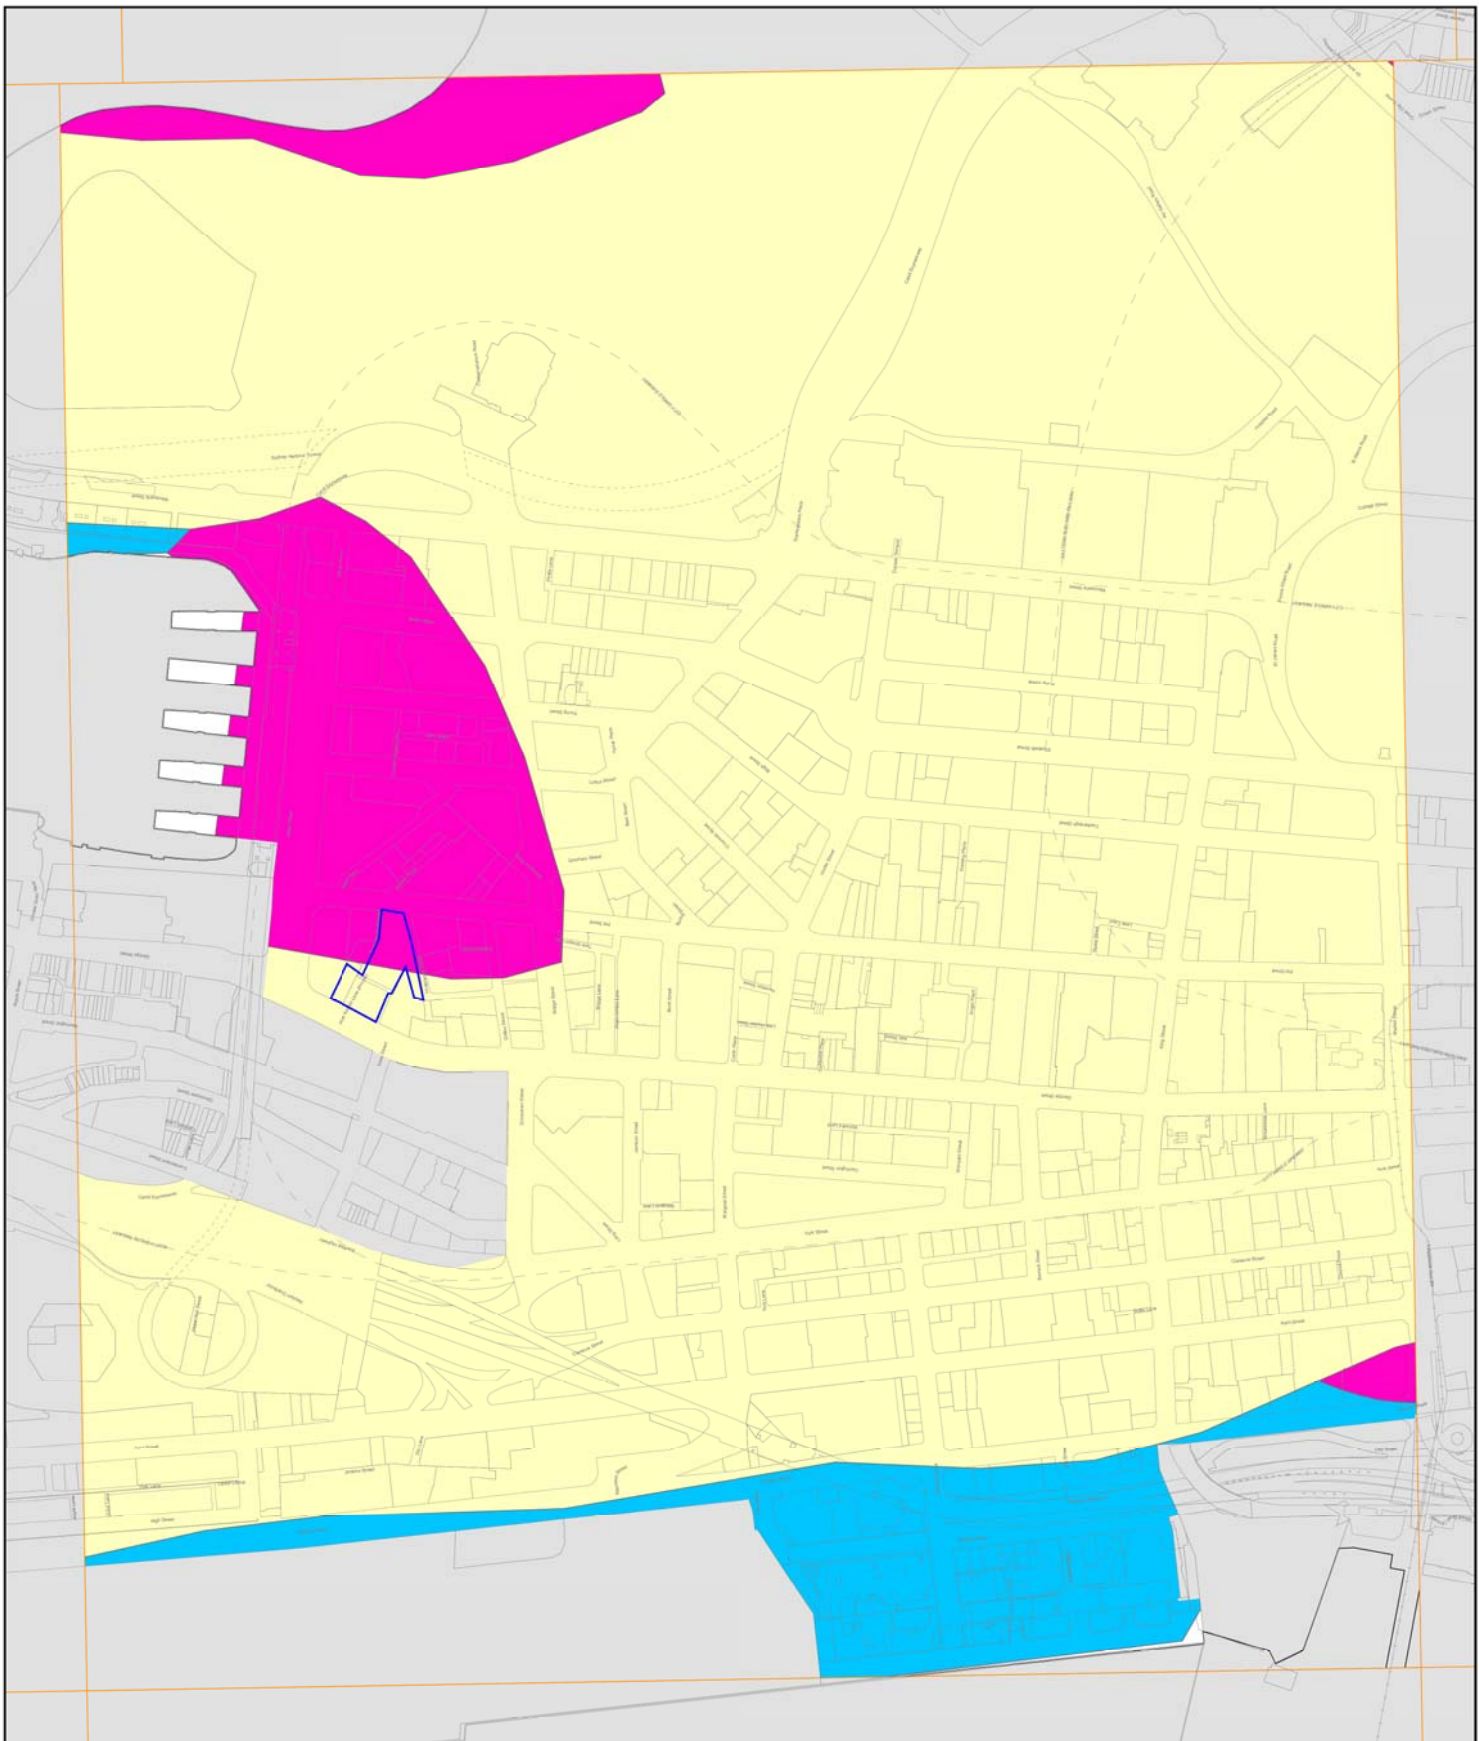
**Acid Sulfate Soils Map
- Sheet ASS_014**

Acid Sulfate Soils

- Class 1
- Class 2
- Class 3
- Class 4
- Class 5

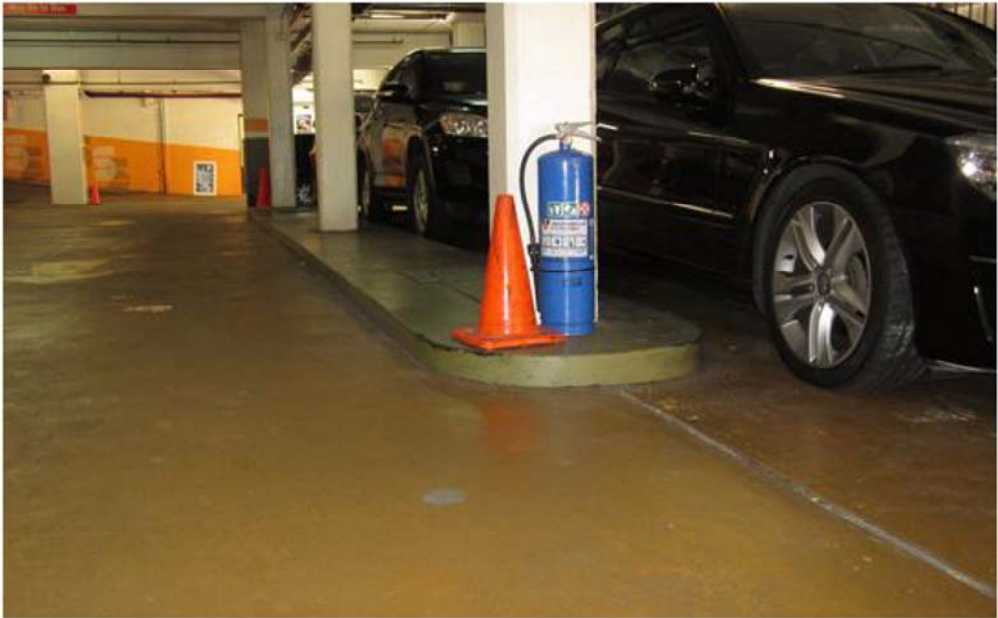
Plate No. 4	Date: 18/12/12

Direction Photo Taken: East		
Description: Former fuel bowser island, 33-35 Pitt Street (car park)

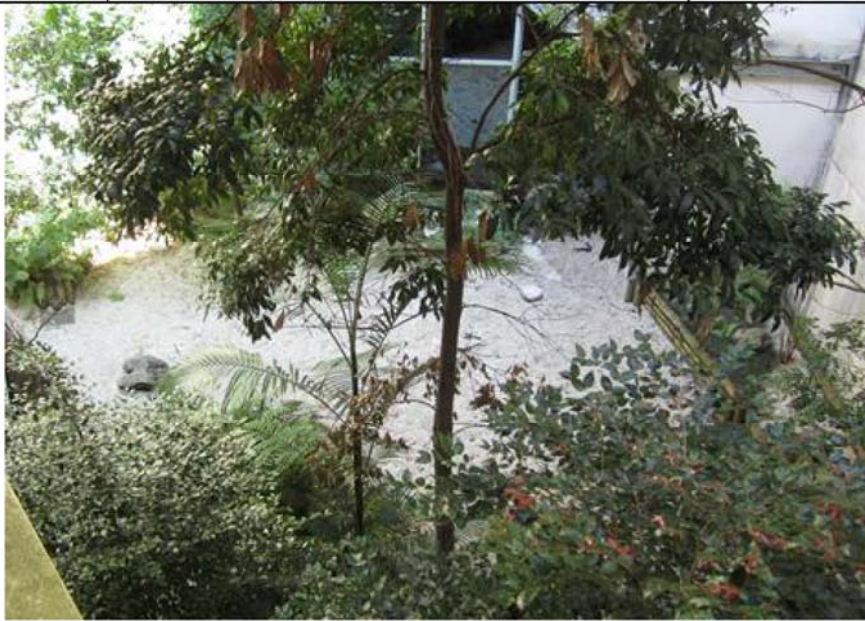
PHOTOGRAPHIC LOG			
Project Name: Phase 1 Contamination Assessment		Site Location: LLCQ Development	Project No: 60282887
Plate No. 9	Date: 18/12/12

Direction Photo Taken: West			
Description: "Mirvac Triangle" – Ground floor garden area. View from adjacent 33-35 Pitt Street.
