Phase 1 Assessment

174 - 176a George Street, Sydney

178 - 186 George Street & 33 - 35 Pitt Street, Sydney

**PHOTOGRAPHIC LOG**

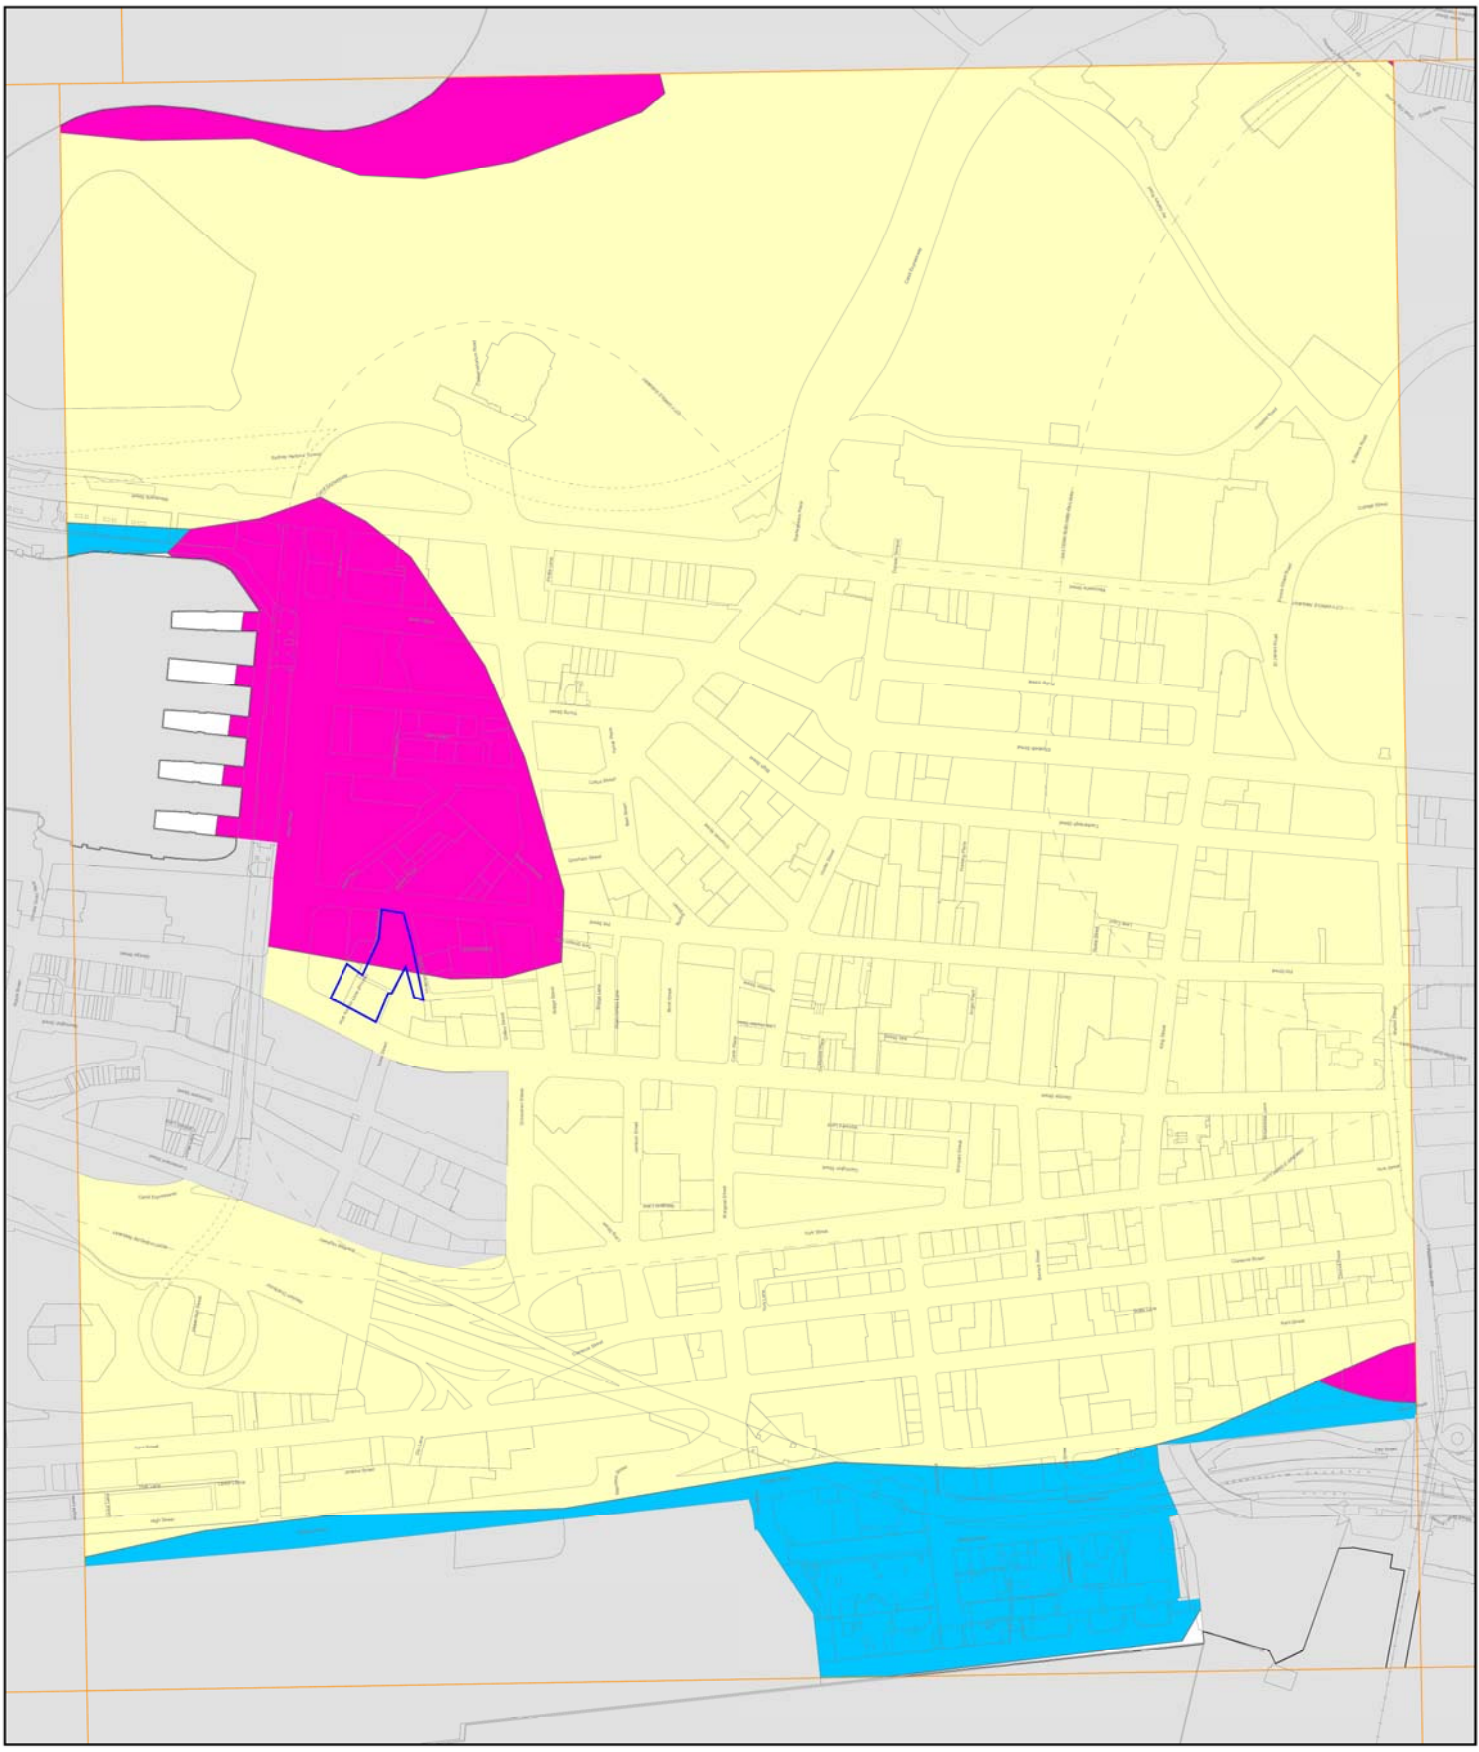
**Acid Sulfate Soils Map**  
 - Sheet ASS\_014

**Acid Sulfate Soils**

- Class 1
- Class 2
- Class 3
- Class 4
- Class 5

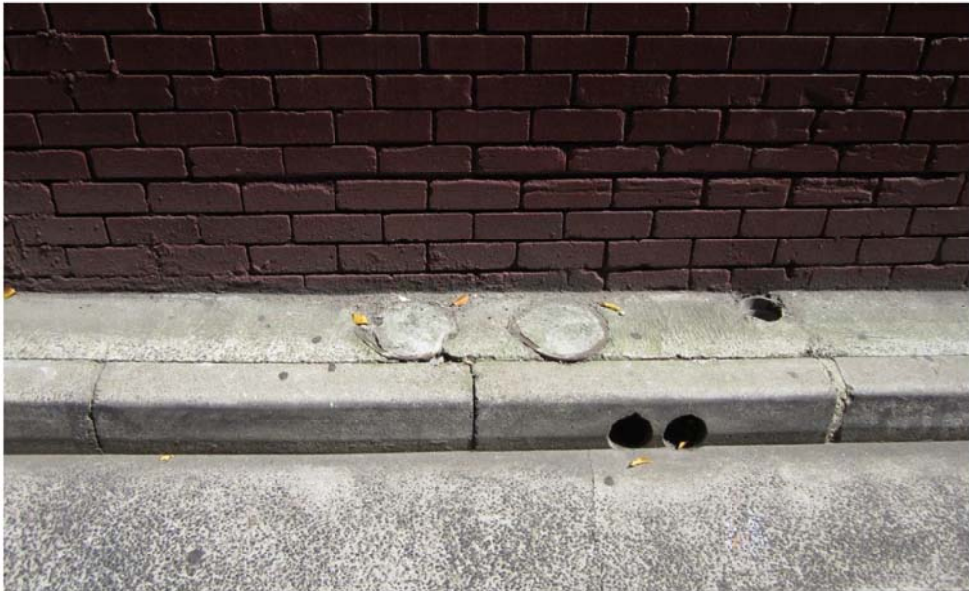
<b>Project Name:</b> Phase 1 Contamination Assessment		<b>Site Location:</b> LLCQ Development	<b>Project No:</b> 60282887
<b>Plate No.</b> <b>1</b>	<b>Date:</b> 18/12/12

<b>Direction Photo Taken:</b> North			
<b>Description:</b> Former Fill points, Underwood Street

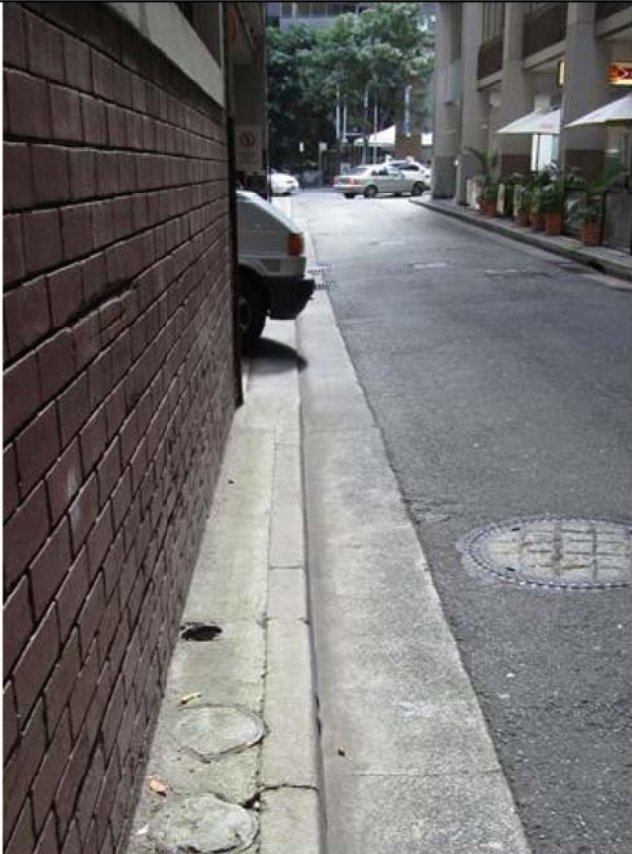
<b>Plate No.</b> <b>2</b>	<b>Date:</b> 18/12/12

<b>Direction Photo Taken:</b> East		
<b>Description:</b> Former Fill points, Underwood Street. Looking east towards Pitt Street.

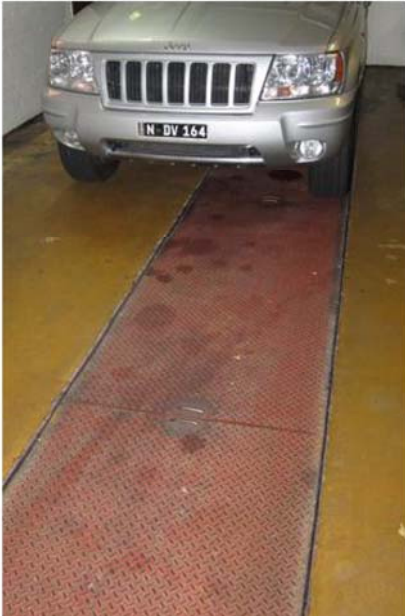
<b>Project Name:</b> Phase 1 Contamination Assessment		<b>Site Location:</b> LLCQ Development	<b>Project No:</b> 60282887
<b>Plate No.</b> <b>3</b>	<b>Date:</b> 18/12/12

<b>Direction Photo Taken:</b>  West			
<b>Description:</b>  Vehicle inspection pit, 33-35 Pitt Street

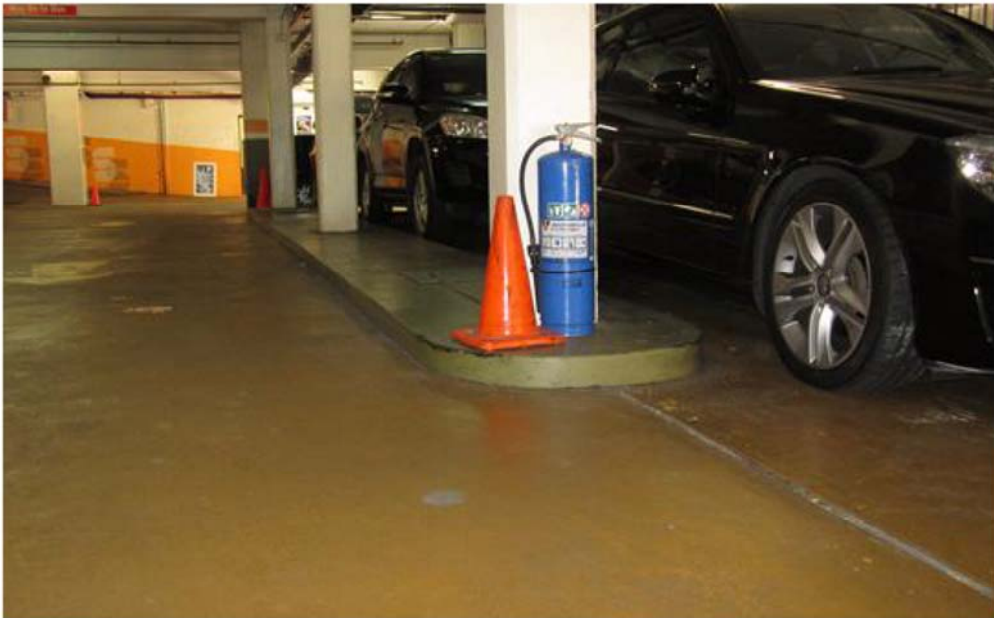
<b>Plate No.</b> <b>4</b>	<b>Date:</b> 18/12/12

<b>Direction Photo Taken:</b>  East		
<b>Description:</b>  Former fuel bowser island, 33-35 Pitt Street (car park)

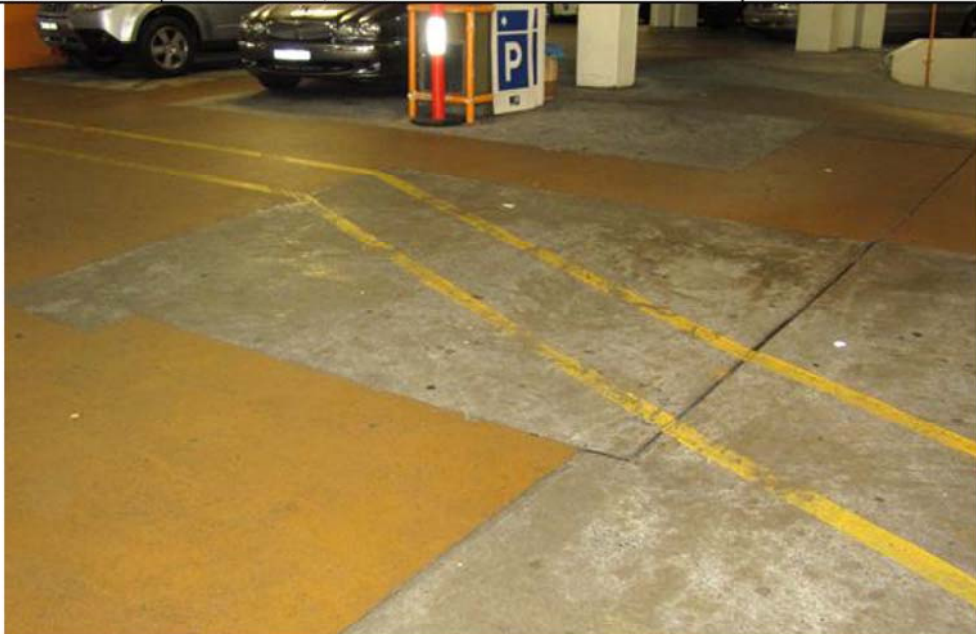
<b>PHOTOGRAPHIC LOG</b>		
<b>Project Name:</b> Phase 1 Contamination Assessment		<b>Site Location:</b> LLCQ Development
<b>Project No:</b> 60282887		
<b>Plate No.</b> <b>5</b>	<b>Date:</b> 18/12/12

<b>Direction Photo Taken:</b>  North west		
<b>Description:</b>  Repaired concrete floor, 33-35 Pitt Street (car park)

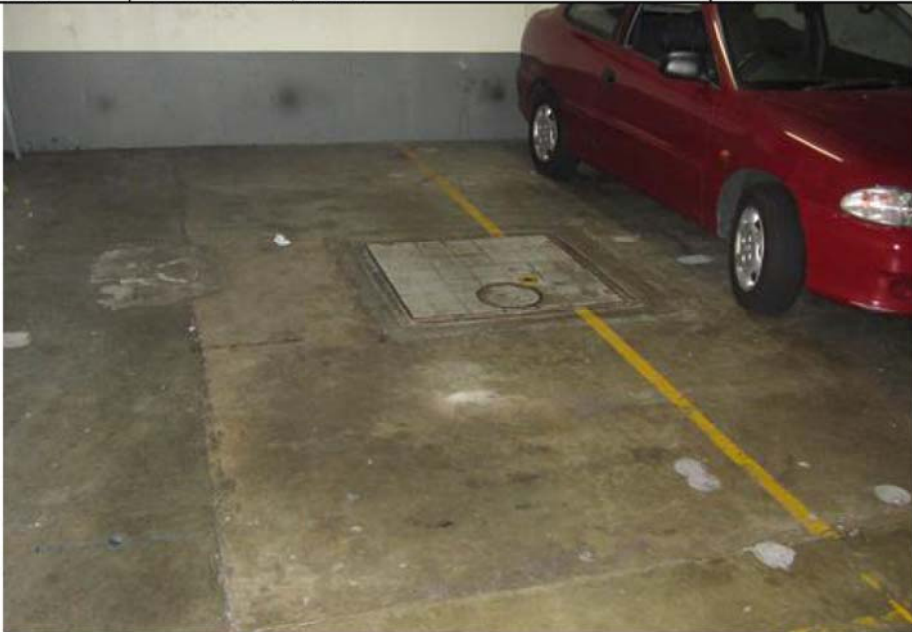
<b>PHOTOGRAPHIC LOG</b>		
<b>Project Name:</b> Phase 1 Contamination Assessment		<b>Site Location:</b> LLCQ Development
<b>Project No:</b> 60282887		
<b>Plate No.</b> <b>7</b>	<b>Date:</b> 18/12/12

<b>Direction Photo Taken:</b>  West		
<b>Description:</b>  UST, 33-35 Pitt Street car park.

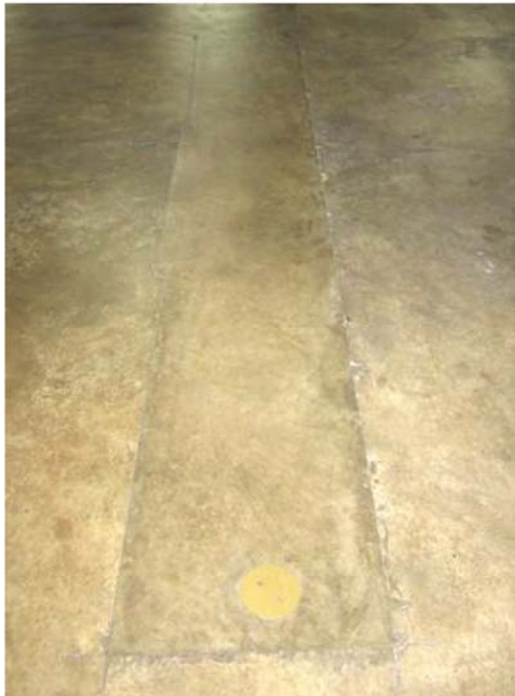
<b>Plate No.</b> <b>8</b>	<b>Date:</b> 18/12/12

<b>Direction Photo Taken:</b>  South		
<b>Description:</b>  Concrete cuts and repair, 33-35 Pitt Street car park.

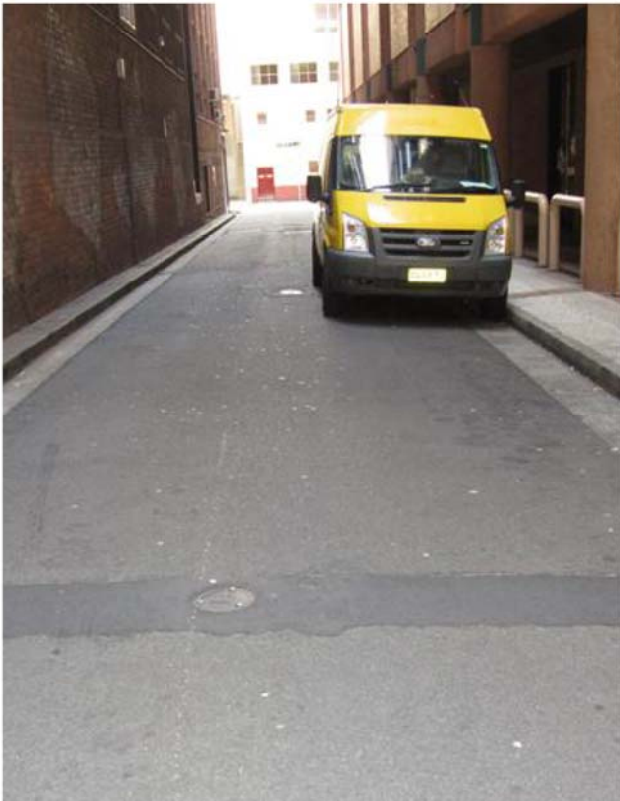
<b>Plate No.</b> <b>12</b>	<b>ate:</b> 18/12/12

<b>Direction Photo Taken:</b> North		
<b>Description:</b> Monitoring wells, Underwood Street. Dalley Street intersection, looking north
