3.0 PHYSICAL ANALYSIS

3.1 GENERAL DESCRIPTION OF THE HAROLD PARK SITE

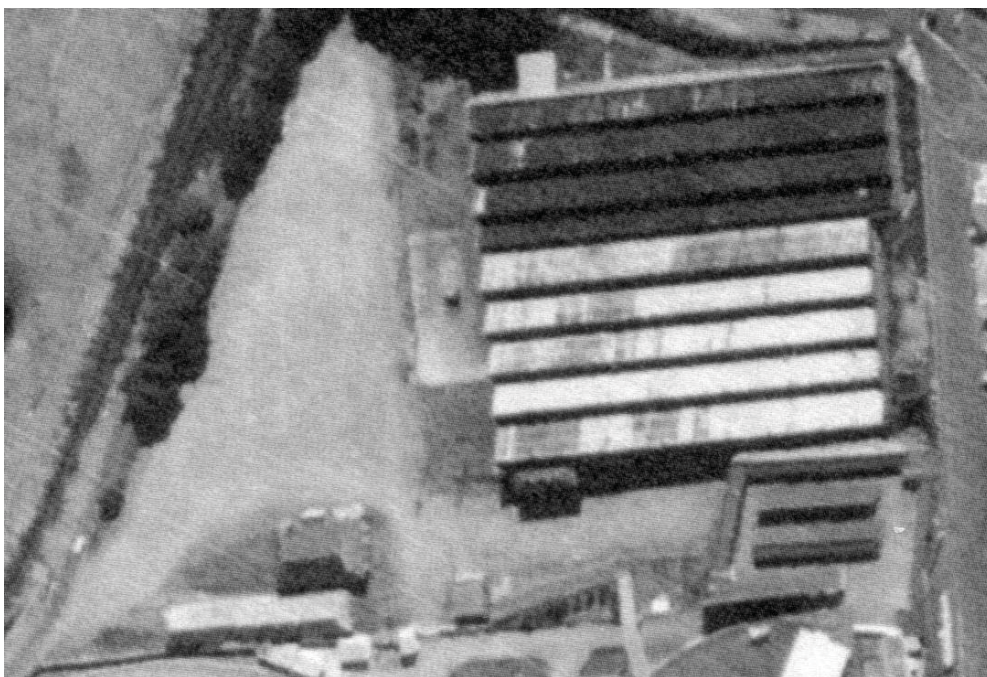
Figure 2.17: 1982 aerial photo. Lands Department Aerial Photograph Sydney 1982 Run 22 NSW 4241-141

Figure 2.17 above shows the site in August 1982. The absence of vehicles in the yard suggests the CHEP lease has ceased. The yard surface has been concreted and the former tramway offices at the south-east corner have been demolished.

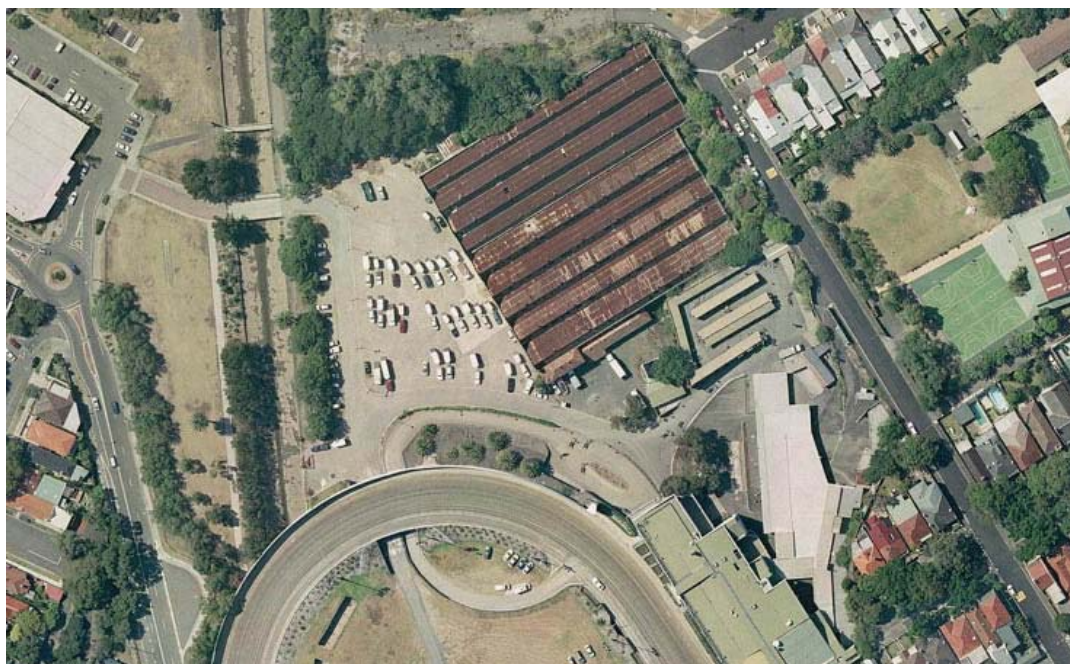
Figure 2.18: 2009 aerial photo of the Tramsheds precinct. NSW Lands Dept Six Viewer.

The existing configuration of the site shown in Figure 2.18 above dates from the 1995 redevelopment of the Paceway. The boundary trees remain.

- the demolition of all freestanding buildings,
- the removal of the previously strongly defined southern boundary with the Paceway, and the construction of the road bridge over the stormwater channel and the tunnel under the banked pacing track associated with the new mid-field car parking arrangements implemented in 1995.

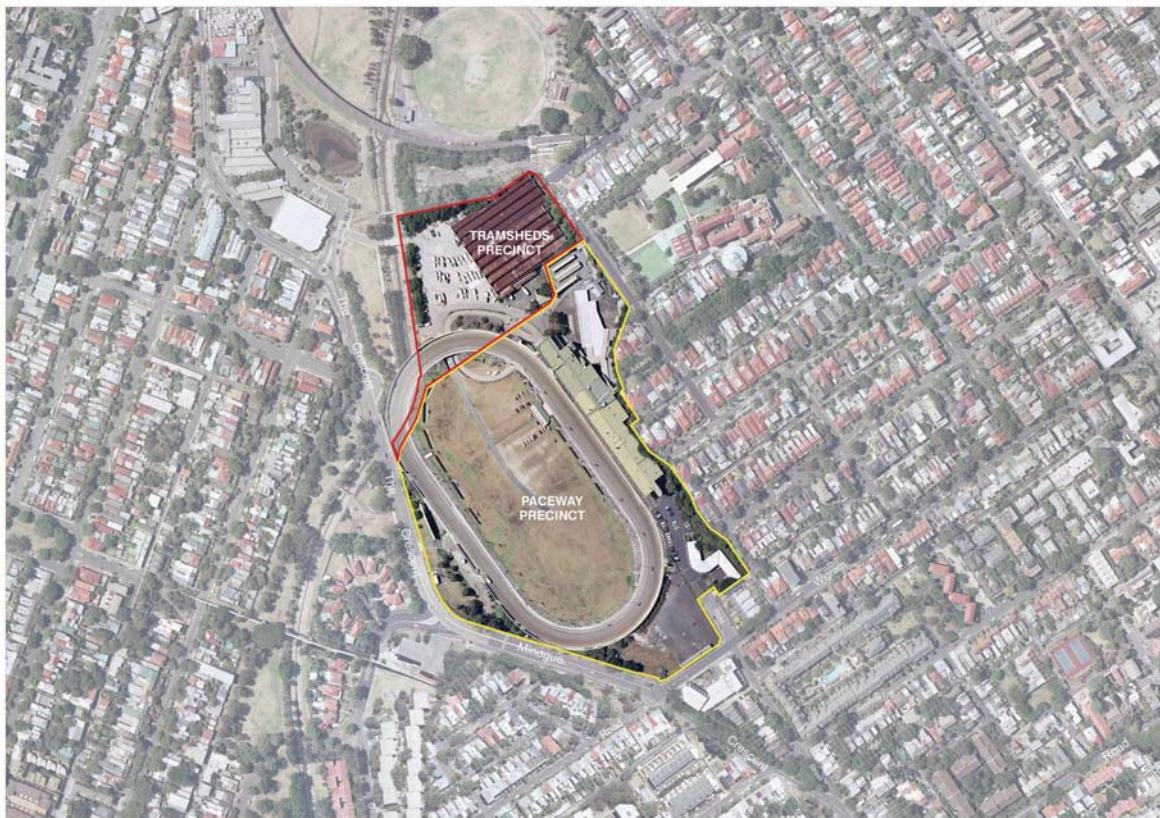
Figure 3.1: Site Precincts

The Harold Park site falls into two distinct precincts: The Paceway and The Tram Sheds. These two precincts have been physically and historically separate for the majority of the history of the site, and have only overlapped since the extension of the paceway track into the Tram Sheds precinct in 1995. Figure 3.1 below outlines the extent of the two precincts. Due to the distinctiveness of the two areas, they will be dealt with as separate precincts throughout this report.

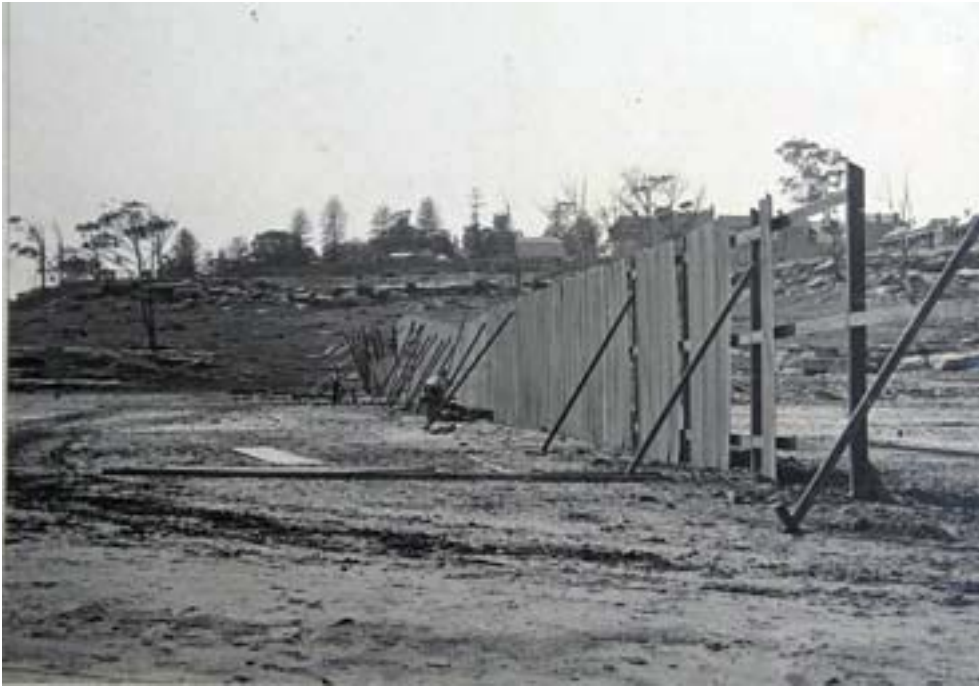
Figure 3.3: Construction of the paceway boundary fence 1909. Image no 3863 from Allen family album

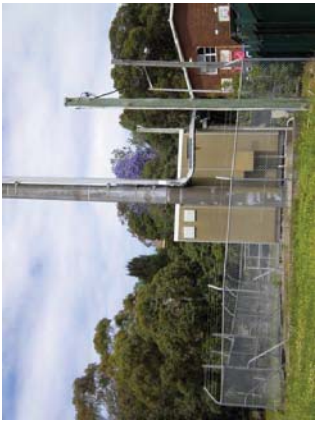
Element Name	Location/Description	Construction Date	Integrity	Condition
Energy Australia Substation	Close to Minogue Crescent/Wigram Road intersection. The substation sits on a concrete slab and is fenced with high cyclone wire fencing. The building is unadorned and functional with Colorbond steel external sheeting with a steel sheeted skillion roof	c. 1990-1995	Intact	Good

<p data-bbox="737 1659 762 2049">Figure 3.4.6 View of the substation.</p>

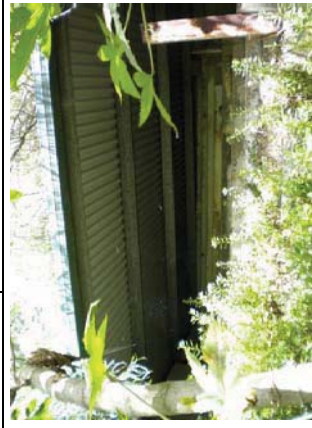
Element Name	Location/Description	Construction Date	Integrity	Condition
<p>c. 1940s Stand - remnant</p>	<p>Close to Minogue Crescent. The structure is approximately 5m long, a remnant of the c1940s concrete seating consisting of reinforced in-situ concrete steps on concrete walls. A room is located under the remnant steps housing an operating switchboard.</p>	<p>c1940s (sometime prior to 1943 open concrete seating, roofed pre 1943) Concrete seating with c1980s switchboard located beneath remnant seating and c1980s concrete blockwork</p>	<p>Only a section of the seats and supporting walls remain.</p>	<p>Poor. This is a remnant portion of a larger seating stand. The structure is overgrown with vegetation, and the full extent of it is not discernible. Shown in 1985 plans as "existing switchboard to remain".</p>

<p>Figure 3.4.7 View of the seating from the NE paceway side, showing the seats and steel roof over.</p>

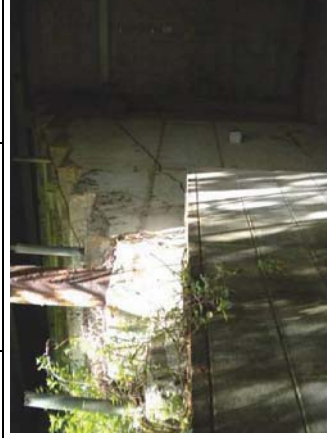
<p>Figure 3.4.8 Closer view of the supporting wall and the weathered steps over.</p>

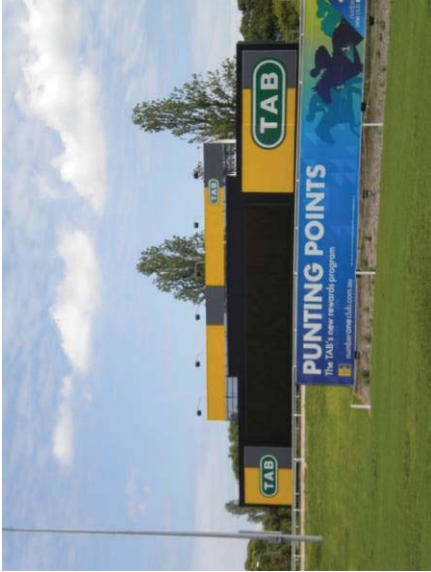
Element Name	Location/Description	Construction Date	Integrity	Condition
Semaphore board	On western side of track near The Crescent. Modern steel framed digital semaphore board flanked by advertising boards	c. 1995	Intact	Good

<p data-bbox="852 1111 879 2049">Figure 3.4.9 View of the Semaphore Board looking west from within the Paceway track.</p>

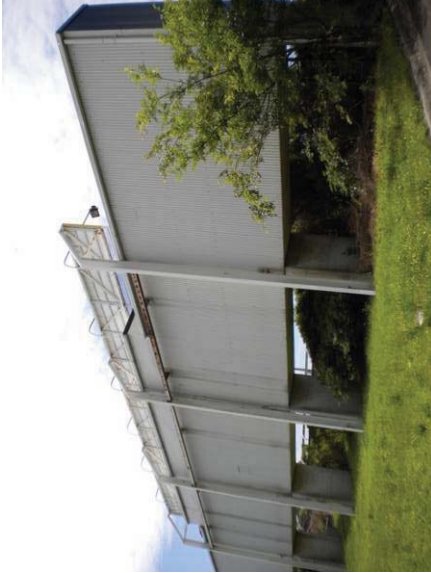
<p data-bbox="852 568 879 1077">Figure 3.4.10 the rear of the Semaphore Board</p>		
Water Tank	Located near semaphore board on western side of track near The Crescent.	C:1995	Intact	Good

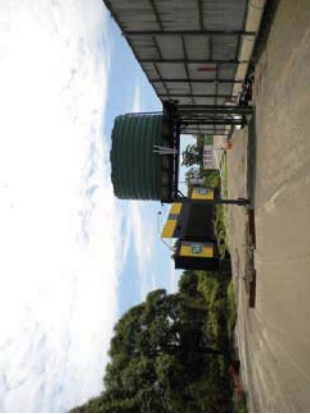
<p data-bbox="1284 680 1311 2049">Figure 3.4.11 The water tank on its stand behind the track advertising hoarding viewed from the south with the track on the right.</p>

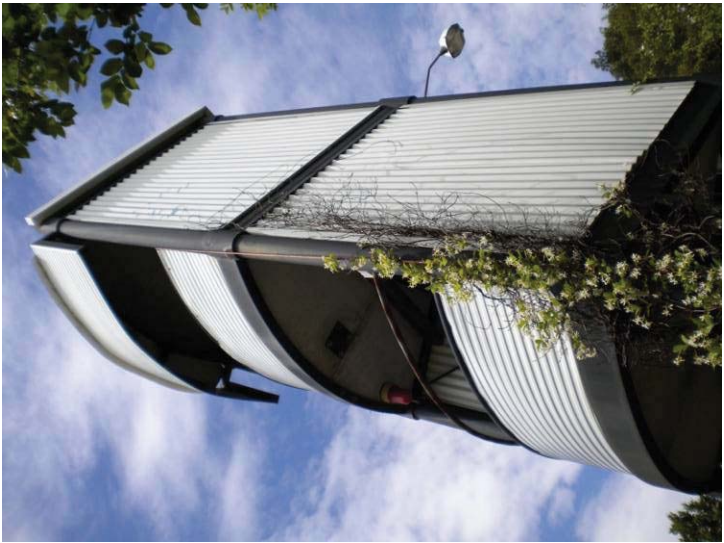
Element Name	Location/Description	Construction Date	Integrity	Condition
Steward Towers	Located at 4 points around the track: one north of the Semaphore board, one on the eastern side of the track north of the grandstand.	1995	Intact	Good

<p data-bbox="1110 1458 1137 2049">Figure 3.4.12 The tower on the SW corner of the track.</p>

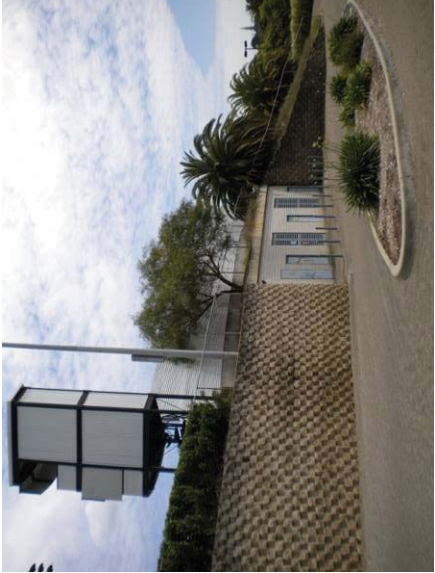
<p data-bbox="820 163 847 1077">Figure 3.4.13 The tower located on the NE corner of the site nearest the Grandstand.</p>

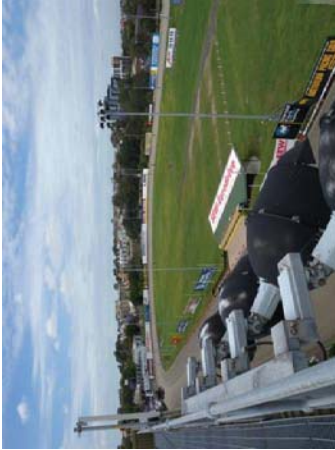
Element Name	Location/Description	Construction Date	Integrity	Condition
<p>Paceway track, hoardings, lighting</p>	<p>The Paceway track is a graded cambered oval earth bermed track with a central grassed area. The north-west corner is a concrete structure suspended over Johnston's Creek; other sections of the track are retained by concrete block walls. Modern advertising hoardings surround most of the track outer perimeter except in front of the Grandstand which screen most of the track form outside the site boundaries. Tall steel pole lighting is located along both sides of the Paceway track</p>	<p>c. 1995 and later</p>	<p>Intact</p>	<p>Good</p>

<p>Figure 3.4.14 View of the Paceway track looking south from the roof of the Grandstand</p>

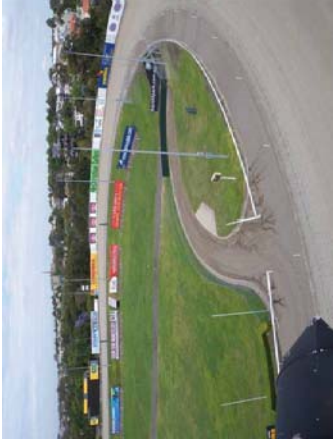
<p>Figure 3.4.15 View of the Paceway track looking NW from the roof of the Grandstand.</p>

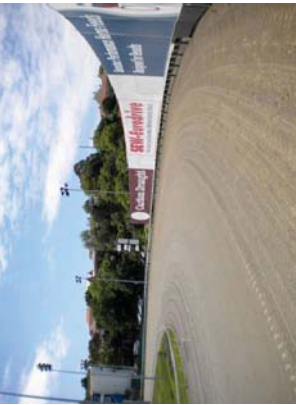
<p>Figure 3.4.17 On the west side of the track looking south.</p>

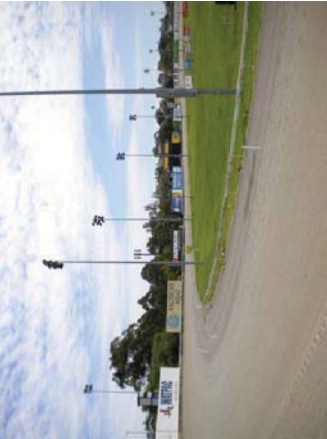
<p>Figure 3.4.18 On the south side of the track looking NW</p>

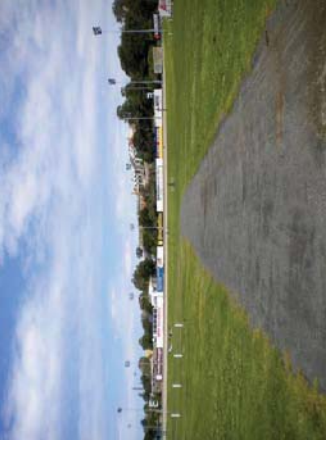
<p>Figure 3.4.19 At the north end of the grassed area in the centre of the track in front of the vehicular entry looking south.</p>

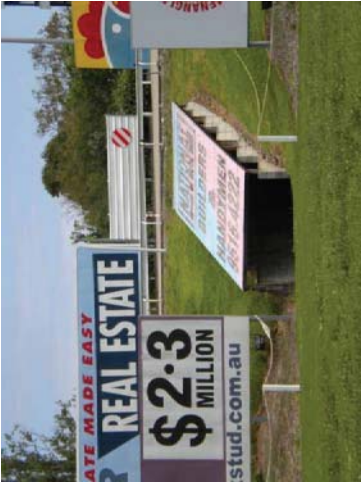
Element Name	Location/Description	Construction Date	Integrity	Condition
Covered structure	A skillion roofed structure located on the western side of the central grassed area of the track with blockwork walls cut into the slope and steel framed roof. The use of this structure is unknown.	C.1980s	Intact	Good

<p>Figure 3.4.20 View of the covered structure on the west side of the grassed centre of the track with track with track behind and above.</p>				
Northern vehicle accessway under track	A concrete framed accessway beneath the northern end of the Paceway track which allows vehicular entry to the Paceway central grassed area	1995	Intact	Good

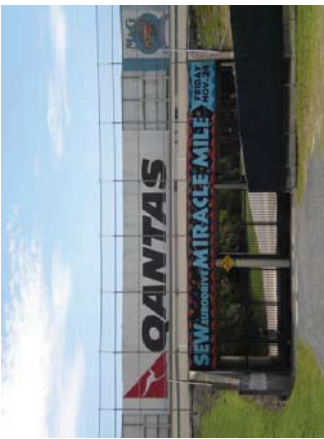
<p>Figure 3.4.21 The accessway seen from within the track looking north.</p>

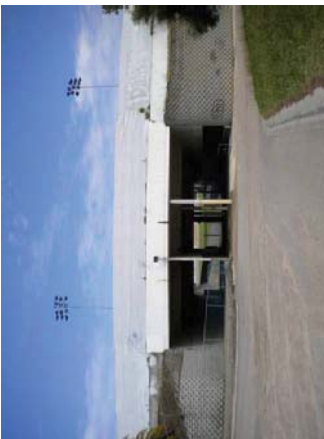
<p>Figure 3.4.22 The accessway seen from outside the track looking south.</p>

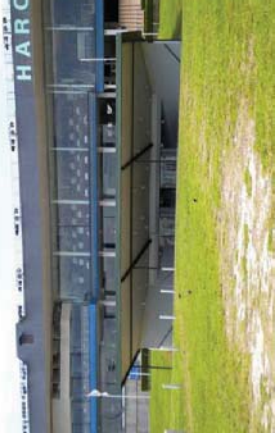
<p>Figure 3.4.23 View of the entry structure from the SW from within the track</p>	1995	Intact	Good
Administration Building	<p>North of Ross Street entry drive. Long, serpentine concrete and steel framed single storey building arranged around a visitors and staff carpark with corrugated steel sheeted roof and large glazed walls to the carpark.</p>

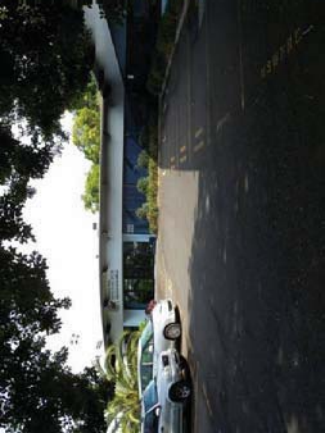
<p>Figure 3.4.25 Looking north at the building's main entry from the staff and visitors carpark</p>	1994	Intact	Good

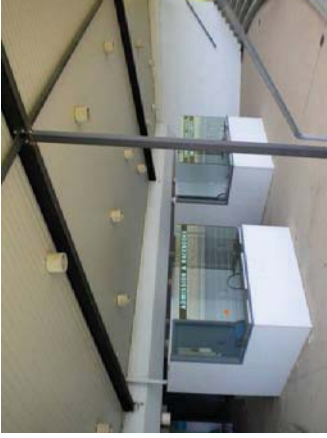
<p>Figure 3.4.24 Detail view of the steps to the right, the entry gates in the centre with the escalators in the background on the left.</p>

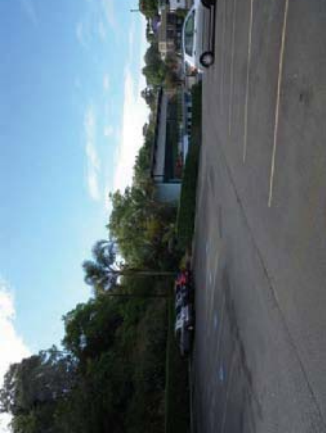
<p>Figure 3.4.26 Looking south to the north face of the building from the carpark in front of the main entrance to the Grandstand.</p>

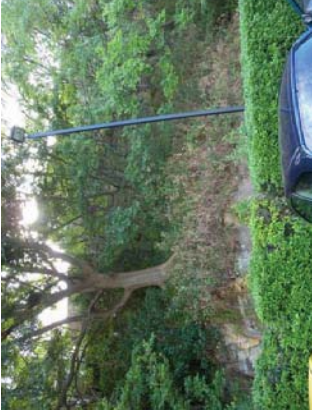
Element Name	Location/Description	Construction Date	Integrity	Condition
<p>Stone cuttings and cliff including sandstone and brick retaining walls</p>	<p>The cutting runs along the eastern boundary of the site and crosses north into the Tramsheds precinct. Evidence of stone cutting, post 1890's retaining walls (brick and sandstone)</p>	<p>Various</p>	<p>Intact evidence of various periods</p>	<p>Moderate. Obscured by vegetation and buildings along most of its length.</p>

<p>Figure 3.4.27 View of the cliff covered in weed growth between Toxteth Rd and Boyce St at the back of the carpark south of the entry to the main Grandstand.</p>

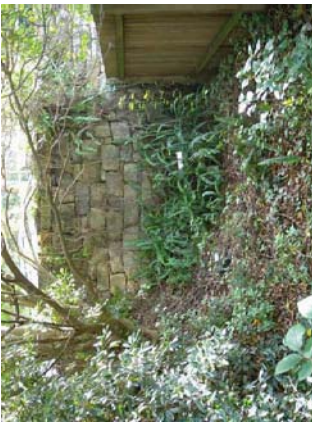
<p>Figure 3.4.28 Part of the cutting in the SE corner of the site made up of a rough coursed sandstone retaining wall below the steps down from Boyce St.</p>

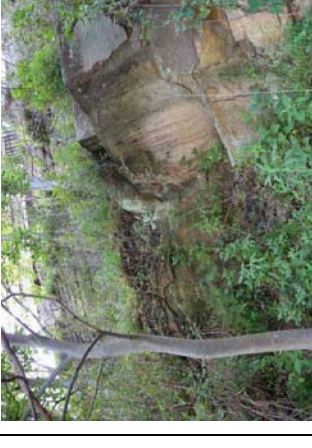
<p>Figure 3.4.29 Part of the cliff made up of excavated stone and overhangs.</p>

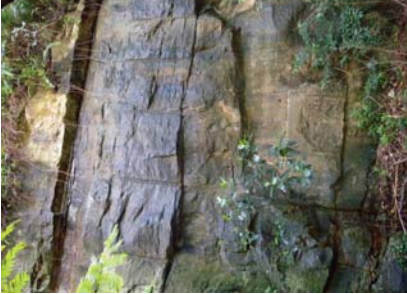
<p>Figure 3.4.30 Detail view of the cliff showing evidence of the strata as well as the drill holes where the stone has been split from the cliff.</p>

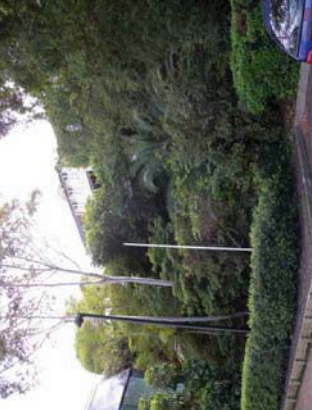
<p>Figure 3.4.31 Wide view of the cliff at the rear of the carpark between Toxteth Rd and Boyce St south of the entry to the main Grandstand.</p>

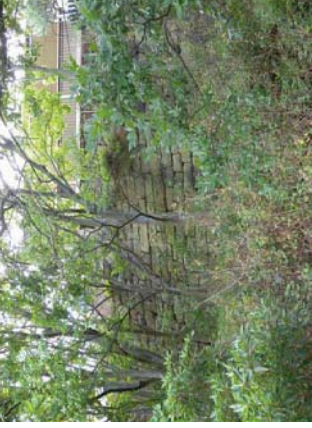
<p>Figure 3.4.32 Length of the cliff above the Grandstand carpark made up of a rough coursed sandstone retaining wall supporting the residences on top of the sandstone cutting.</p>

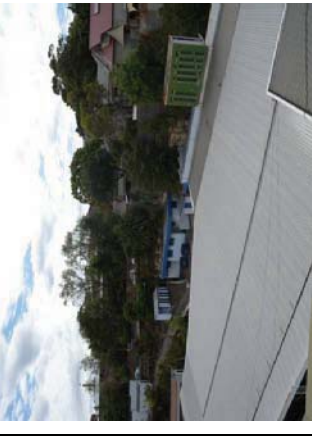
<p>Figure 3.4.33 Looking from on top of the cliff at the end of Arcadia Rd over the main Grandstand.</p>

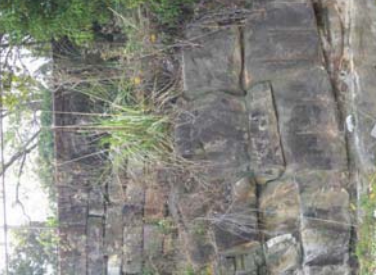
<p>Figure 3.4.34 Detail view below Maxwell Rd showing a section of cliff with the stone retaining wall located on top of an excavated face.</p>

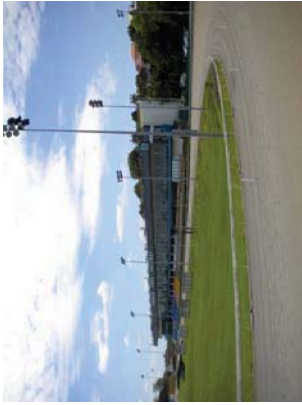
Element Name	Location/Description	Construction Date	Integrity	Condition
Grandstand	<p>Alongside the track's eastern straight, between the straight and the stone cliff. The Grandstand is a long and large 2 tiered reinforced concrete framed stand with block and brick infill walls, aluminum windows and glazing and a steel framed steel decked low pitched roof with a deep fascia and overhang which shades the windows overlooking the track. The west elevation facing the track is clad with large gazed walls and large semi-circular stair ends the south elevation. The Grandstand is fronted by open tiered seating</p>	1961 (south section); 1986-87 remainder	The 1961 concrete framed open 2 tier grandstand encased in 1986-87. Difficult to discern the interface between the different development stages	Good

<p>Figure 3.4.35 Looking NE across the track to the west, main elevation of the Grandstand and semi-circular stair at the south end.</p>

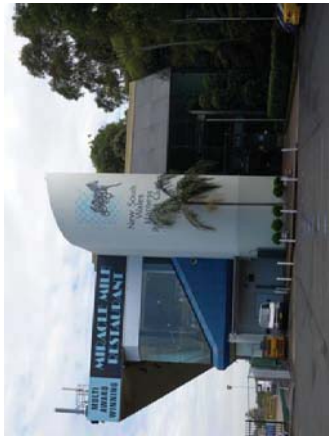
<p>Figure 3.4.36 South end of the Grandstand showing semi-circular stair and profile of glazed upper tier with main restaurant. Entry to the right of the stair.</p>

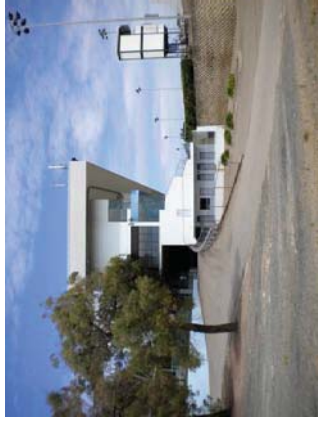
<p>Figure 3.4.40 View of the north end of the Grandstand.</p>

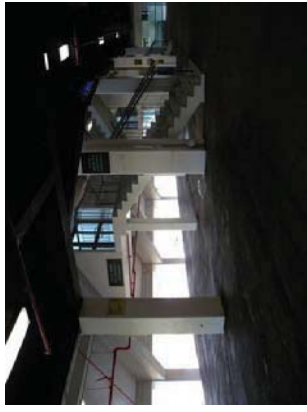
<p>Figure 3.4.41 View of the open ground floor of the Grandstand showing the concrete frame with the track to the left</p>

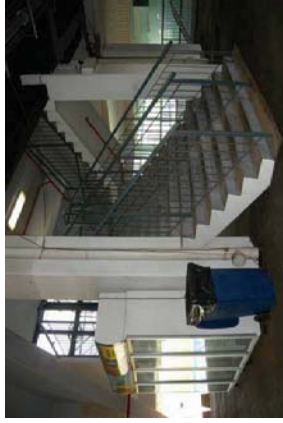
<p>Figure 3.4.42 Detail view of one of the 1960s stairs from the ground floor</p>

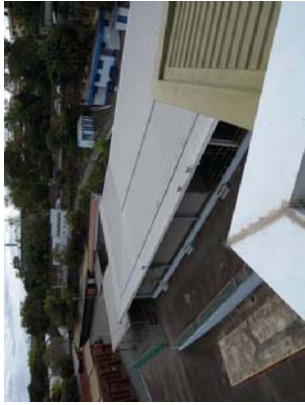
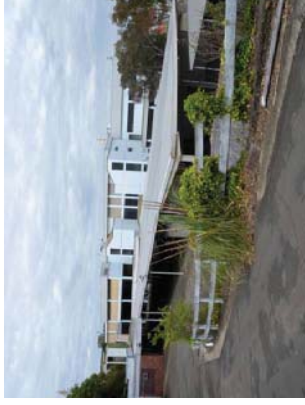
The ring is located generally north of the Grandstand and consists of a series of open steel posts and frames supporting low pitched roofs sheeted with steel sheeting.

c. 1960s-1980s	Altered	Good
Figure 3.4.43 Looking NE from the Grandstand roof onto the roofs over the Betting ring 1953 Tote Building

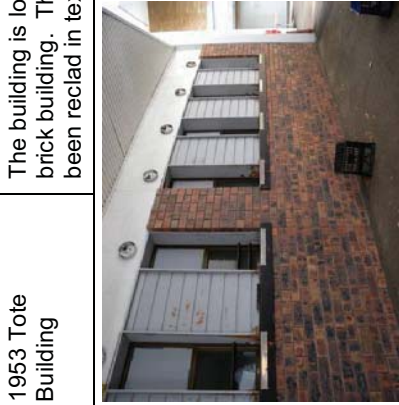
Figure 3.4.45 Front elevation showing timber panels and textured brick on lower wall and recent aluminium windows.

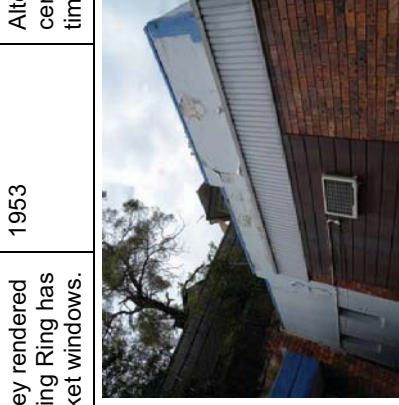
Figure 3.4.46 Detail view of the front elevation.

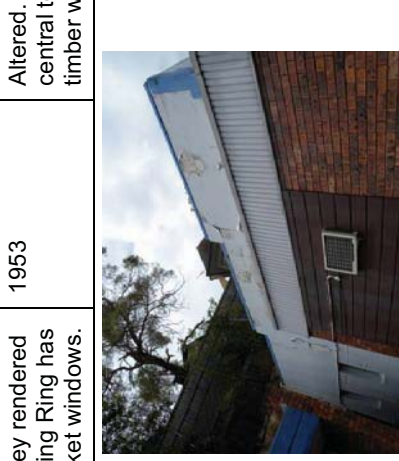
Figure 3.4.47 View of the north end of the building.

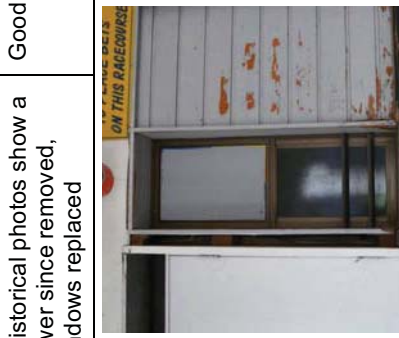
Figure 3.4.48 Detail view of a ticket window.

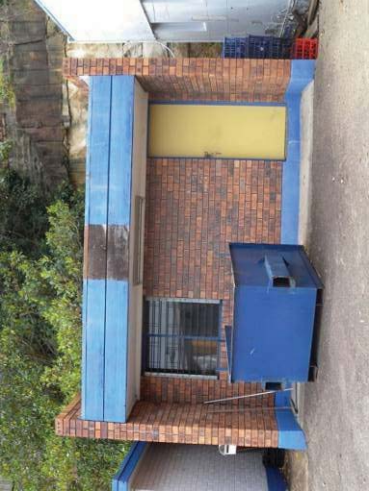
<p data-bbox="699 1140 730 2051">Figure 3.4.49 View of the front of the building with the 1953 Tote building to the right.</p>				
Utility Building 2	Small flat roofed painted brick single storey building located north of Utility Building 1.	c. 1960s	Brickwork painted, otherwise intact	Good

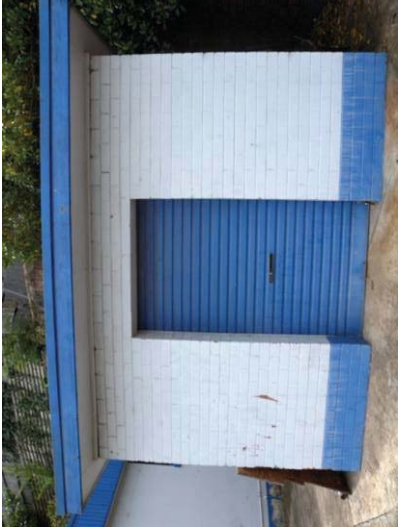
<p data-bbox="1225 1538 1257 2036">Figure 3.4.50 View of the front of the building.</p>

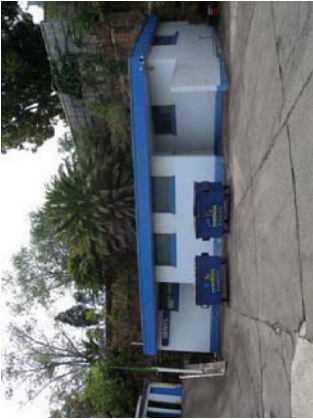
<p>Figure 3.4.51 View of the front of the building.</p>

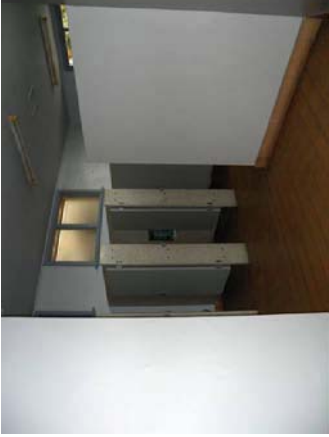
<p>Figure 3.4.52 View of the interior showing the terrazzo stall partitions.</p>			
Entry Building	Single storey rendered brick building with narrow doorways with timber tongue & grooved ledged and braced doors, turnstiles and timber counters to interior.	c. 1930s	Relatively intact; fibro asbestos addition to northern end	Poor, esp. fibro addition (requires removal due to safety issues).

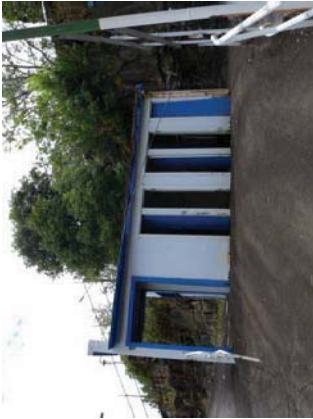
<p>Figure 3.4.53 View of entry building from the SW showing the building's elevation facing into the Paceway. Main entry on the left and turnstiles on the right.</p>

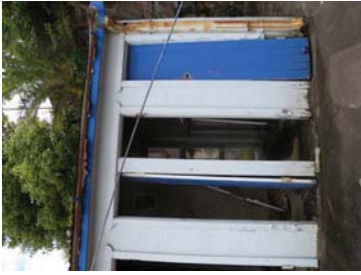
<p>Figure 3.4.54 Detail view of the elevation facing into the Paceway precinct showing the entry stalls.</p>

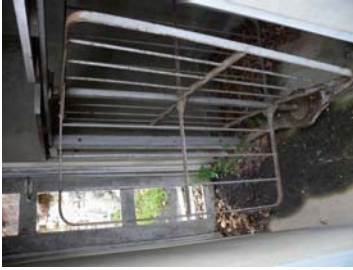
<p>Figure 3.4.55 Detail view of one of the surviving turnstiles.</p>

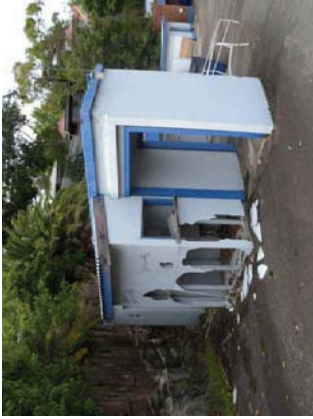
<p>Figure 3.4.56 View of the elevation of the building facing out of the Paceway precinct showing the fibro clad timber framed office.</p>

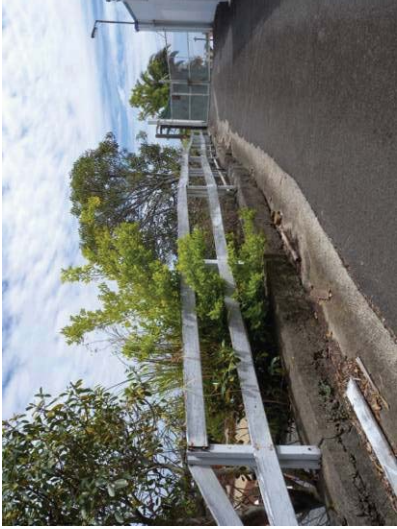
Element Name	Location/Description	Construction Date	Integrity	Condition
Retaining wall and timber post & rail fencing	Stone retaining wall and timber post & rail fencing along the western edge of the path accessing the Paceway from Maxwell Street (west of Entry building)	c. 1940s	Intact	Moderate, sections of the timber fence in poor condition and collapsing.

<p>Figure 3.4.68 Looking NE up the entrance road from Maxwell Rd with the stone retaining wall and timber fence on the left.</p>				
Paceway landscaping	There are areas of formal landscaping adjacent to the carpark near Ross Street and also at the northeastern edge of the Paceway.	1950s-1995 or later	Intact	Good

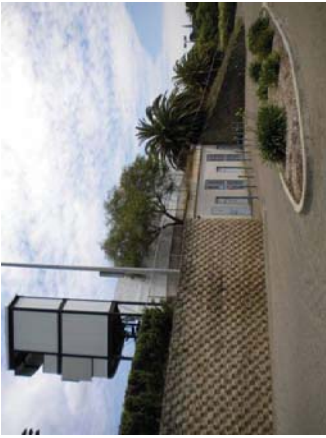
<p>Figure 3.4.69 The landscaping NE of the Paceway track</p>

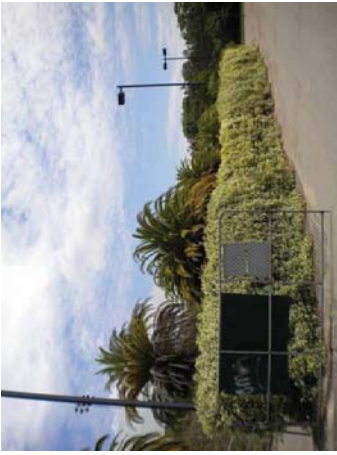
<p>Figure 3.4.70 Landscaping north of the Paceway track.</p>

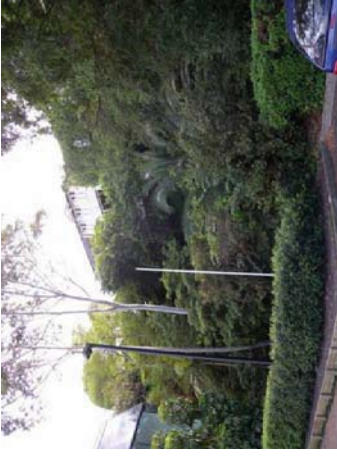
<p>Figure 3.4.71 Landscaping at rear of the Grandstand carpark south of the Grandstand near the stone cutting.</p>

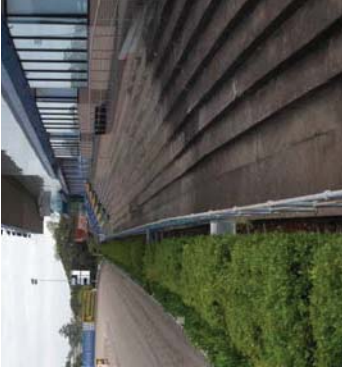
<p>Figure 3.4.72 Hedging in front of the open tired seating in front of the Grandstand</p>

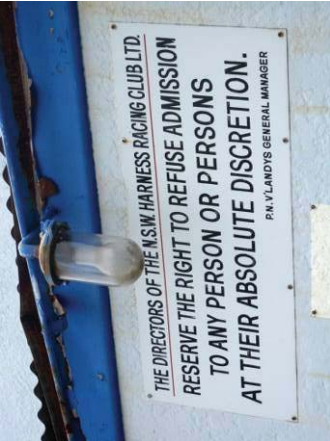
<p>Figure 3.4.78 Sign and light fitting on Ticket sales building</p>

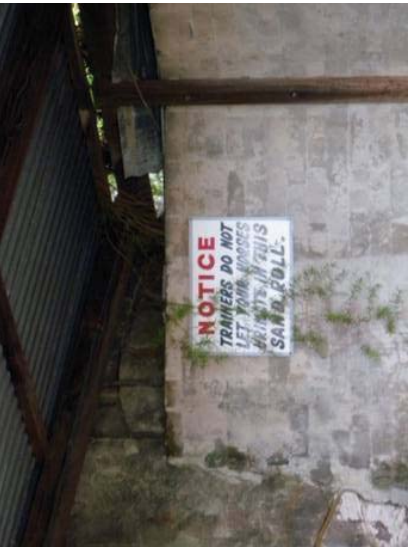
<p>Figure 3.4.79 Sign in Race stalls</p>

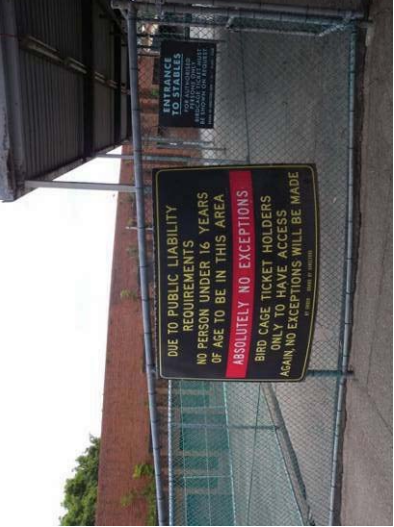
<p>Figure 3.4.80 Sign near bar and race stalls area</p>

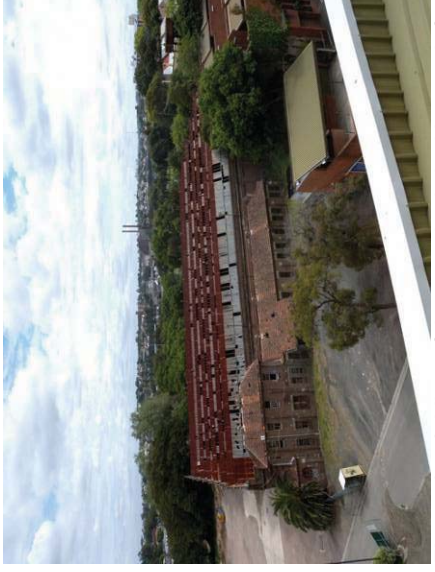
Element Name	Location/Description	Construction Date	Integrity	Condition
Tramsheds - general	The tramsheds are located between Chapman Road (a pedestrian path) to the north and the Paceway race stalls to the south, Maxwell Road to the east, Johnstons Creek to the west. The main portion of the tramsheds is a sawtooth roofed parapeted brick structure. The Office and Amenities block is a brick structure attached to the southern wall of the 1904 tram shed.	1904-1909	Remaining tramsheds structures are relatively intact. A number of small separate buildings within the Tramsheds Precinct have collapsed.	Moderate/poor

<p>Figure 3.5.1 View of the tramsheds looking north from the roof of the Grandstand with the Office and Amenities building in front of the sheds.</p>

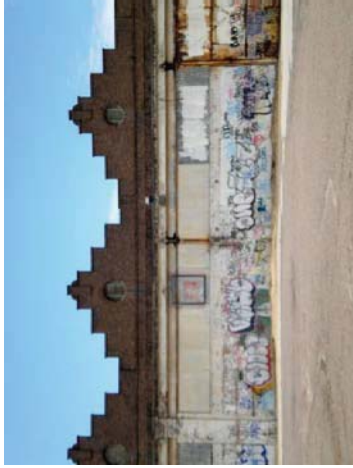
Element Name	Location/Description	Construction Date	Integrity	Condition
1904 Tram Shed	The 1904 Tramshed is the main section of the Tramsheds building, located between the 1909 Tramshed to the north and the office & amenities block to the south. The Tramshed is a steel framed structure with brick external walls	1904	Intact	Moderate

<p>Figure 3.5.2 View of part of the west elevation of the 1904 Tramshed.</p>

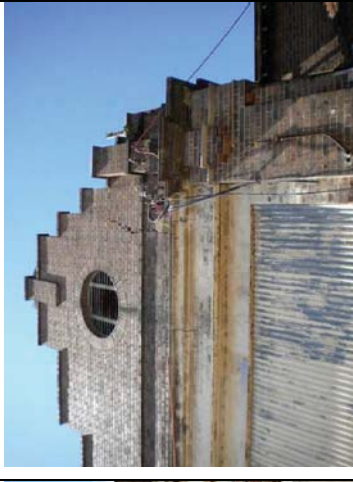
<p>Figure 3.5.3 Detail view of the SE corner and stepped parapet of the 1904 Tramshed.</p>

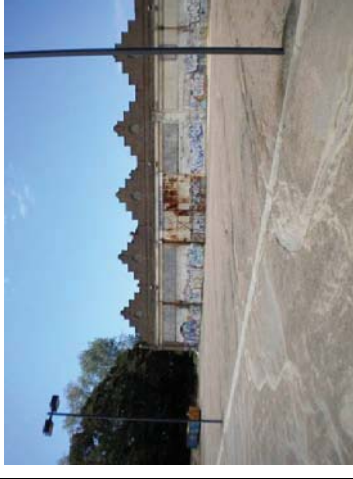
<p>Figure 3.5.4 Long view of the west elevation, 1909 Tramshed on the left with the forecourt in the foreground</p>

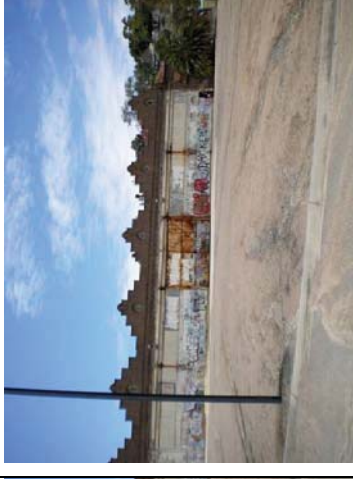
<p>Figure 3.5.5 Long view of the west elevation, 1904 Tramshed on the right.</p>

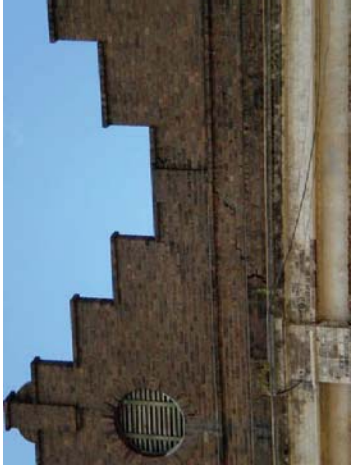
<p>Figure 3.5.6 Detail view of the stepped parapet roof of the 1904 Tramshed.</p>

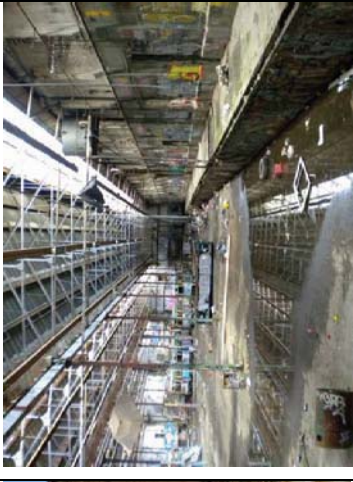
<p>Figure 3.5.7 View of the interior of the 1904 Tramshed looking east from just inside the west wall with the south wall on the right.</p>

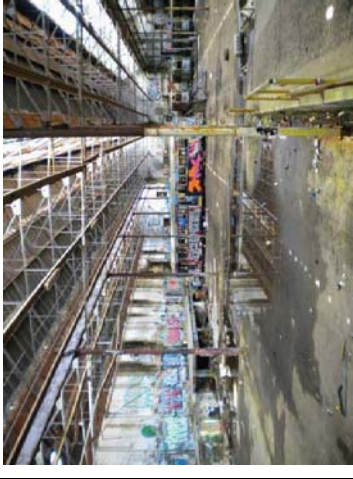
<p>Figure 3.5.8 View of the interior of the 1904 Tramshed looking east from just inside the west wall with the party wall between the two sheds on the left</p>

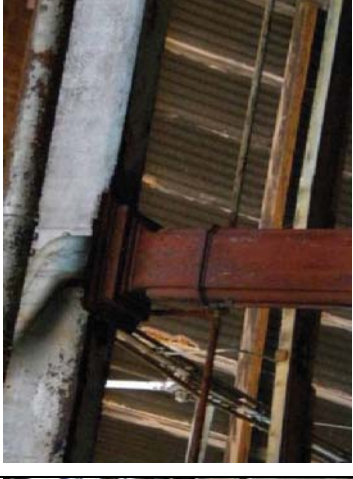
<p>Figure 3.5.9 Detail view of the junction of the steel posts and the bottom cord of the sawtooth roof.</p>

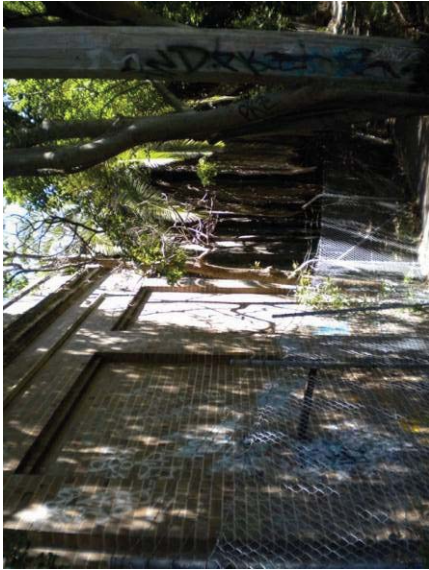
Element Name	Location/Description	Construction Date	Integrity	Condition
1909 Tram Shed	Attached to the northern wall of the 1904 Tramshed	1909	Intact	Very Poor

<p>Figure 3.5.10 View of the exterior of the north panelled brick wall of the 1909 Tramshed.</p>

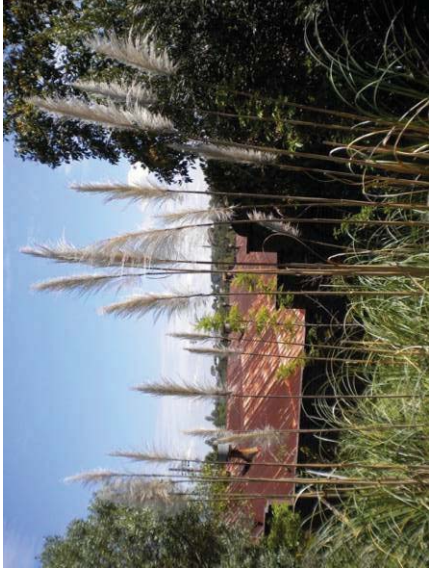
<p>Figure 3.5.11 Looking at the roof and part of the stepped parapet of the 1909 Tramshed from Maxwell Rd.</p>

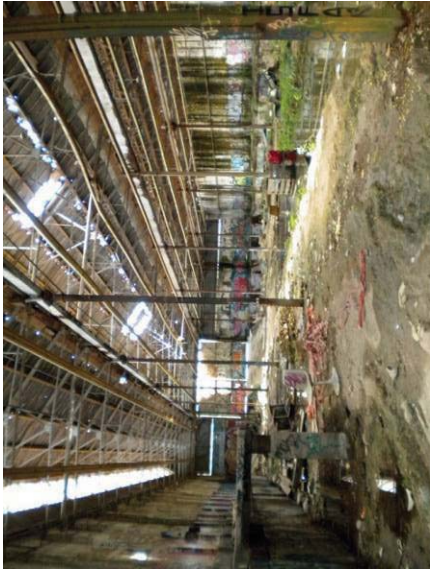
<p>Figure 3.5.12 View of the interior of the 1909 Tramshed looking west from just inside the east wall with the party wall between the two sheds on the left.</p>

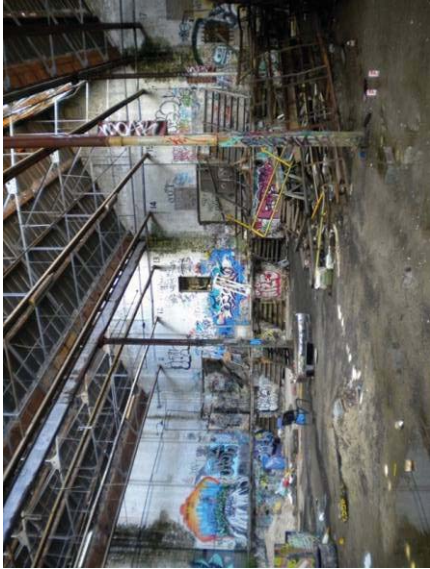
<p>Figure 3.5.13 View of the interior of the 1909 Tramshed.</p>

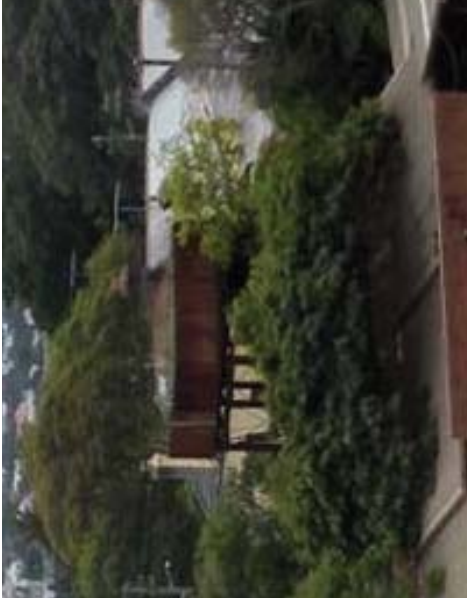
Element Name	Location/Description	Construction Date	Integrity	Condition
Water Tank	Riveted rectangular steel tank, pipes and valves elevated on steel posts. The water tank fed a Grinnell automatic sprinkler system, which saved the sheds from a fire on 17 July 1919.	Installed prior to 1919	Intact	Moderate

<p data-bbox="874 562 906 2051">Figure 3.5.14 Long view of the tank on its posts partially hidden by vegetation seen from the roof of the Paceway Grandstand.</p>

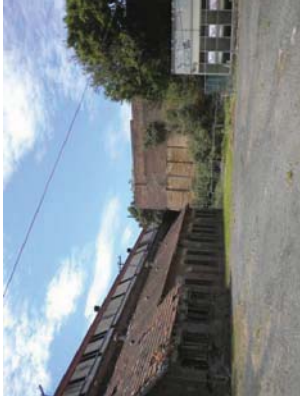
Element Name	Location/Description	Construction Date	Integrity	Condition
Office and amenities building	Brick, hipped and skillion terracotta tiled roofs, 2 storey at west end, single storey at east end, attached to southern wall of the southern (1904) tram shed. Interiors feature metal lath and plaster ceilings, and plastered walls. Fittings are generally vandalized/deteriorated	1904	Most window glass missing, interior fittings vandalized; staircase to 1st floor not usable	Poor

<p>Figure 3.5.15 View of the area in front of and to the south of the Office and Amenities Building on the left.</p>

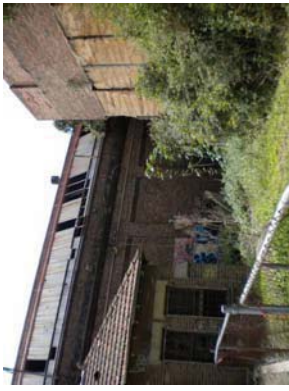
<p>Figure 3.5.16 Detail view of the east end of the Office and Amenities Building with the 1904 Tramshed behind and the in-situ concrete retaining wall supporting the race stalls to the right.</p>

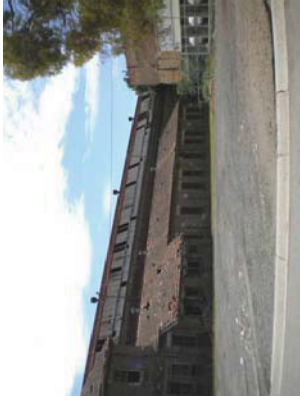
<p>Figure 3.5.17 Long view of the Office and Amenities Building looking NE across the site of the former garden.</p>

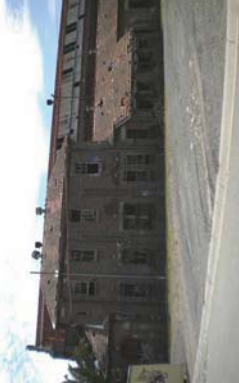
<p>Figure 3.5.18 Long view of the west two storey end of the Office and Amenities Building.</p>

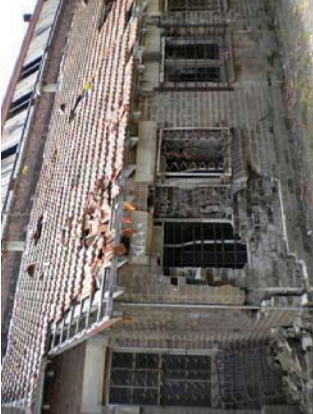
<p>Figure 3.5.19 Detail view of the deterioration of parts of the building.</p>

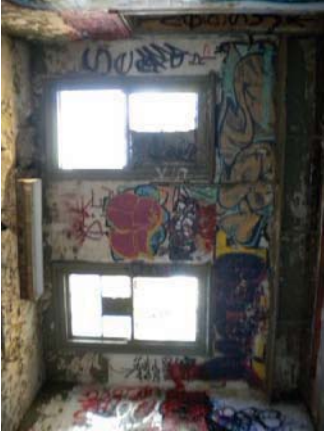
<p>Figure 3.5.20 The interior of the Office and Amenities Building showing one of the small rooms and the level of deterioration and vandalism.</p>

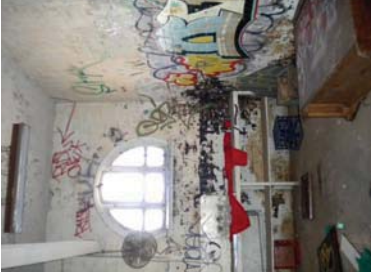
<p>Figure 3.5.21 The interior of the westernmost room in the building</p>

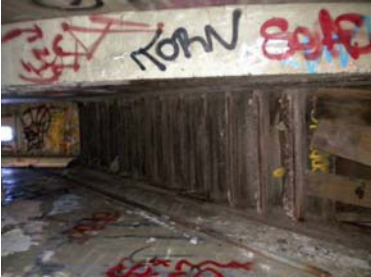
<p>Figure 3.5.22 The stair to the first floor.</p>

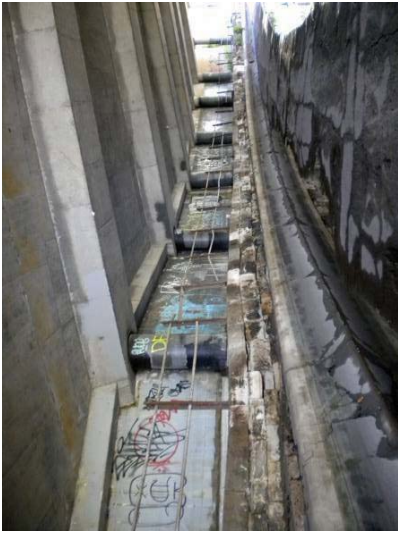
Element Name	Location/Description	Construction Date	Integrity	Condition
Sandstone retaining wall and fencing	Beneath the suspended section of the 1995 Paceway track, along the edge of the Johnstons Creek stormwater channel, is a section of sandstone retaining wall and fencing consisting of lengths of tramway tracks which marks the boundary of the former tram access route from The Crescent	C.1940s	Intact	Moderate

<p>Figure 3.5.23 Looking SW along Johnston's Ck with the section of retaining wall on the left above the concrete creek wall</p>

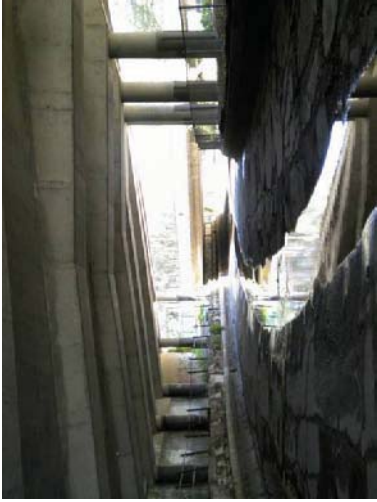
<p>Figure 3.5.24 Longer view of the area under the elevated section of the Paceway track showing the tramway easement retaining wall as it approaches The Crescent.</p>			
Moveable Heritage				
Trams and one bus parked within the 1904 tram shed

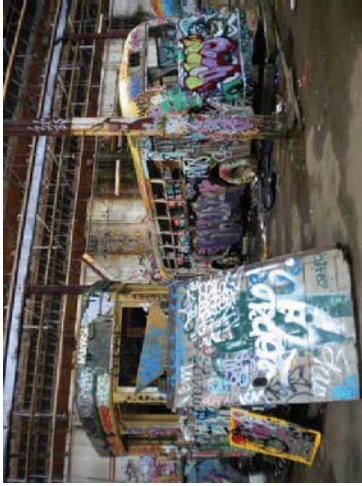
<p>Figure 3.5.26 Tram No. 2050 (left) and bus, east of Tram No. 1993, 1904 Tramshed. Note Tram 2050 is a Café Tram which operated out of Rozelle Depot.</p>

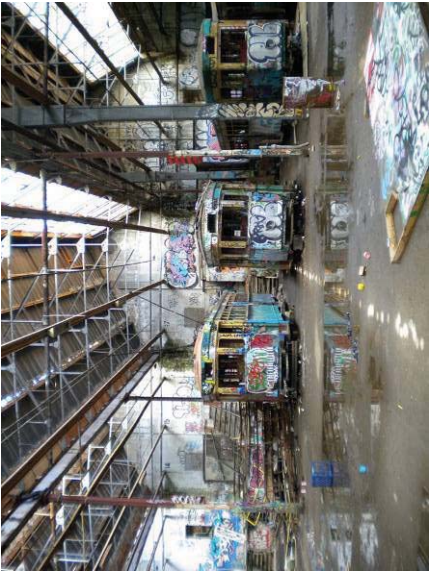
<p>Figure 3.5.27 Tram Nos. 1995, 1923 and 1943 (left to right) at east end of 1904 Tramshed. Note Tram No. 1995 operated out of Rozelle.</p>

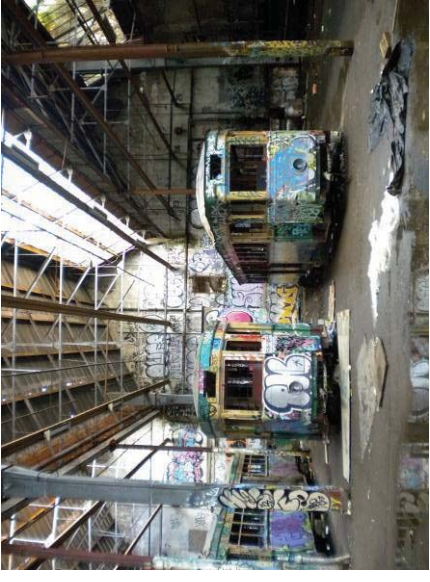
<p>Figure 3.5.28 Tram Nos. 1943 (left) and 1753 (right), south end on east side of 1904 Tramshed. Note Tram No. 1753 operated out of Rozelle.</p>

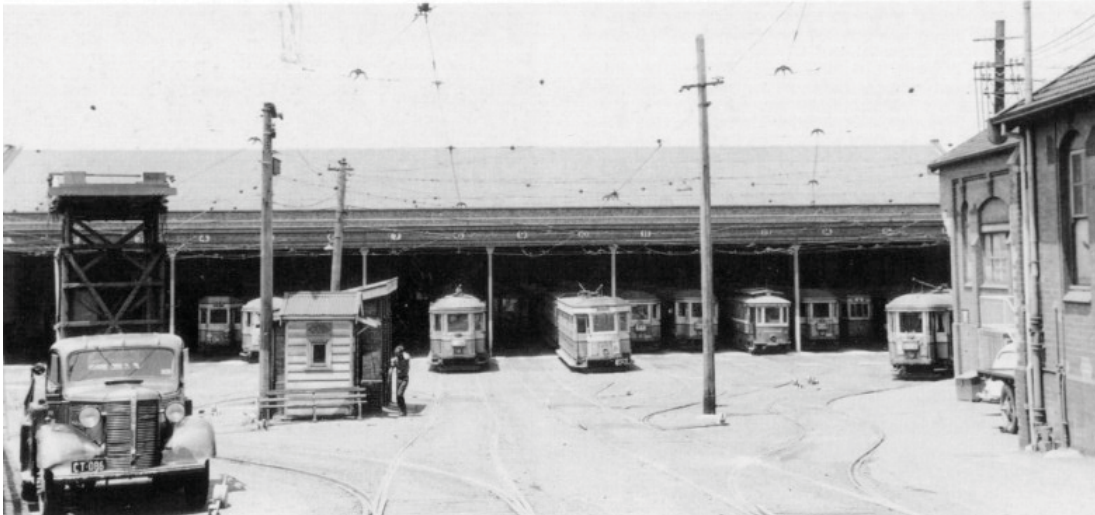
Figure 4.25: Newtown Depot in the 1950s. Source: Keenan, David, *The South-Western Lines of the Sydney Tramway System*, Transit Press, Sans Souci, 1992, p.60

Newtown Depot was opened in 1900 as a sixteen road depot. The design of the depot was essentially the same as used at Ultimo. The depot served routes via King Street to Summer Hill, Canterbury, Earlwood and services to Glebe. The depot has been largely vacant and unused since closure as an operational depot in 1957.
