3.0 PHYSICAL ANALYSIS

3.1 GENERAL DESCRIPTION OF THE HAROLD PARK SITE

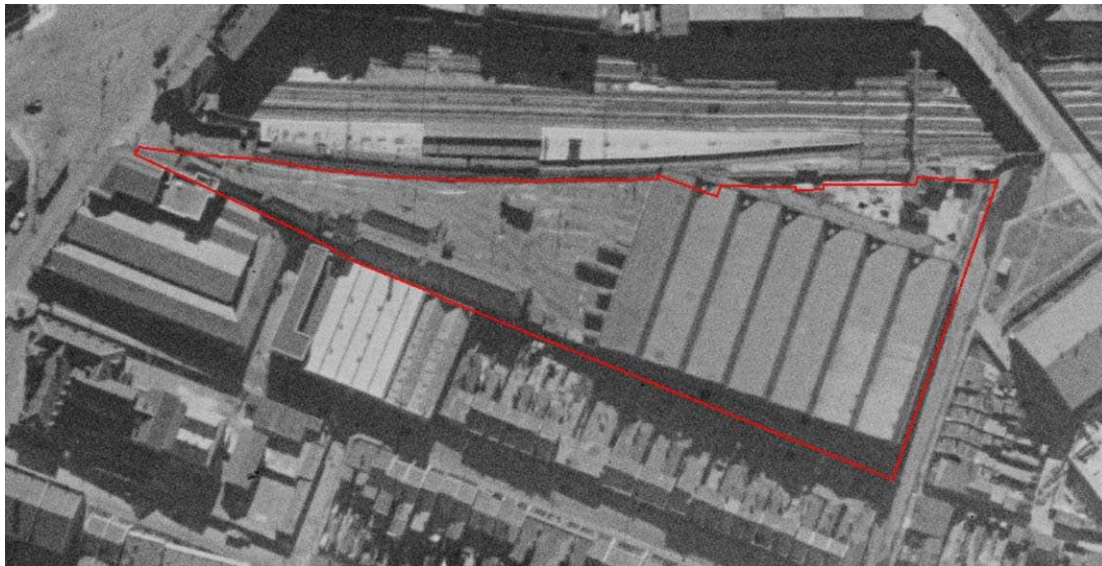
Figure 4.26: The layout and urban context of Newtown Depot in 1943. Source: NSW Roads and Traffic Authority, 'From the skies' CD-ROM

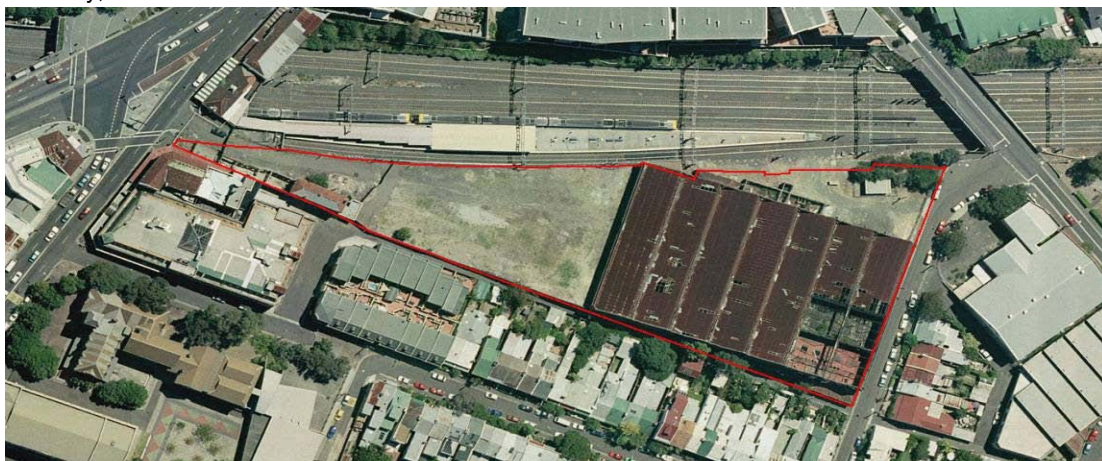
Figure 4.27: The layout of the now closed and neglected tram depot at Newtown in 2009. Source: NSW Lands Dept Sixviewer.

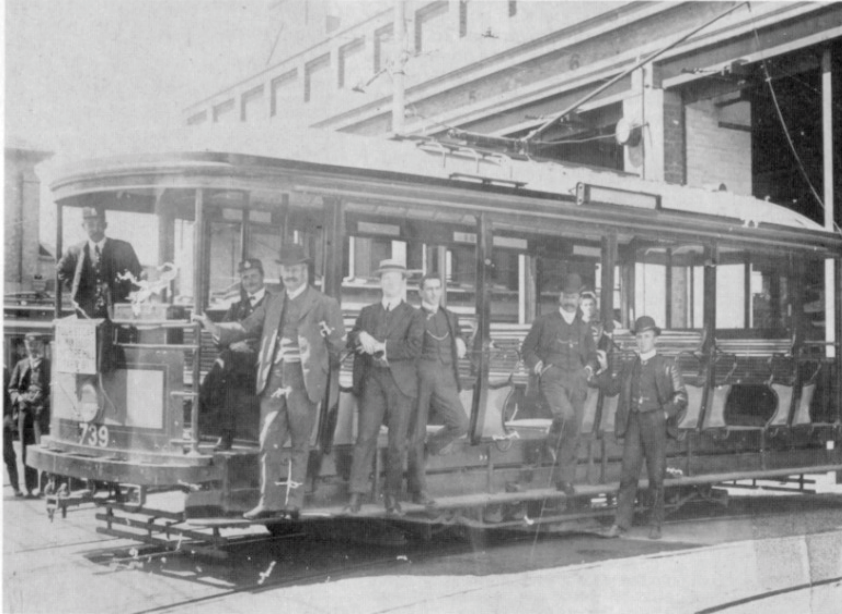
Figure 4.28: North Sydney Depot around 1900. Source: Keenan, David, *The North Sydney Lines of the Sydney Tramway System*, Transit Press, Sans Souci, 1987, p.23

A cable tram depot had opened on this site in 1886 and on the conversion to electric operation the depot was extensively rebuilt in 1902 to enlarge the tram shed to twelve roads. The front elevation of the shed had a parapet with recessed panels. The old cable shed was converted to a cinema (and is now the Independent Theatre) while the electric tram sheds were closed in the 1920s and demolished in the 1990s for residential development.

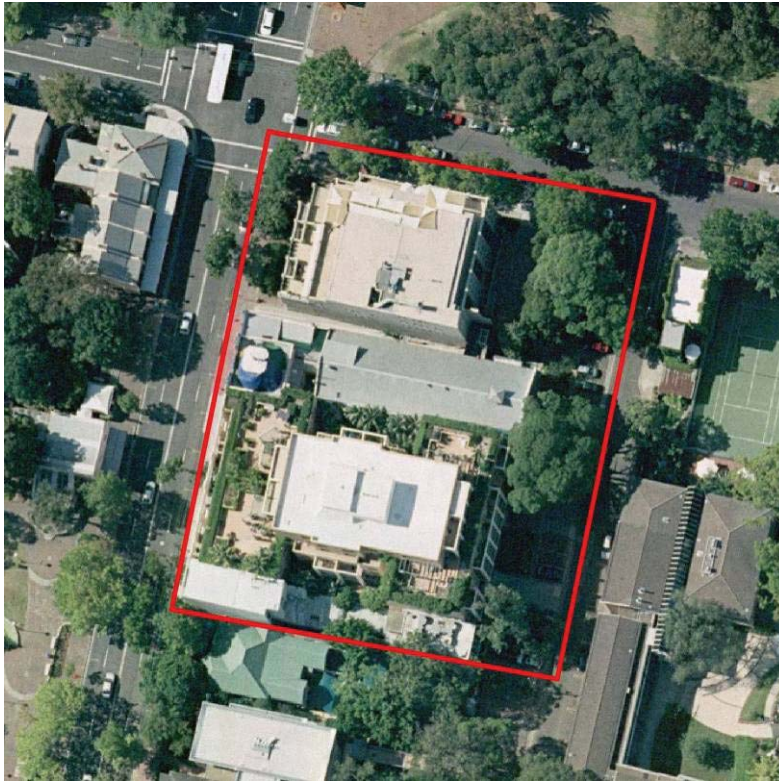
Figure 4.30: The redeveloped site of the Ridge Street Depot, 2009. Source: NSW Lands Dept Sixviewer

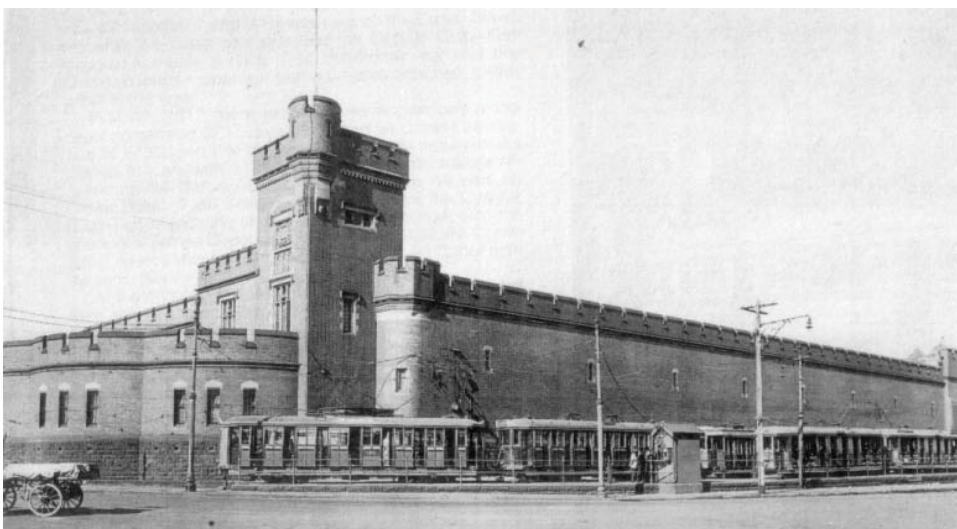
Figure 4.31: Fort Macquarie Depot in 1927. Source: Keenan, David, *The City Lines of the Sydney*

Fort Macquarie Depot on Bennelong Point was completed in late 1901 as a twelve road depot. The highly ornate façade was designed to harmonise with the style of the nearby Government House. Castellated parapets and a castellated corner tower concealed the saw-tooth roof. The depot was also unique for its large encircling track that allowed trams to continue the return journey without the crew changing ends. The depot served the Circular Quay Railway Station and services to Woolloomooloo. The depot was closed in 1955 and demolished to make way for the Opera House.

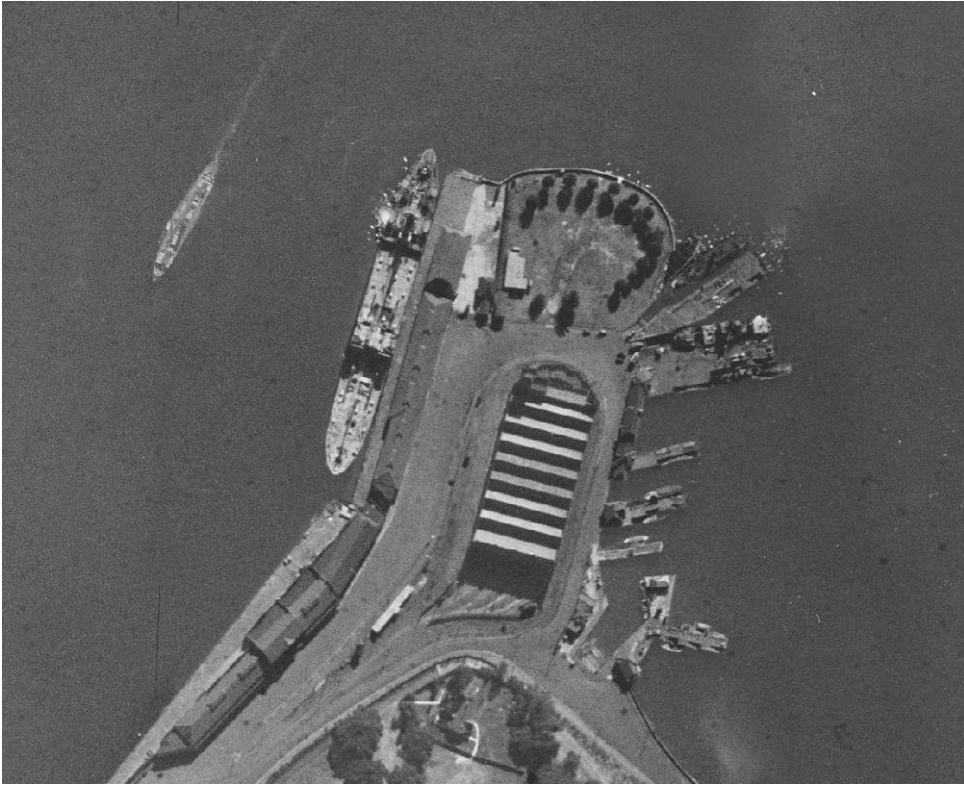
Figure 4.32: The layout and harbourside setting of Fort Macquarie Depot in 1943. Source: NSW Roads and Traffic Authority, 'From the skies' CD-ROM

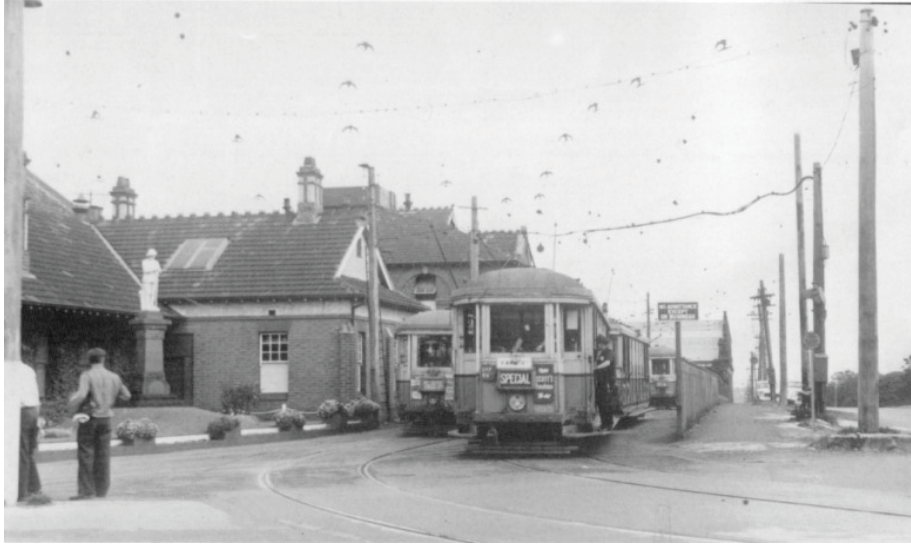
Figure 4.34: The Oxford street entry to Waverley Depot in 1957. Source: Keenan, David, *The Eastern Lines of the Sydney Tramway System*, Transit Press, Sans Souci, 1989, p.63

Waverley Depot was opened in 1902 as a seventeen road depot. The front elevation of the depot was the same as Ultimo, but the side elevations, which on the west look to Centennial Park, were designed as stepped Dutch style gables with circular ventilation openings. This design is similar to that used at Rozelle Depot on its east and west elevations. The depot served the Bondi and Bronte routes. The depot was converted to bus operation in 1959 and today only the western section of the car shed remains.

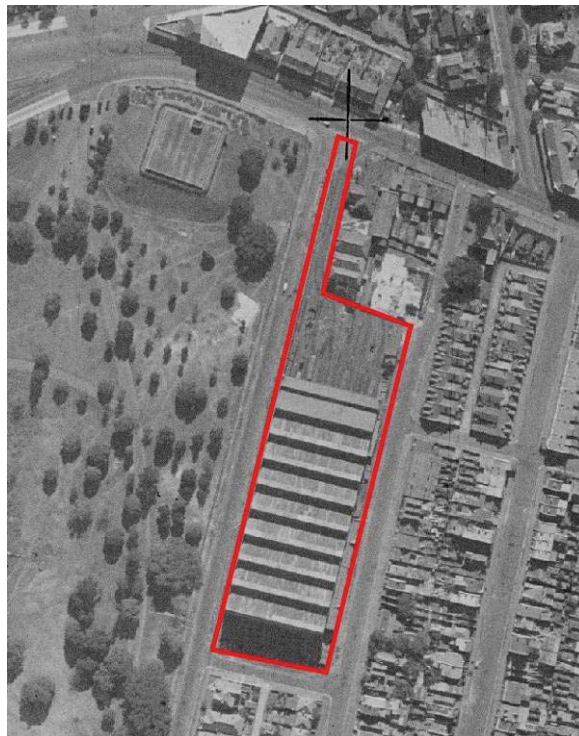
Figure 4.35: The layout and park side setting of Waverley Depot in 1943. Source: NSW Roads and Traffic Authority, 'From the skies' CD-ROM
