Conservation management strategy (John Oultram Heritage & Design)

**7-9, 11-13 & 15 RANDLE STREET,
SURRY HILL, NSW**

CONSERVATION MANAGEMENT STRATEGY

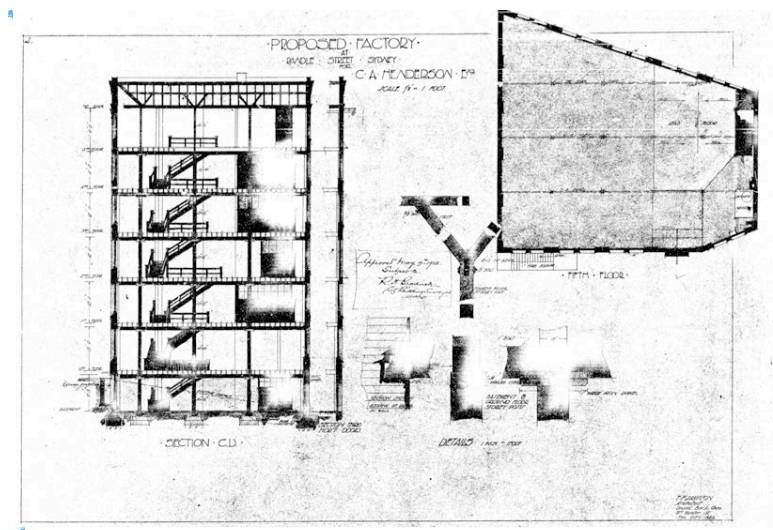
Figure 3.1 Plans of the fifth floor and section of the factory as designed in 1912 (architect TP Sampson) for RC Henderson's hat factory. The top floor housed the boiler room for the steam pressure moulding equipment

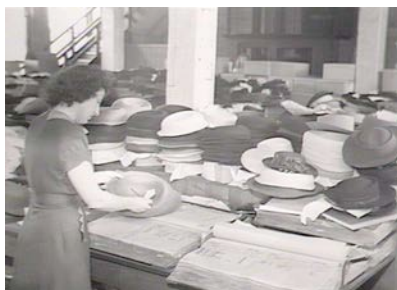
Figure 3.2 Quality control and checking. Both the staircase and hardwood columns are visible. March 1949

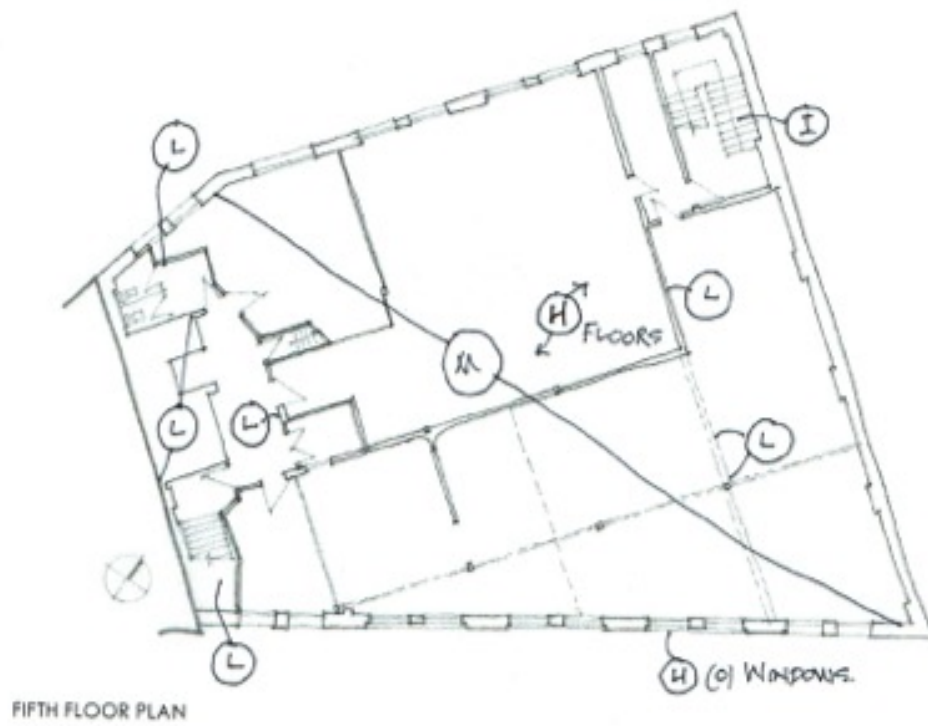
Figure 3.4.4 11-13 Randle Street, Surry Hills
Significant Spaces and Fabric

The rankings of spaces and fabric are shown in Figures 3.4.1 to 3.4.4 below.

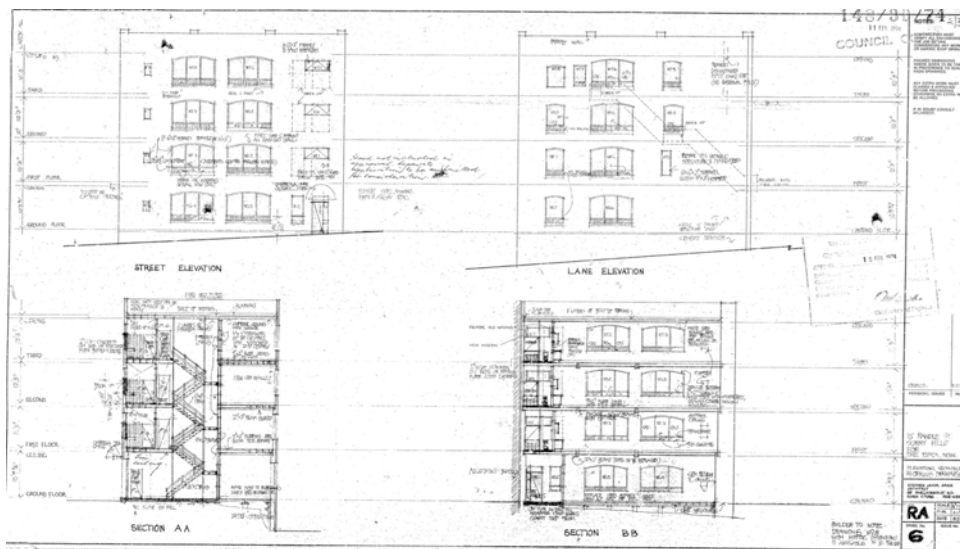
Figure 4.2 The building was badly damaged by fire in 1973 and was remediated the following year. That work was extensive. Elevations and sections by Stephen Javor. RAIA

The building was damaged by fire in in 1973 and was refurbished in 1974.

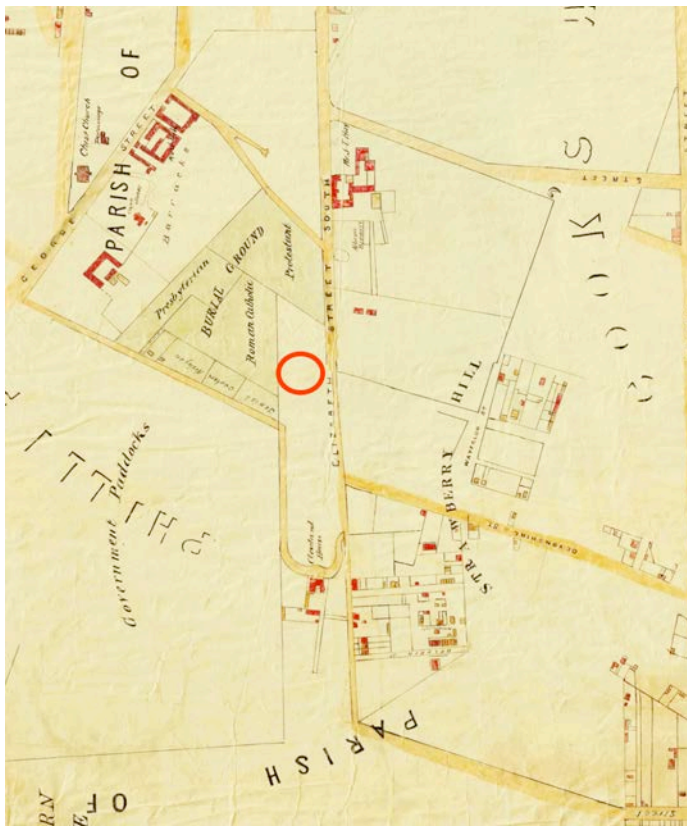
Figure 5.1.2 Detail from Francis Webb Shields' survey of Sydney dated 1844 showing Cleveland House and surrounding government reserves

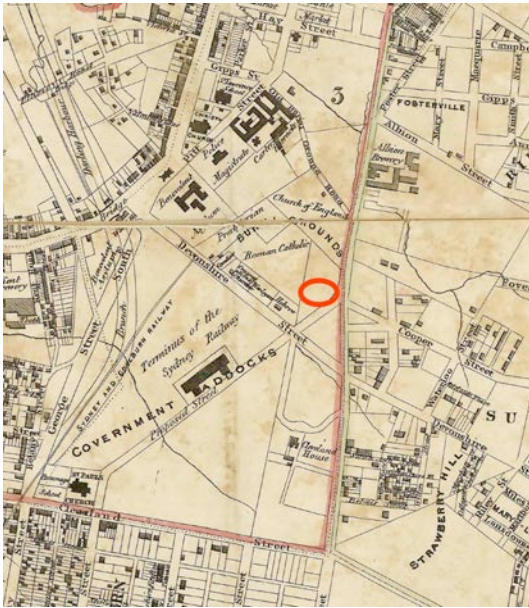
Figure 5.1.4 Detail from Waugh and Cox's commercial map of City of Sydney published in 1854, when the city began to experience marked development owing to the onset of gold mania. In this map the alignment of Randle Street was plotted as the main road to the then incomplete railway station. Randle Street as shown did not eventuate south of Devonshire Street

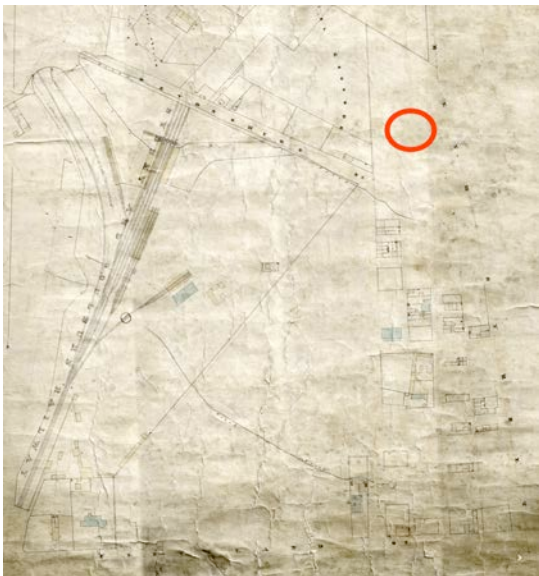
Figure 5.1.5 Detail from Sheet 23 of the City Council's detailed survey of Sydney dated 1855

The plan shows development on the Cleveland Estate south of Devonshire Street, but the area north continued as vacant paddock. The layout of the first railway station opened in 1855 was shown and its Devonshire Street frontage. Randle Street was put through a little later and provided a shorter route between Elizabeth Street and Devonshire Street. The area north of Devonshire Street was government reserve (cemeteries, barracks, etc) until 1900

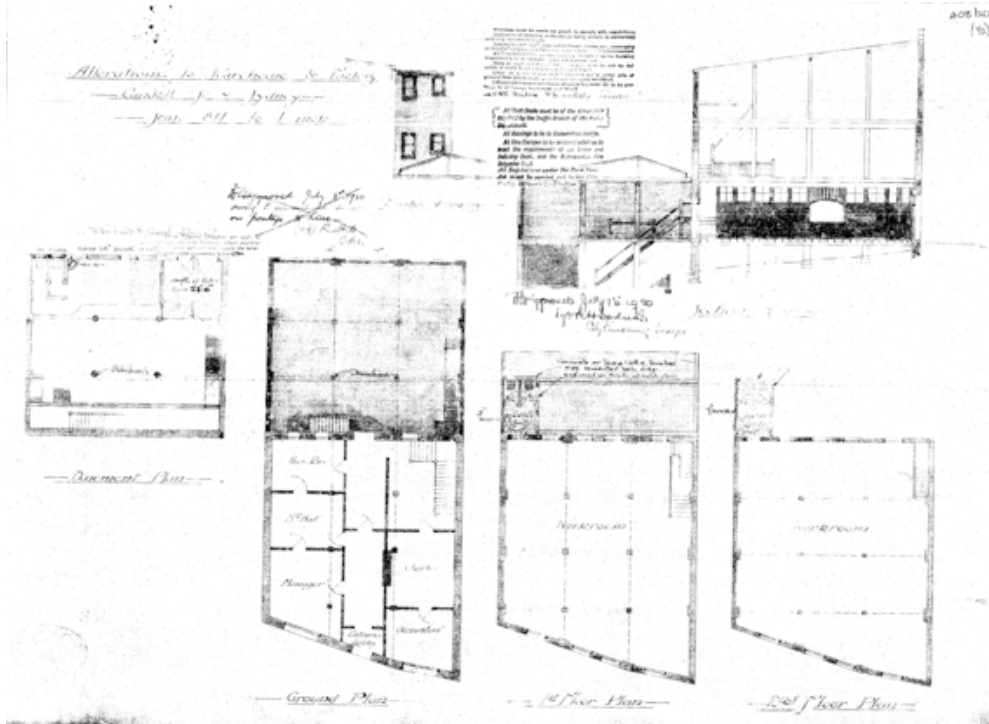
Figure 5.2.1 Plan of additions made in 1920 to the rear of the building

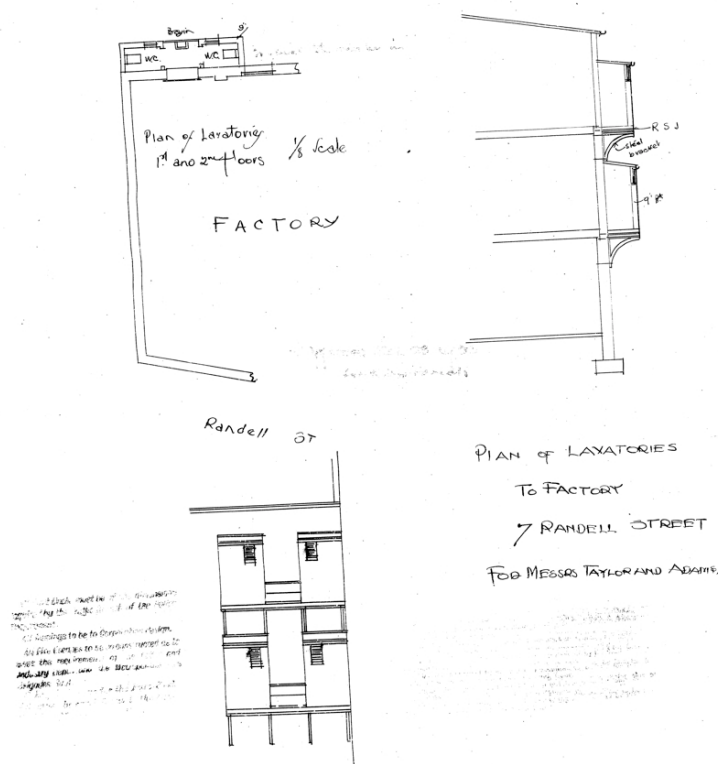
Figure 5.2.2 Alterations were undertaken also in 1920 to increase the number of lavatories for the upper floors

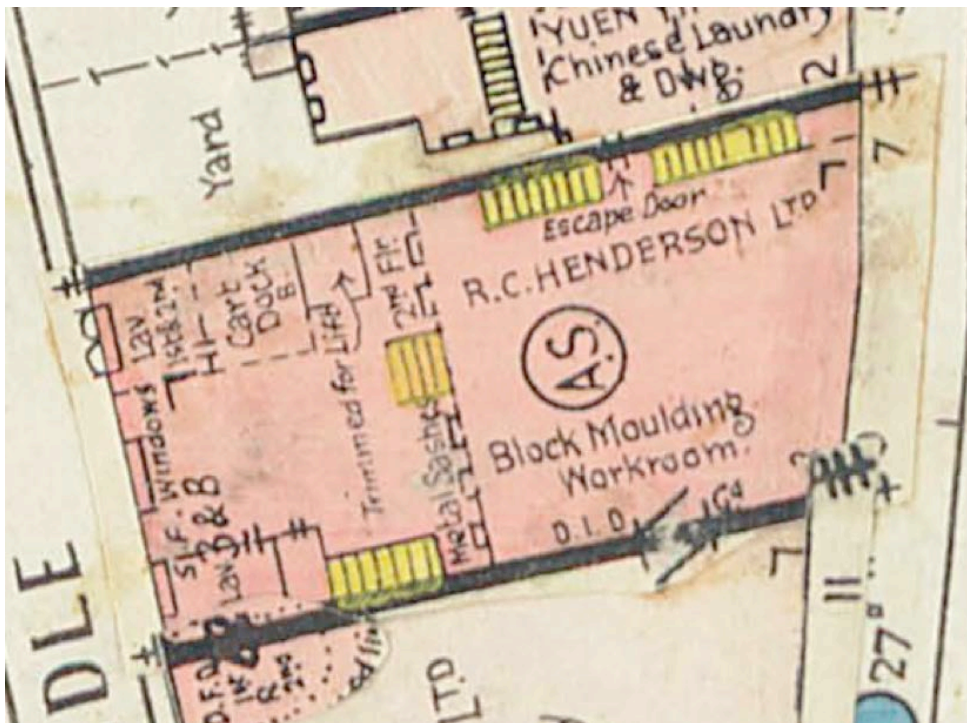
Figure 5.2.3 Detail from the Fire Underwriter's Sheet 250.

The physical changes in this period were recorded probably in the Fire Underwriter's survey that depicted new staircases, a cart dock, and door openings on the western wall to the main Henderson factory at Nos. 9-13 Randle Street.

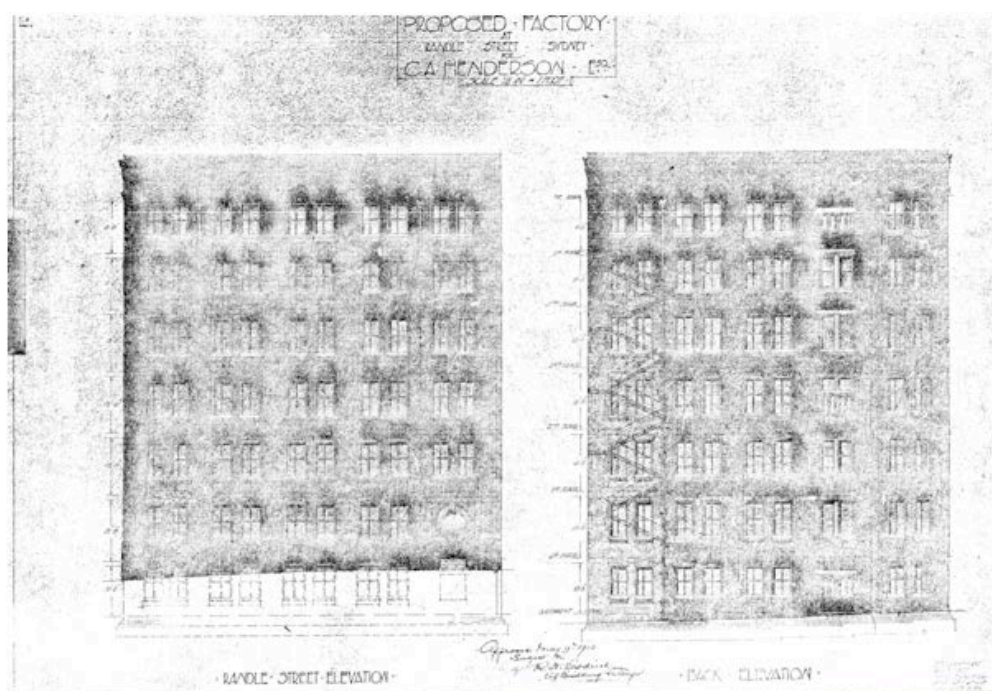
Figure 5.3.1A Elevations of the factory as designed in 1912 (architect TP Sampson) for RC Henderson's hat factory

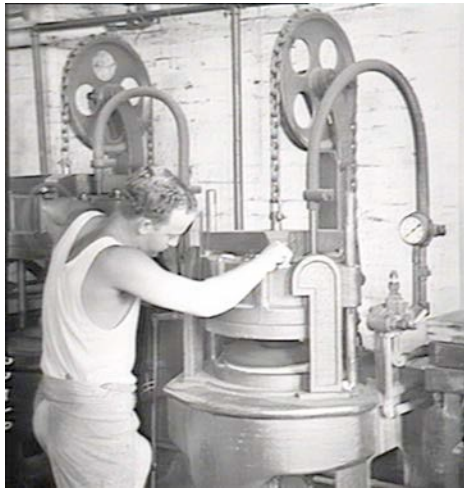
Figure 5.3.2 Rolling the brim with steam under great pressure

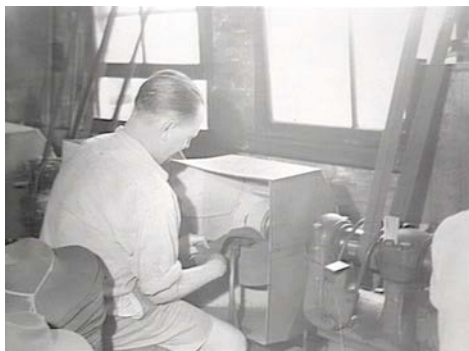
Figure 5.3.3 Skilled machinist preparing a felt hat by machine sanding the brim and crown. Note the overhead belt driven machinery in this part of the factory (possibly Nos. 7-9). March 1949

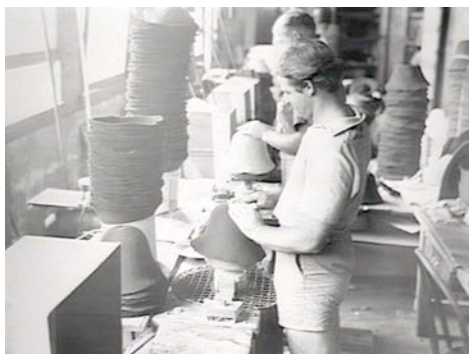
Figure 5.3.4 The second stage in the sanding of felt hat to remove any irregularity or blemish. March 1949

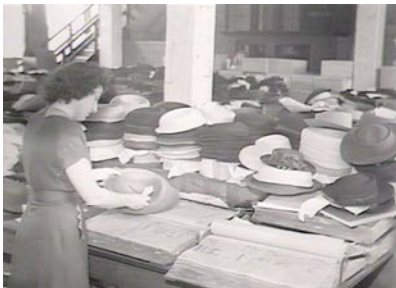
Figure 5.3.8 Quality control and checking. Both the staircase and hardwood columns are visible. March 1949

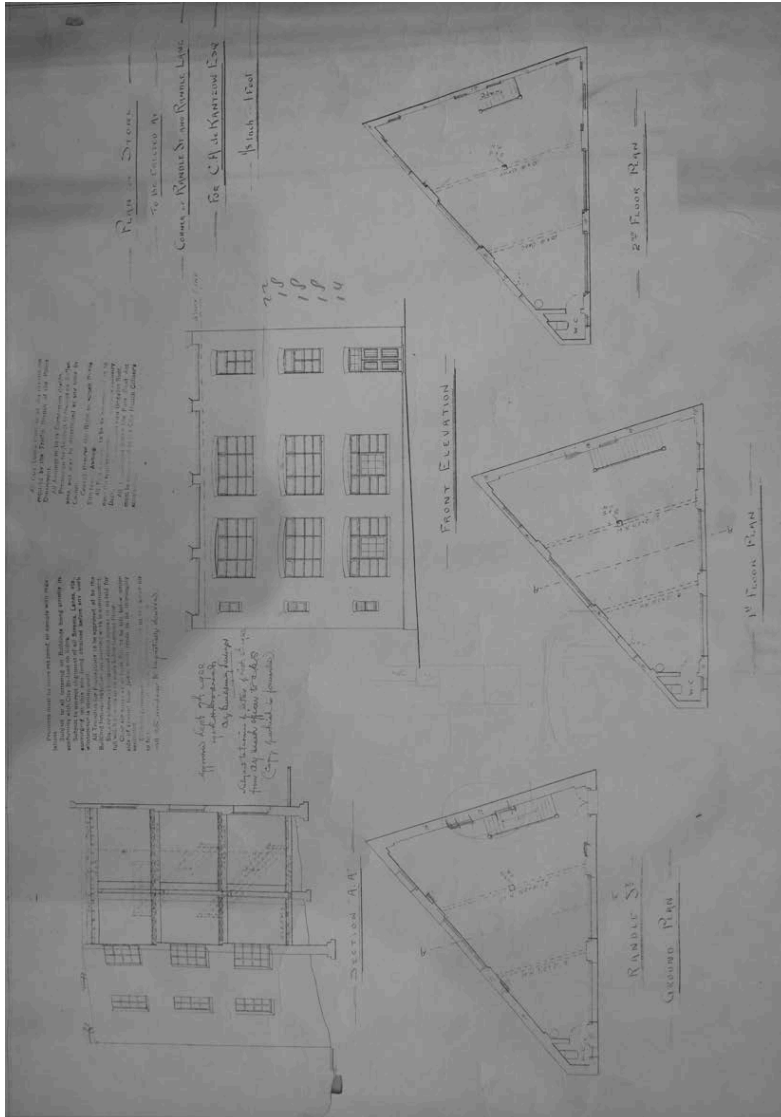
Figure 5.4.2 The building as designed in 1922 and completed in 1923 as a store. The architect was probably WW Gray

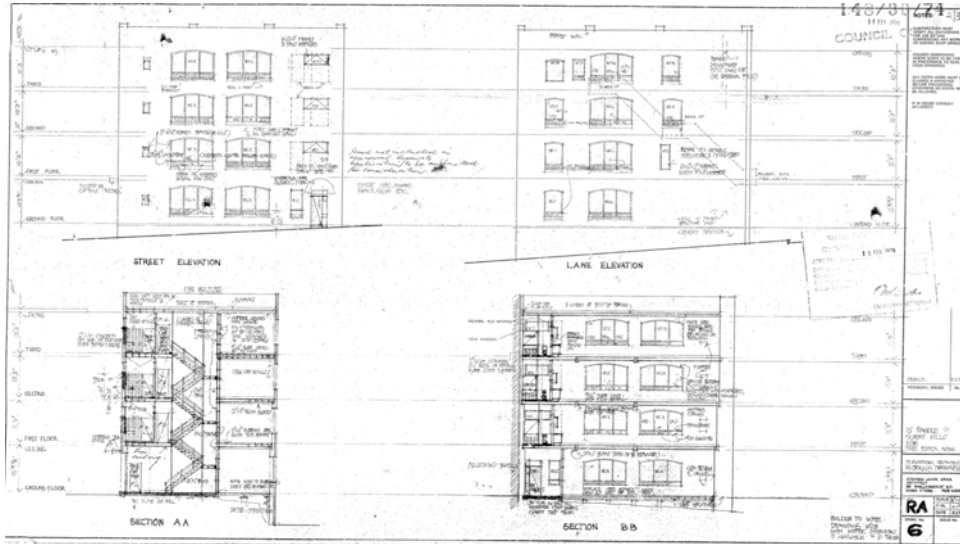
Figure 5.4.3A The building was badly damaged by fire in 1973 and was remediated the following year. That work was extensive. Elevations and sections by Stephen Javor. RAIA

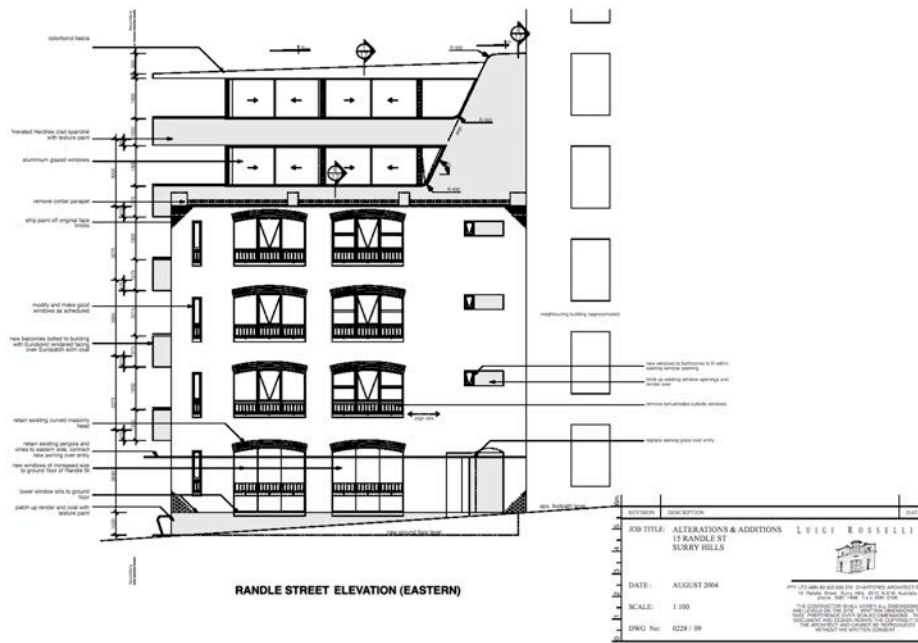
Figure 5.4.4 About 30 years after the fire in 1973, in 2005, the office building was converted to loft apartments. The work included addition of two floors and a wall of Juliet balconies. The architect was Luigi Rosselli
