**PHOTOGRAPHS OF RETAINING
STRUCTURE AND SITE MAP**

ATTACHMENT A – PHOTOGRAPHS OF RETAINING STRUCTURE

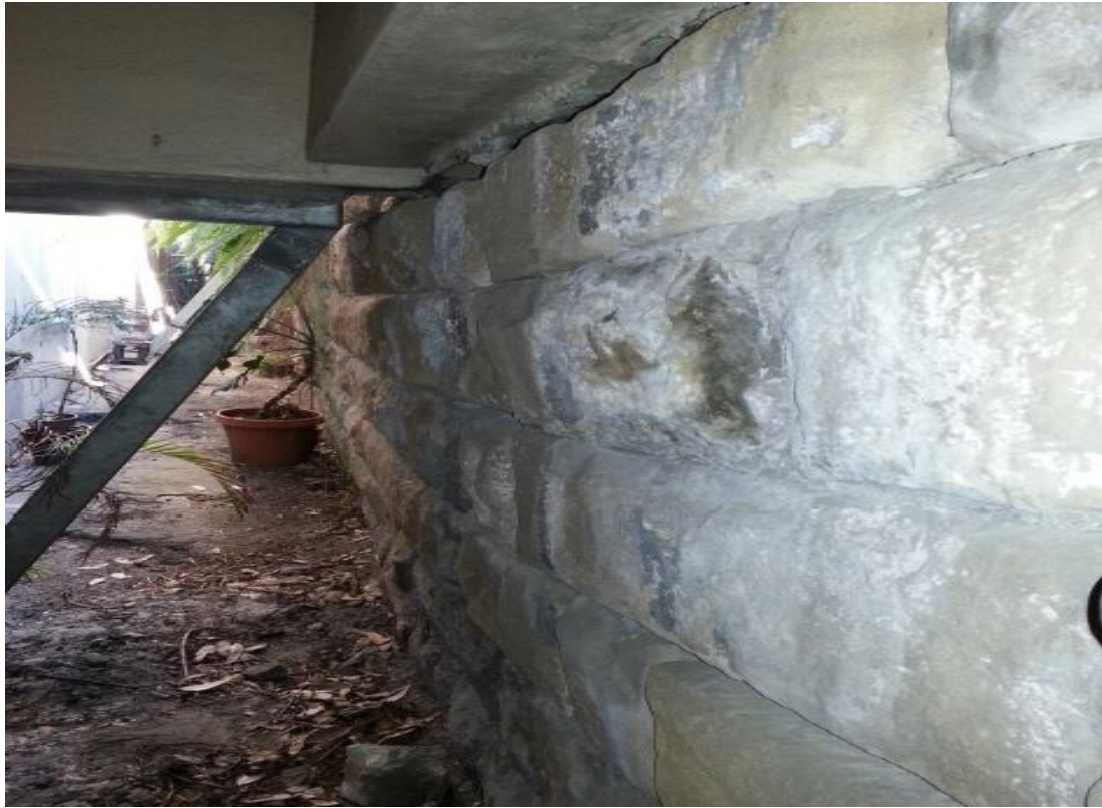
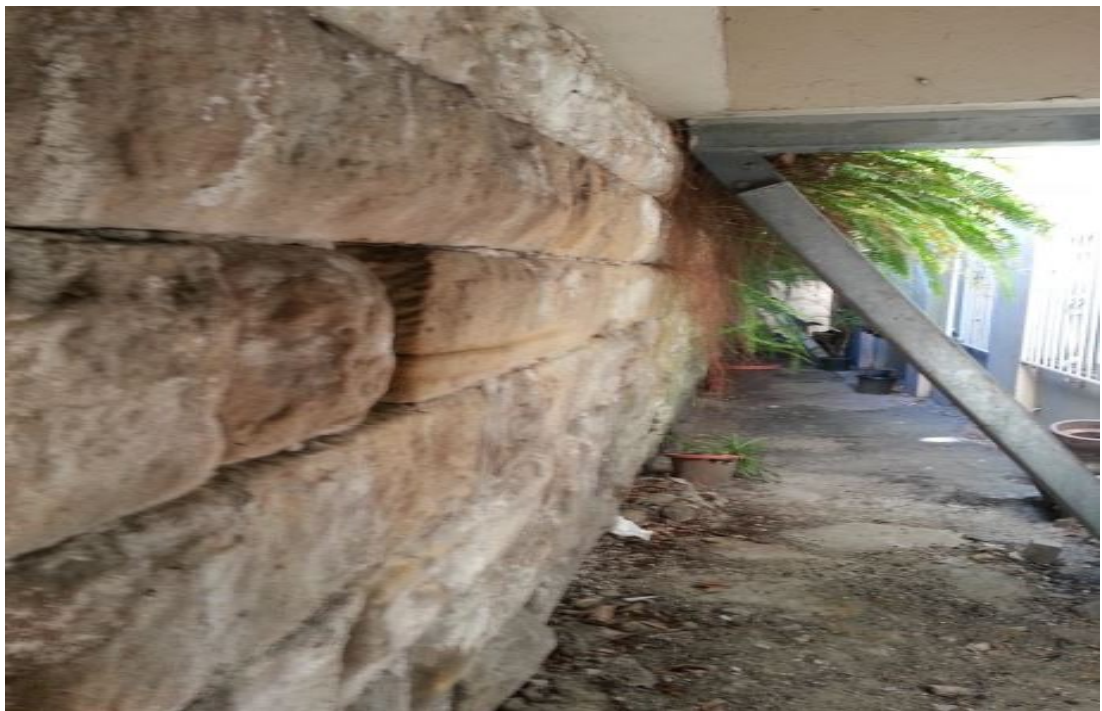
Photo 1 & 2 – Bulging and tilting sandstone block retaining wall. Steel brackets installed by Owners Corporation to support suspended access to building
