FIGURE 2
STUDY AREA

FIGURE 3
LIDAR SURVEY

FIGURE 8A
**FLOODING & ELEVATION MARKS
 CROWN STREET LOW POINT**

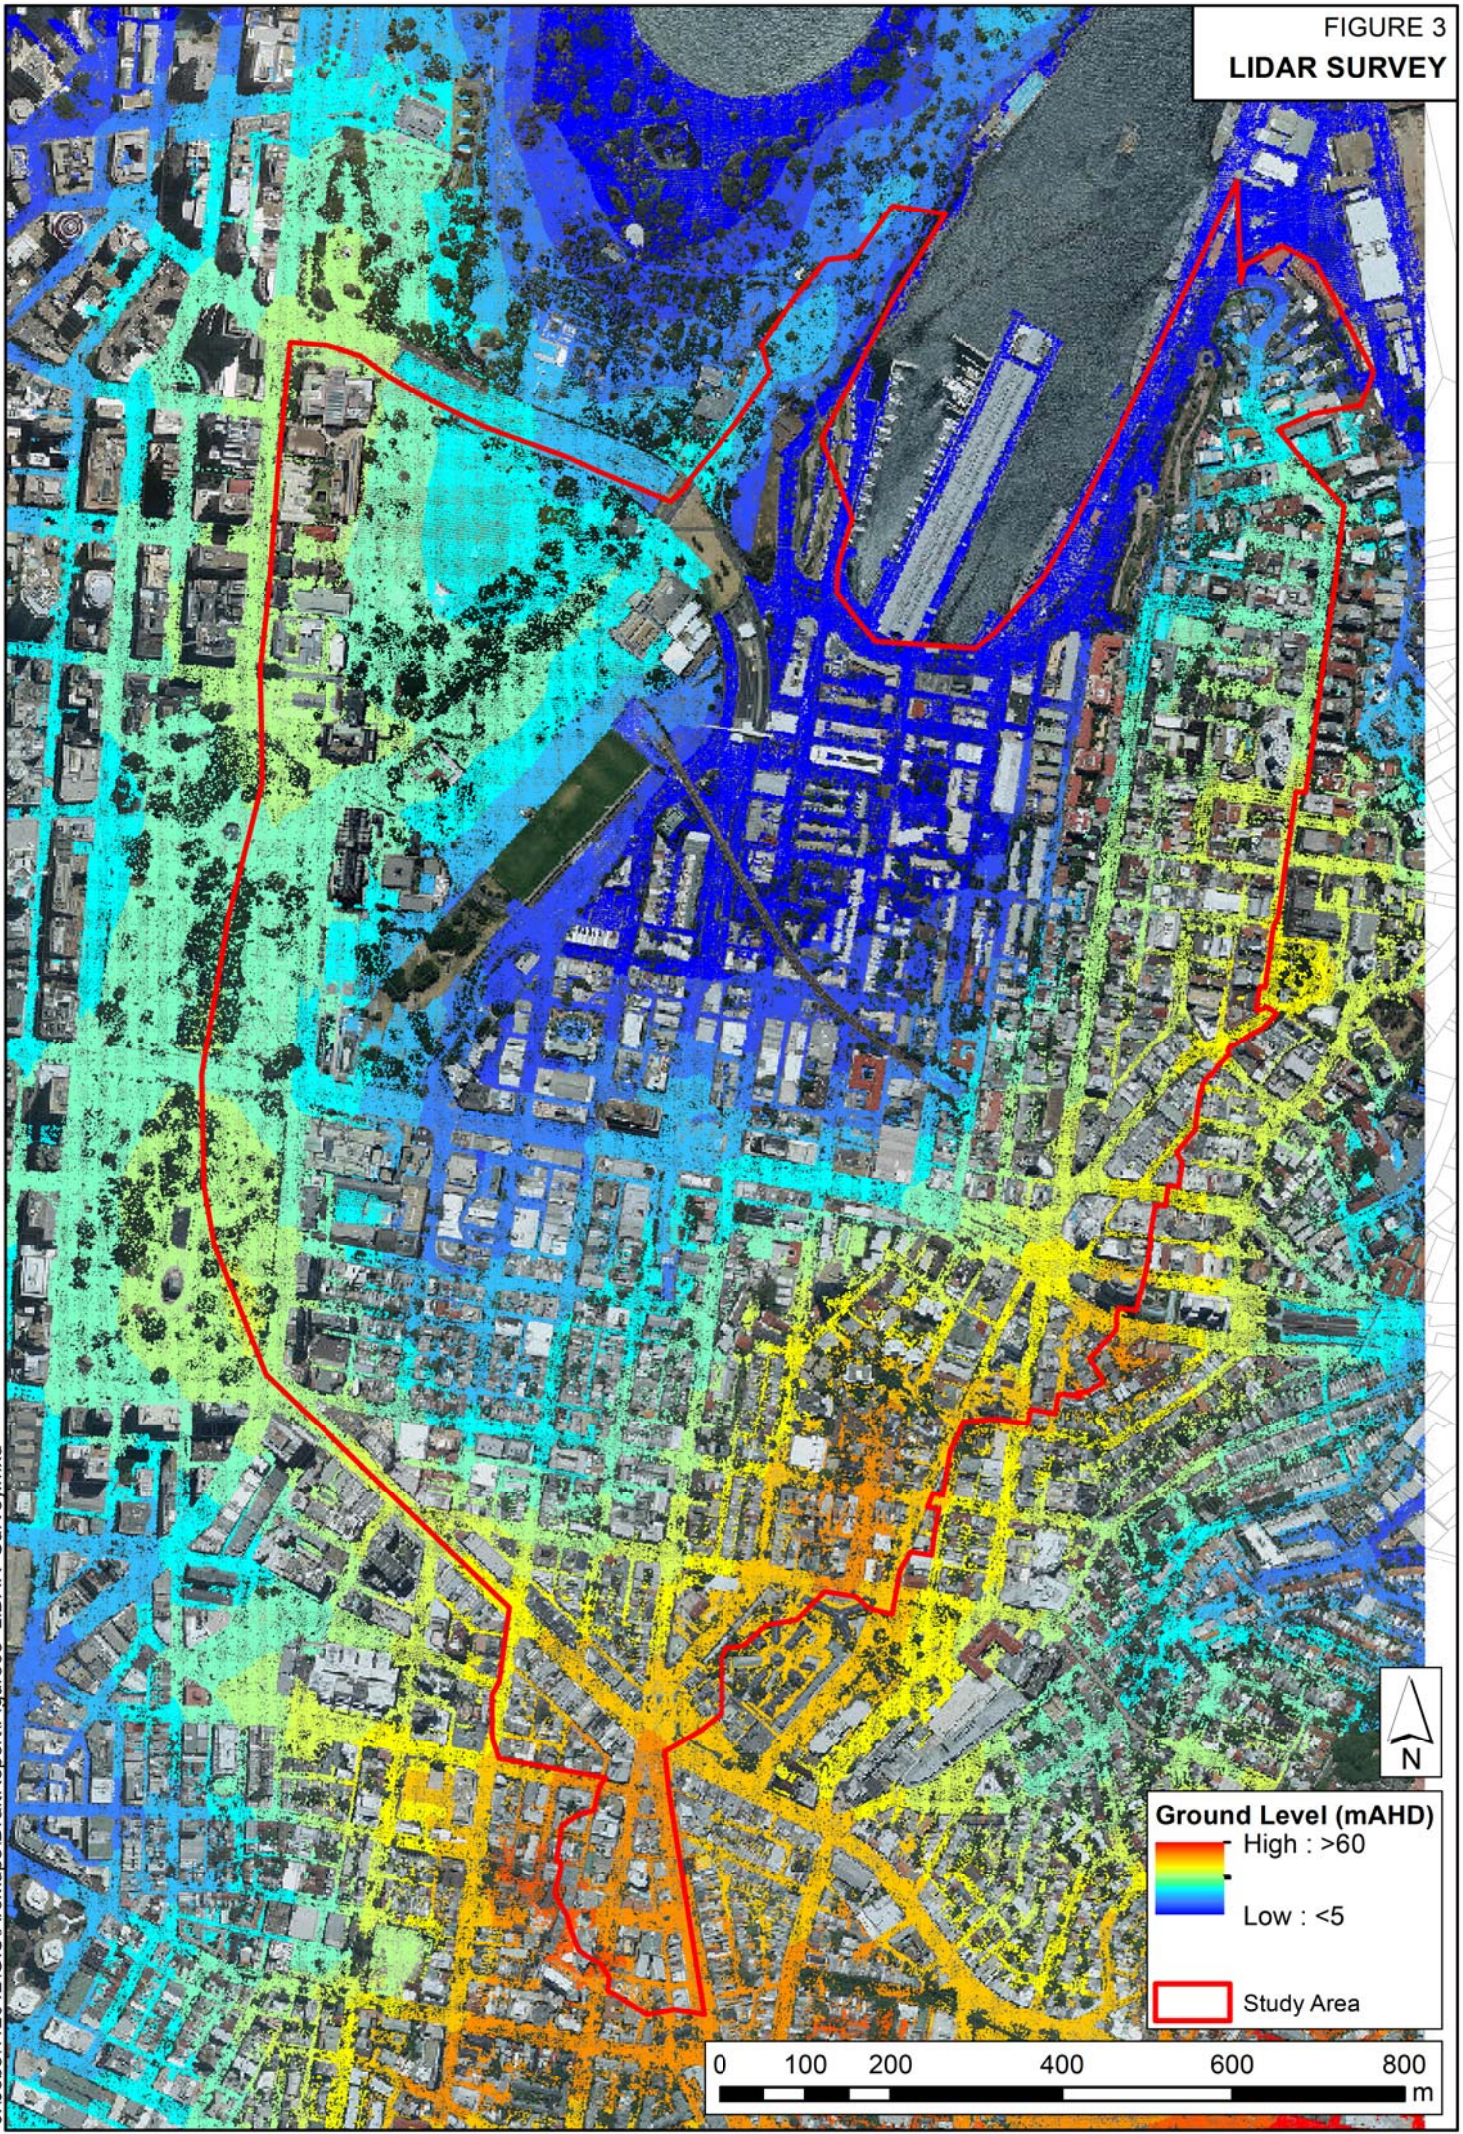
Ground Level (mASL)
High : >60
Low : <5
Study Area

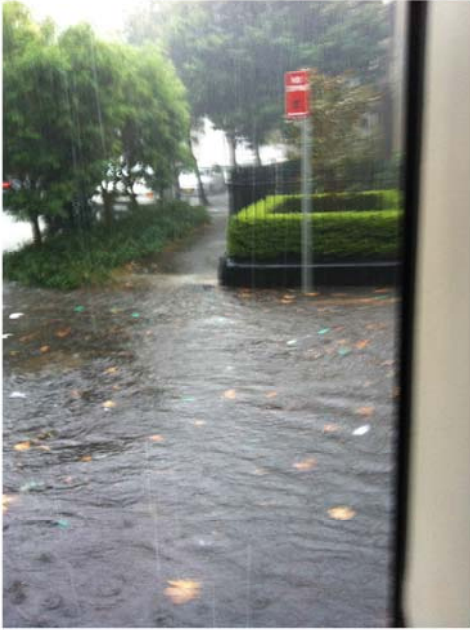
Flooding on the corner of Bossley Terrace & Crown Street, 7:39am, 17 April 2012.

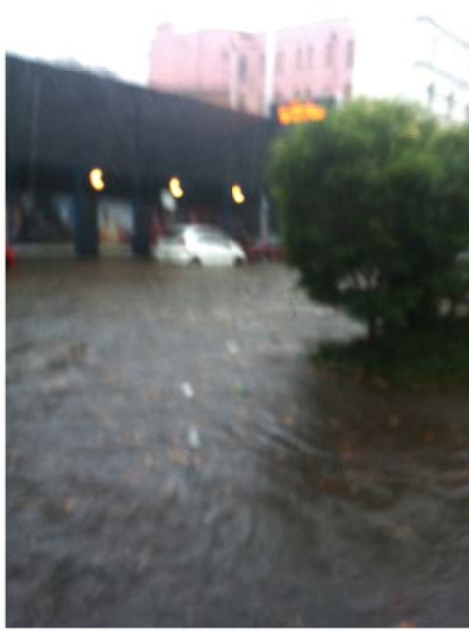
Flooding at Crown Street Low Point, 7:44am, 17 April 2012.

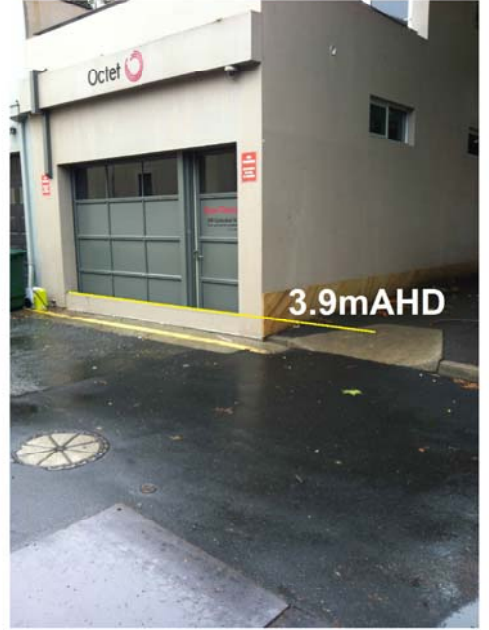
Flood barrier installed at Bossley Terrace, with approximate elevation of barrier height. 3.9m AHD

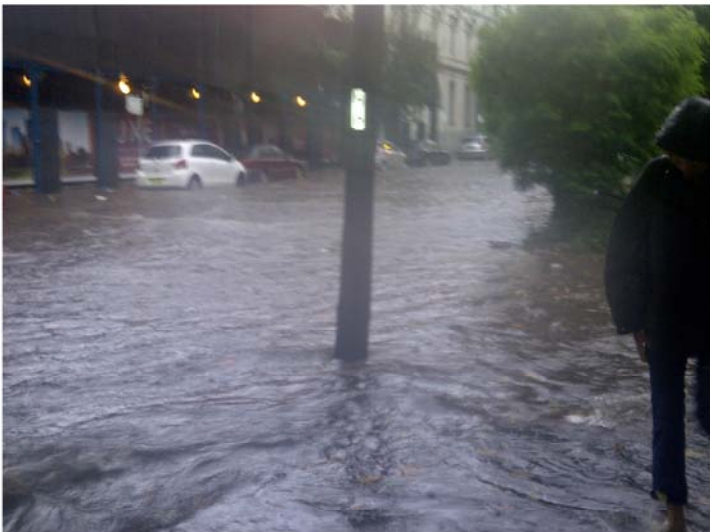
Flooding at Crown Street low point, Woolloomooloo, 7:50am, 17 April 2012.

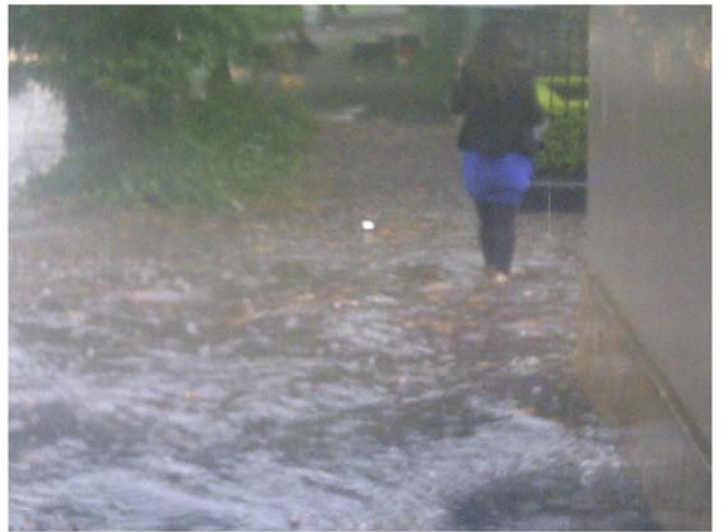
Flooding at corner Bossley Terrace and Crown Street, Woolloomooloo. 7:51am, 17 April 2012.

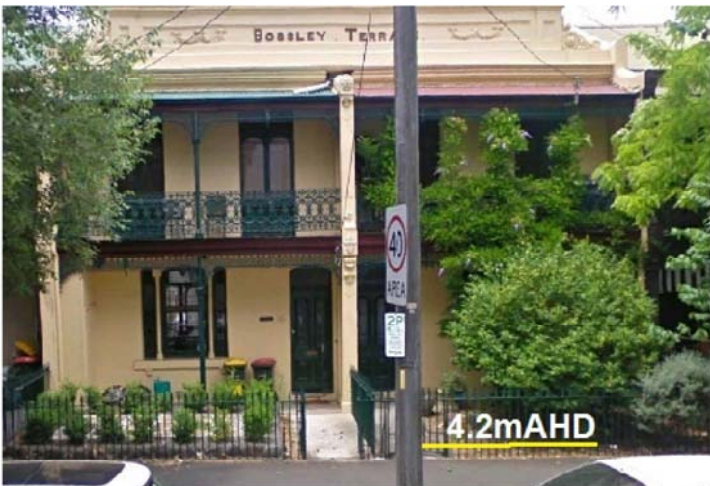
Approximate elevation of regular flooding along front fence outside, 18 Crown St, Woolloomooloo. 4.2m AHD

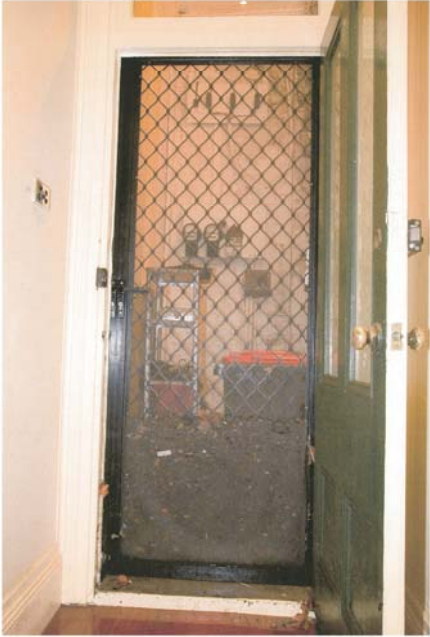
FIGURE 8B
**FLOODING & ELEVATION MARKS
 VICTORIA STREET**

Floodmarks at residence entrance on Victoria St, Potts Point

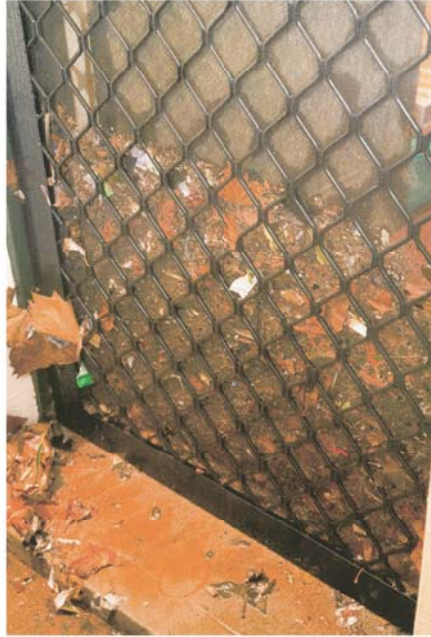
Floodmarks at residence entrance on Victoria St.

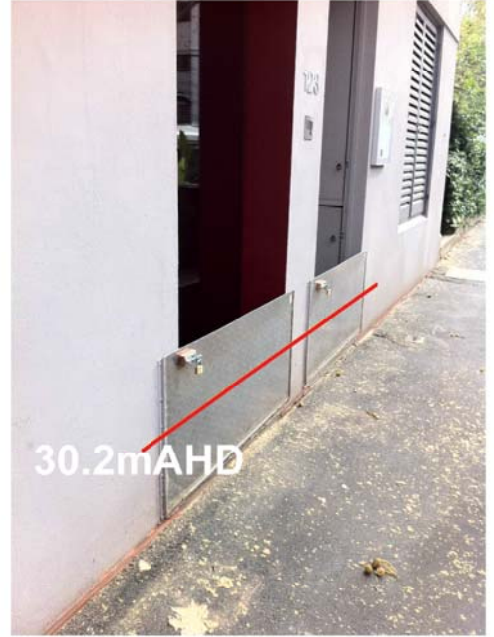
Floodgates installed to avoid inundation at Victoria St, with approximate elevation of flooding in February 2010.

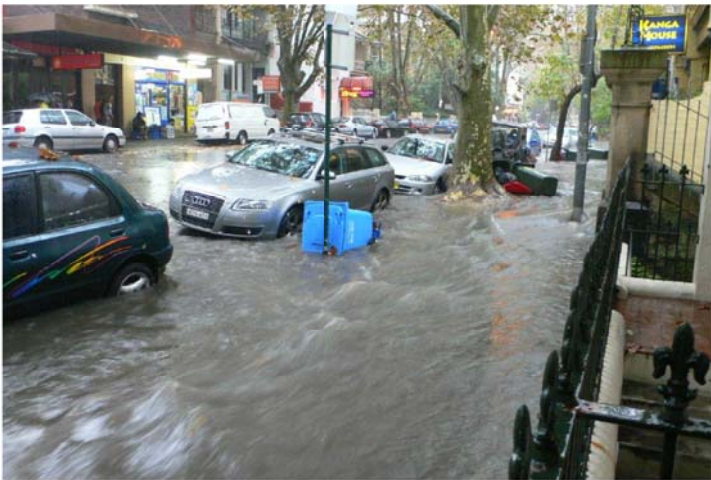
Flooding, Victoria St, April 2012.

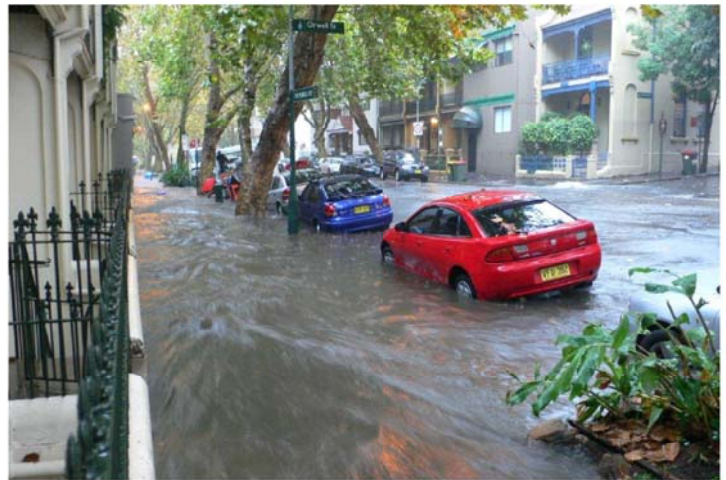
Flooding, Victoria St, April 2012.

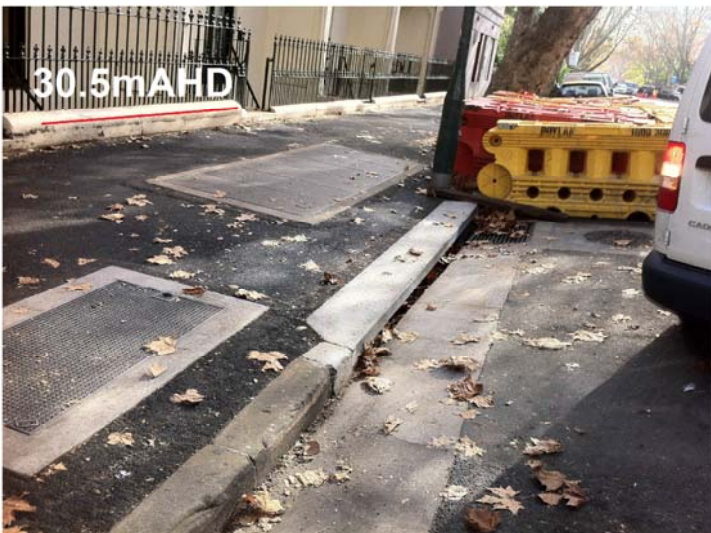
Approximate elevation of flooding on Victoria St during June 2007 storm.

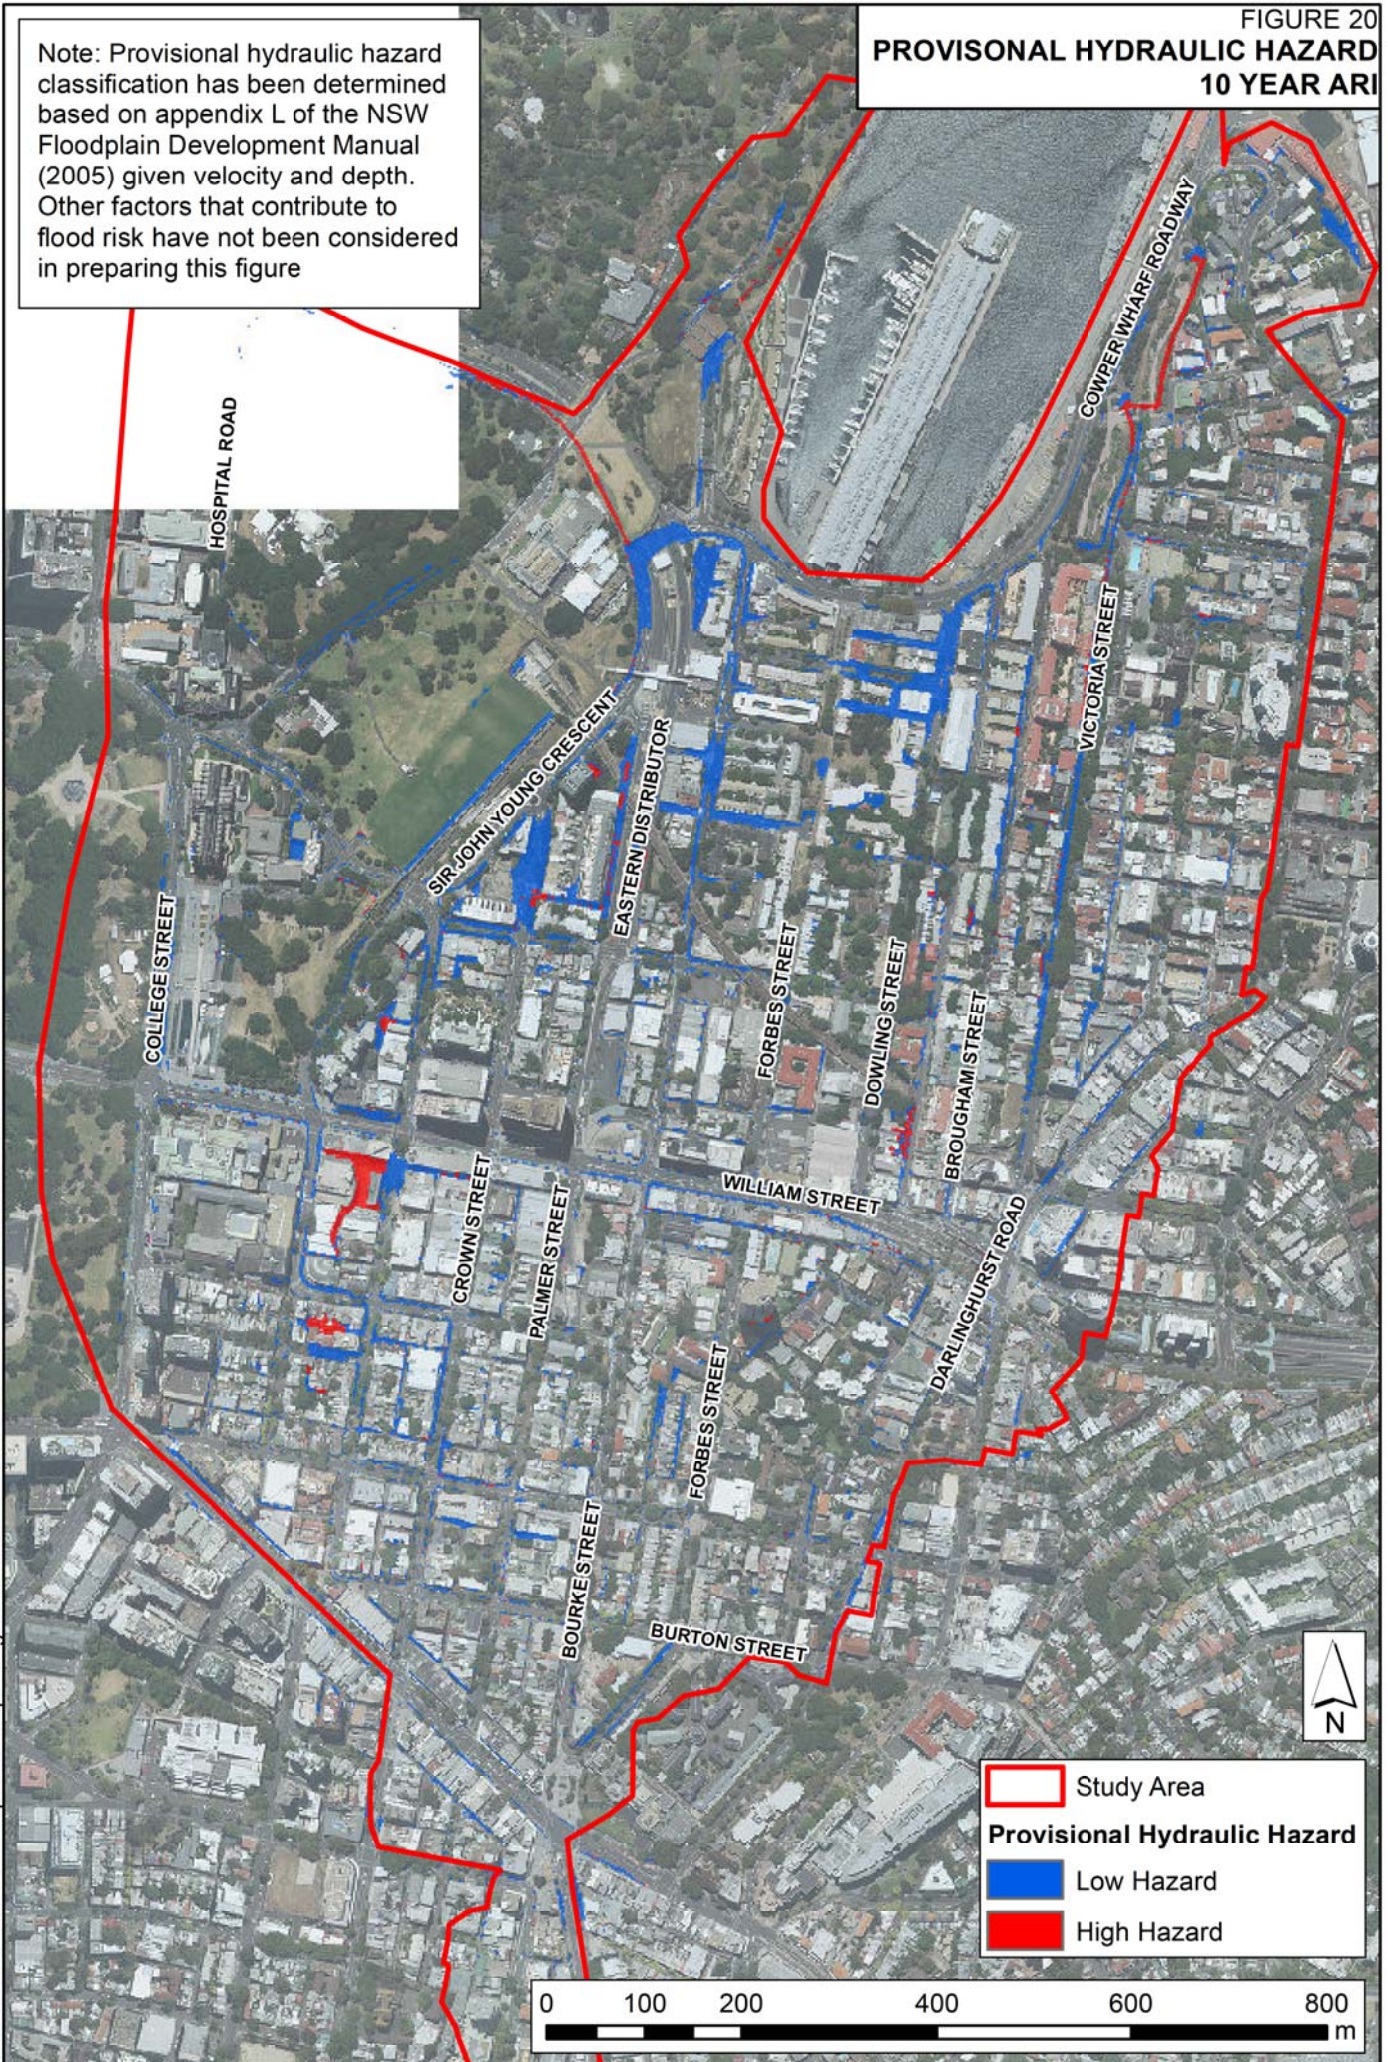
FIGURE 20

**PROVISIONAL HYDRAULIC HAZARD
10 YEAR ARI**

Note: Provisional hydraulic hazard classification has been determined based on appendix L of the NSW Floodplain Development Manual (2005) given velocity and depth. Other factors that contribute to flood risk have not been considered in preparing this figure
