FIGURE 3
LIDAR SURVEY

FIGURE 10
HYDROLOGIC MODEL CATCHMENT LAYOUT

FIGURE 11
HYDRAULIC MODEL CATCHMENT LAYOUT

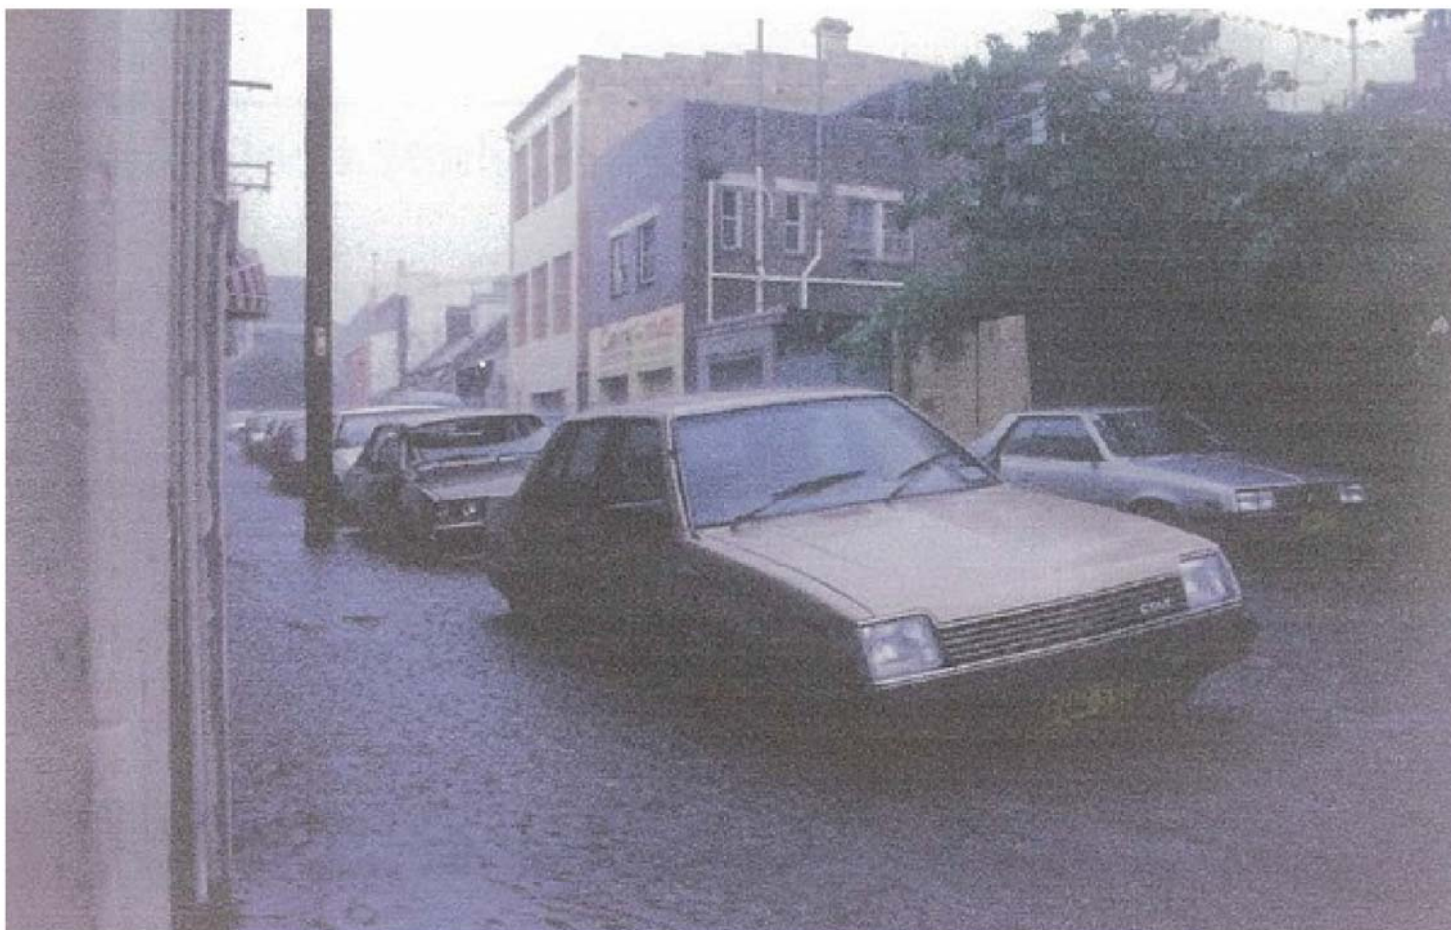
Flooding in Victoria Street, Paddington on January 6, 1989. This location is immediately outside the study area, though indicates the downstream flooding within the same catchment.
