## Relevant Information for Central Sydney Planning Committee

**FILE:** D/2023/97 **DATE:** 28 March 2024

**SUBJECT:** Information Relevant To Item 5 – Development Application: 12A and 14-26 Wattle Street, Pyrmont – D/2023/97

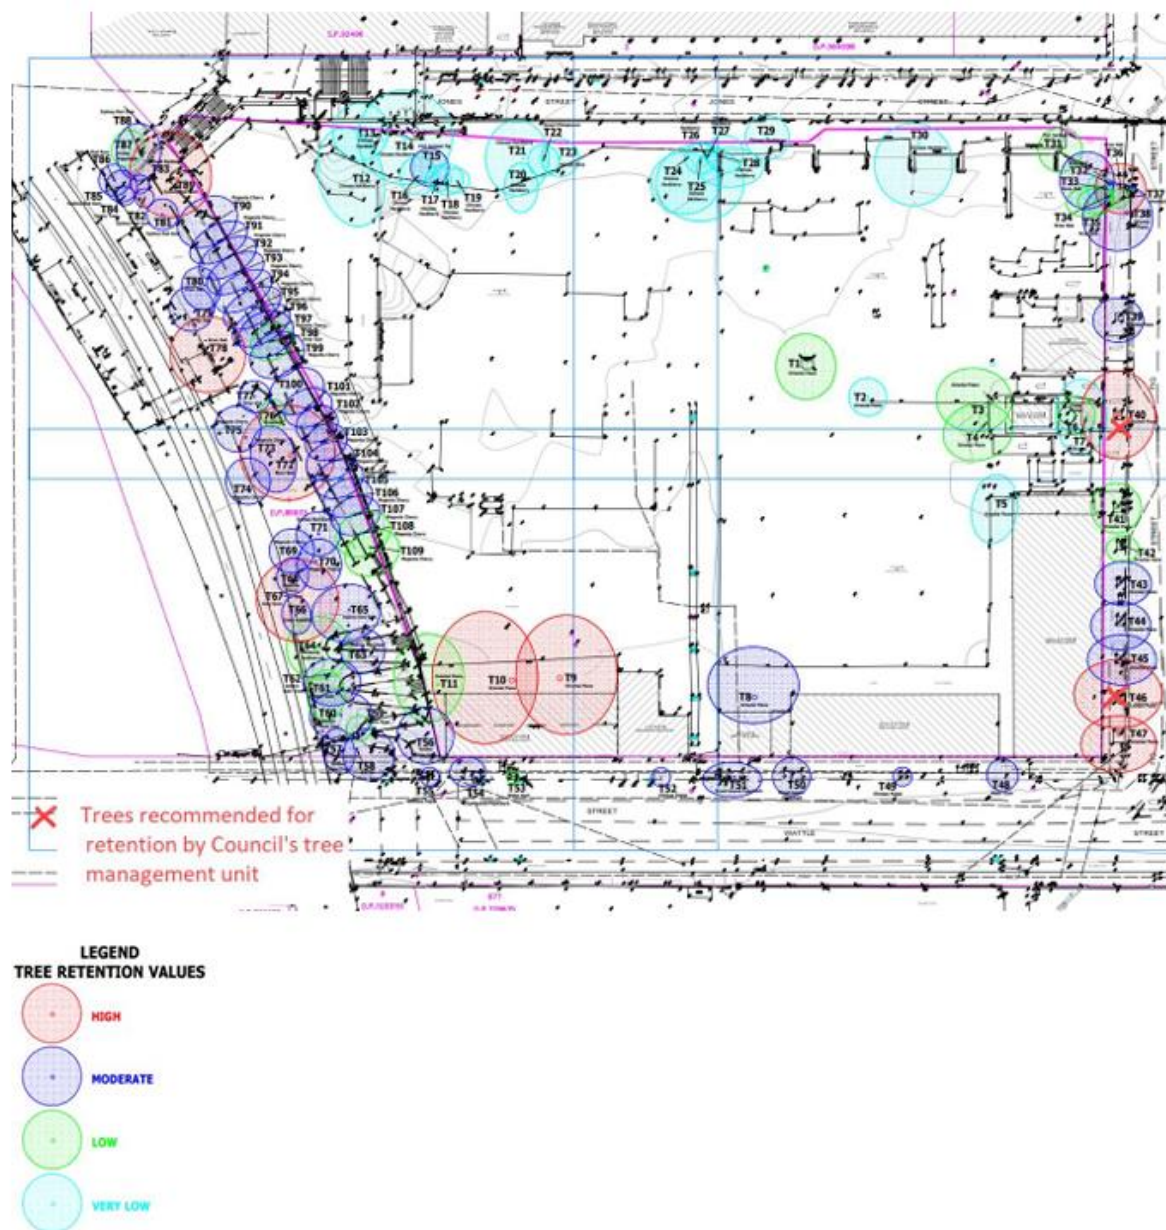
**Figure 1:** Tree retention value plan showing trees recommended for retention by the City's Tree Management Unit

Refer to Figure 1 below depicting the location Tree 40.

The City's Tree Management Unit advised during the assessment of the development application that Tree 40 is part of a group of street trees on Fig Street that are considered to be prominent landscape elements.

However, Condition 31 – Street Trees and Detailed Design Application of D/2019/649 (the Concept Approval) approved the Arboricultural Impact Assessment Report prepared by Earthscape Horticultural Services, dated 3 September 2019, which recommended the removal of Tree 40. Further to this, subsequent Arborist reports provided by the applicant for D/2023/97 support the original recommendation to remove Tree 40.

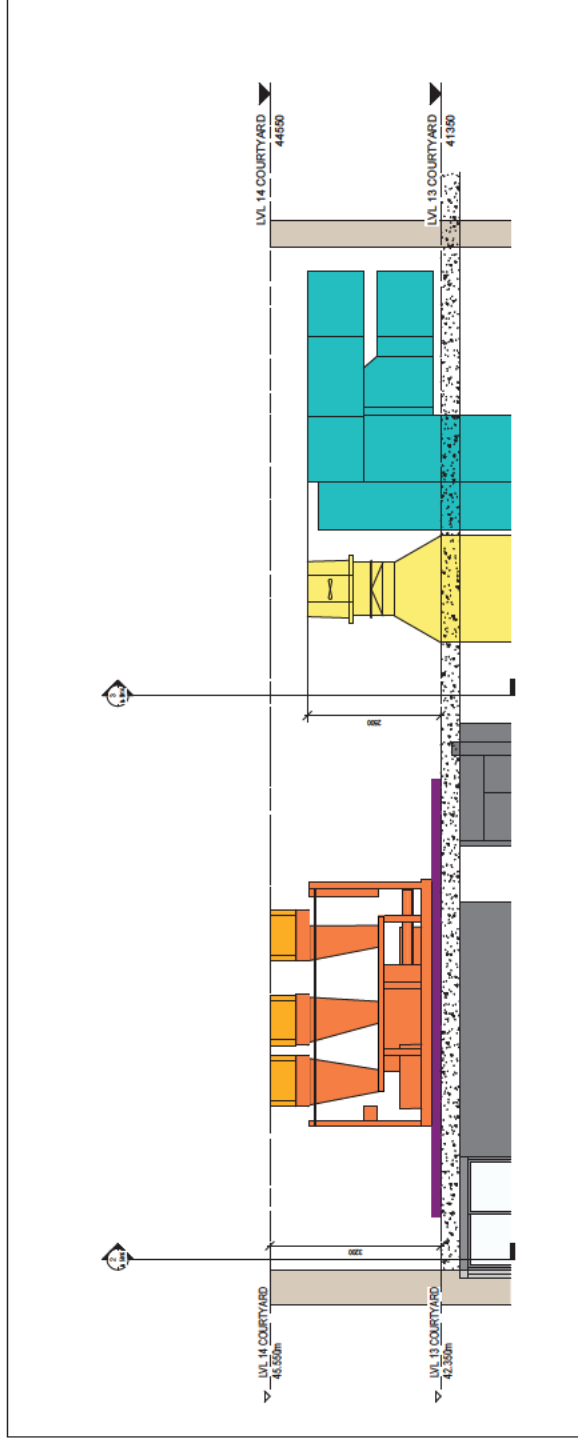
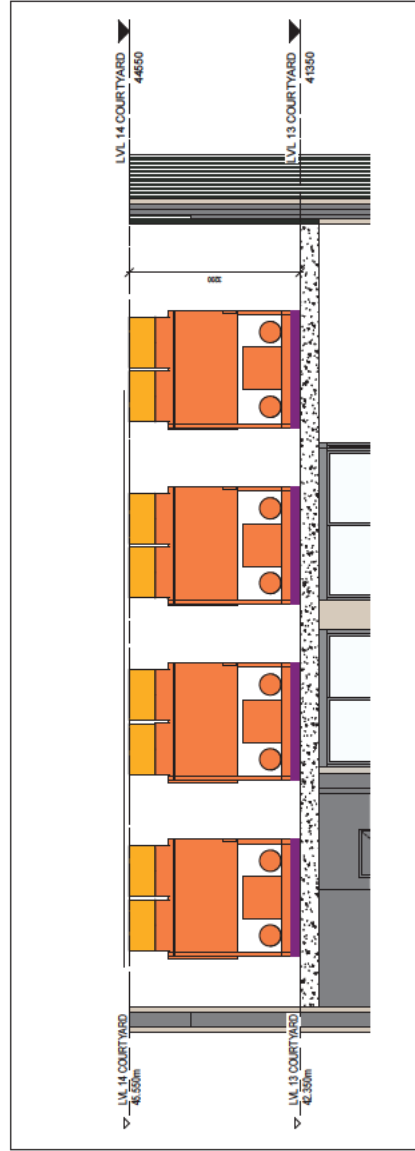
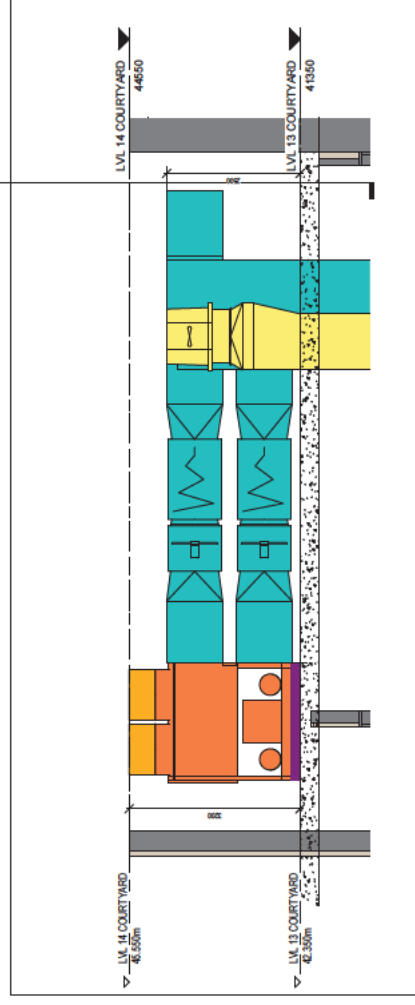
ISSUED TITLE  
 MECHANICAL SERVICES  
 HVAC - BUILDING C - ROOF  
 SECTIONS

SECTION VIEW 1

SECTION VIEW 2

SECTION VIEW 3

- a stair pressurisation system for each fire stairs core at a height of at least 2.5m;
- lobby relief (smoke exhaust) system at a height of at least 2.5m and separated from the stair pressurisation system at a minimum distance of 6m; and
- the air conditioning system/plant (5x off air cooled chillers) for the entire development at 3.2m in height.

All three types of mechanical systems are required to be open to the air, and the extrusion of the architecture to create a parapet zone, as currently proposed, acts to conceal the rooftop plant area. A 2m reduction of the parapet zone would expose the plant area. Further, relocation of the air conditioning system to the other buildings, particularly Jones Street, will result in visual impact.

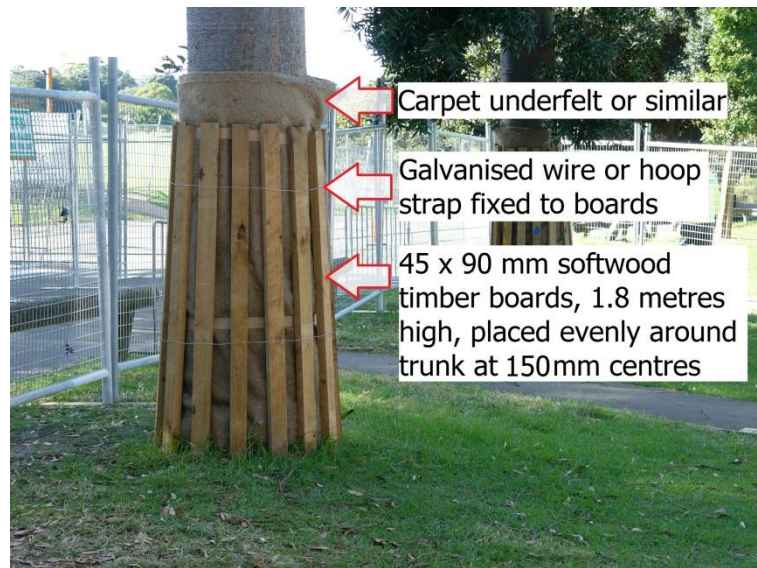
**Figure 3 – Detail of Trunk Protection**

10.7.1 Trunk protection boarding shall be erected around Trees [T43, T44, T45, T46 & T47] to avoid accidental damage, as indicated on the Tree Protection Plan (**Appendix 6**). The trunk protection shall consist of a layer of carpet underfelt (or similar) wrapped around the trunk, followed by 1.8 metre lengths of softwood timbers (90 x 45mm in section) aligned vertically and spaced evenly around the trunk at 150mm centres (i.e. with a 50mm gap) and secured together with 2mm galvanised wire or galvanised hoop strap as shown in **Figure 3**. Recycled timber (such as demolition waste) may be suitable for this purpose, subject to the approval of the Project Arborist. The timbers shall be wrapped around the trunk (over the carpet underfelt), but not fixed to the tree to avoid mechanical injury or damage to the trunk. Trunk protection should be installed prior to any site works and maintained in good condition for the duration of the construction period. Carpet underfelt (alone) is sufficient for trees with a trunk diameter of less than 200mm. This shall be wrapped around the trunk in a double layer and held in place with heavy-duty fibre reinforced adhesive tape (e.g. Gaffer Tape).

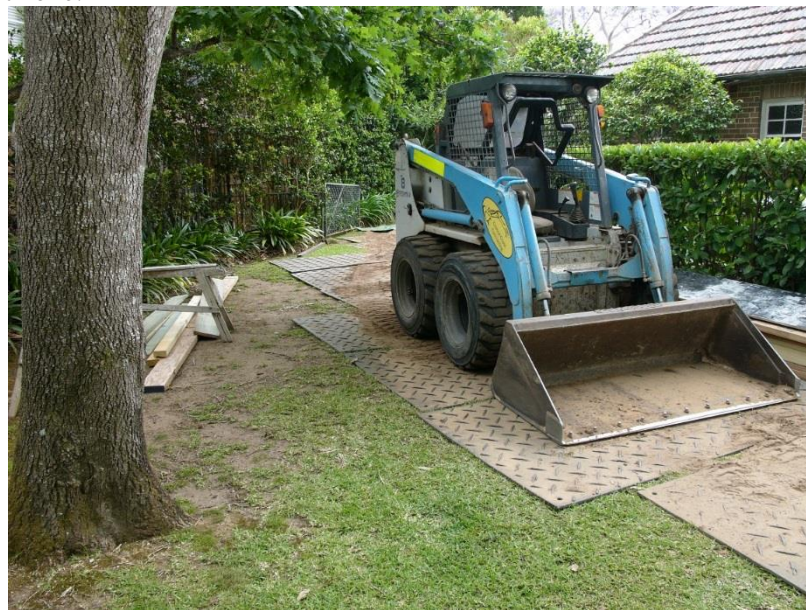
**Figure 4 – Showing typical detail for truck mats.**

10.8.1 Construction haul routes shall be confined to existing paved areas wherever possible. Where this is not feasible and construction haul routes or access for plant and equipment must traverse soft landscape areas within TPZs of **[any tree nominated for retention]**, 20mm thick marine ply sheets or truck mats (such as Envirex Versadeck® access mats) (refer **Figure 4** shall be placed over the top of the ground surface to minimise compaction and disturbance of the underlying soil profile and root zone.

10.8.2 Ground protection shall be installed prior to any site works and maintained in good condition for the duration of the construction period. On completion of the works, ground protection shall be removed without damage or disturbance to the underlying soil profile.
