Arboricultural Impact Assessment

43-49 Mountain Street Ultimo Arboricultural Impact Assessment

Prepared for Apt Residential

Project Name	43-49 Mountain Street Ultimo Arboricultural Impact Assessment
Project Number	AIA2502175
Prepared by	Alex de Jong – AQF Level 5 Arborist
Status	Final
Version	v4
Last saved on	10 June 2025

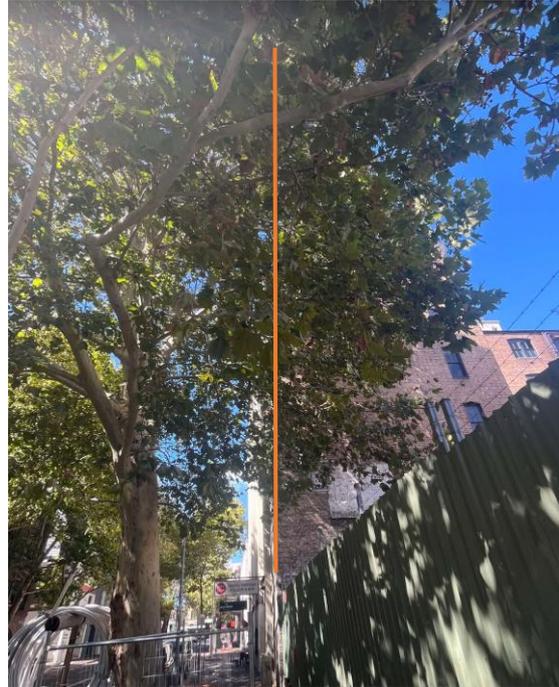
Photo 2: Tree 1 – Canopy Required for Pruning

- **Tree 1 (*Platanus x acerifolia*):** City of Sydney Council have agreed to approve the removal of Tree 1 due to the future safe useful life of the tree. Refer to the below email from Sally Peters (City of Sydney – Mgr Central Sydney Planning) regarding Tree 1.

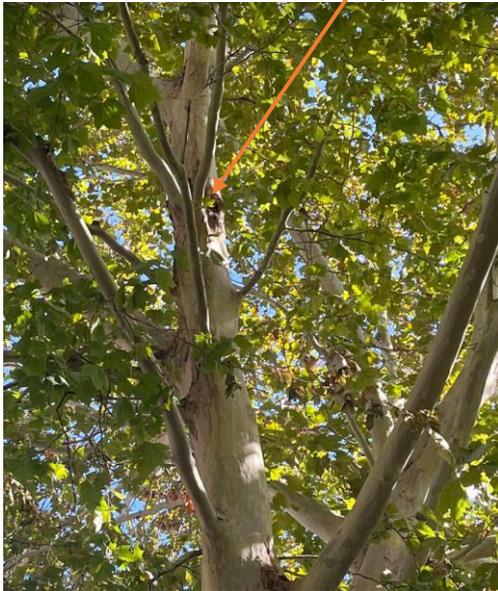
Photo 3: Tree 1 - Cavity

The City has conducted a detailed inspection of the plane tree in Mountain Street, and have found that the tree has multiple defects resulting from cockatoo damage to create breeding hollows. We expect that the damage and decay to this tree will progress, and reduce the future safe useful life of the tree.

As a result of this investigation, we do not object to the removal and replacement of the tree.
