SCHEDULE OF CONSERVATION WORKS

Former First Church of Christ Scientist

262-270 Liverpool Street, Darlinghurst

FINAL
NOVEMBER 2018

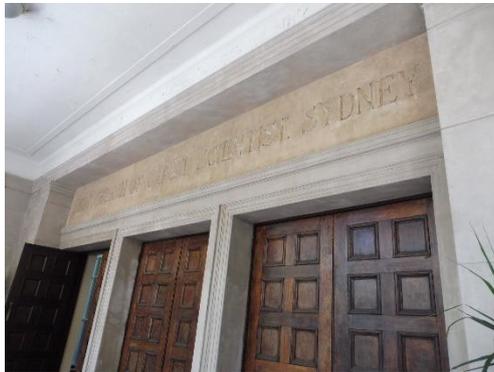
Figure 4 – Sign marking above front doors to be kept.

- External render to be cleaned as specified without removing the previous sign markings above the entrance doors.
- All external walls to be checked by a structural engineer, who should determine which cracks need to be structurally repaired.

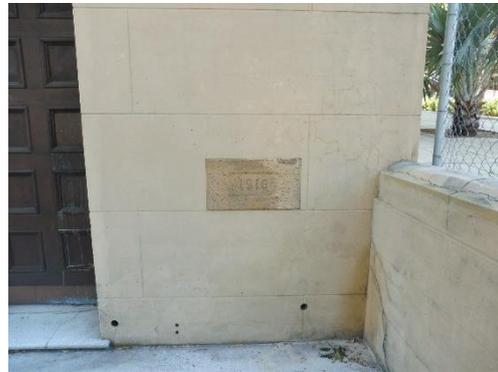
Figure 5 – Stone next to Stair 1 Entry, examples of large cracks and previous fixings to be repaired, and hairline cracks to be left as is.

- Hairline cracks which do not pose a structural risk to the building to be left as is.
- Cracks which require structural repairs and/or leave the masonry visible on facades and garden walls are to be repaired with new render.

- Previous fixing points are to be repaired with new render.
- New render to match existing in colour, finish and materials, including profile details and ashlar lines. Allow to provide samples of new render for approval by heritage architect/consultant before completing repair work. Samples are to be provided adjacent to existing clean render for comparison.

- Conserve the date stone next to the Stair 1 entry.
- Entry porch ceiling to be retained, repaired and repainted to match existing.
- Timber entrance doors to Entry Hall, Stair 1, Stair 2 and North Foyer are to be retained. Any missing external handles are to be reconstructed to match existing details. Doors and original hardware to be re-polished. North Foyer doors will require rehanging. Non-original internal locks may be removed and/or changed to suit the new use. Consult the heritage architect/consultant about fixing details.
- All original steel windows to north and east facades to be kept and restored as specified.
- Modifications to external openings and walls are to be done carefully to avoid loss of original render. Detailing for modification is to be done in conjunction with heritage architect/consultant.

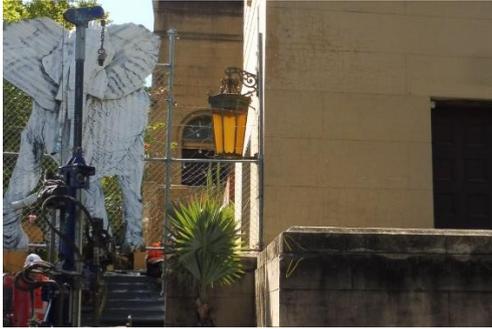
Figure 8 – 1 of the 3 carriage lamps to be retained.

- Remove unused services lines and tidy up used lines as much as possible and make good at previous fixings.
- Retain the 3 large externally mounted carriage lamps to the façade and check they are functional.

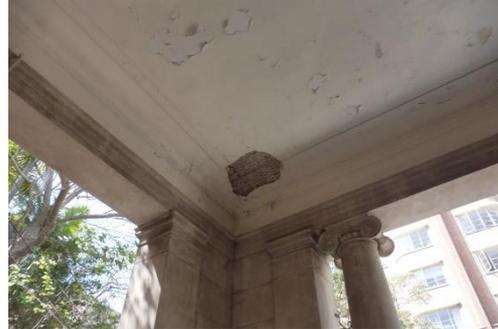
Figure 9 – Entry porch to be repaired and repainted.

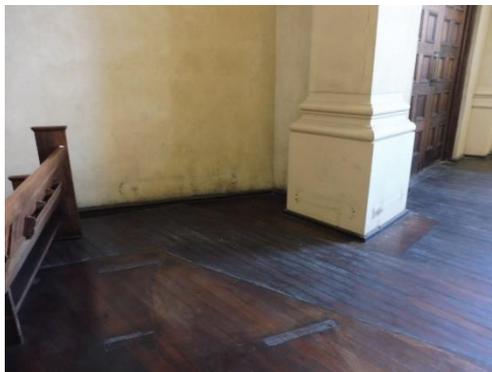
Figure 10 – Previous fixings to Auditorium wall to be made good. Floor to be repolished, and fixing points filled.

- All original ceilings, cornices, walls, doors and floors are to be conserved. Recent residential infill to be removed. Fixing details and services routes for new infill to be discussed with heritage architect/consultant before proceeding.
- Stage, organ and pews as shown in architectural drawings are to be retained at their current location. Organ to be checked and regularly maintained by an organ specialist. Allow to investigate service on stage and tidy up as necessary. (exception – all original organ related services to be kept even if found redundant)
- Lighting track attached to beam above stage and adjacent lights to be removed and fixing points made good.
- Auditorium flooring which will be left visible after construction to be re-polished. Pews fixing points to be filled with appropriate filler approved by heritage architect/consultant.

Existing floors are to be cleaned/sanded to create a uniform colour base. Finish off using a minimum of two (2) coats of approved floor polish, rubbed back between coats. Provide sample area for approval before proceeding.

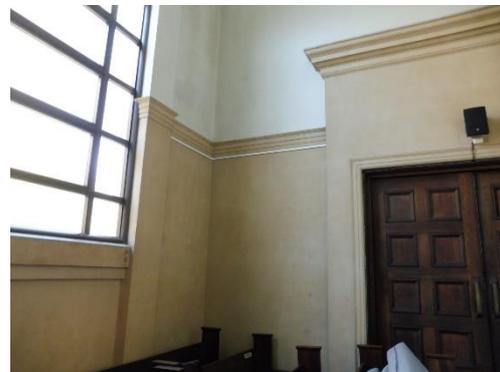
Figure 11 – Modern white picture rails and obsolete services to be removed. Original door to be repolished.

- Previous fixing points are to be repaired with new render.
- Remove all recent white picture rails and make good at fixings.
- All original or early doors including frames, windows including frames, partitions, panelling, furniture and other joinery noted to be kept at its current location or reused is to be re-polished or re-painted to match its original finish (including hardware). Please discuss with heritage architect/consultant individual finish to each door. Allow to remove paint of all joinery originally polished.

Where existing polished joinery is scheduled to be re-polished, apply two coats of shredded bees wax in mineral turpentine or alternative wax approved by heritage architect/consultant and buff to a polished finish.

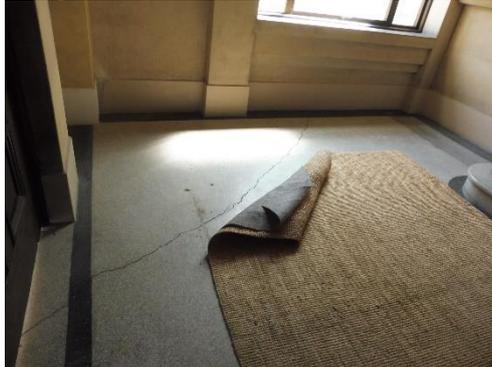
Figure 12 – Cracks to stairs floors to be filled in colour to match background.

- Flooring cracks to be filled with modern filler approved by the heritage architect/consultant in colour to match existing floor.
- Timber panelling to mezzanine levels above stairs 1 and 2 are to be retained. Infill gaps on timber panelling by inserting new timber in the shape of pews fixing points where timber is recessed. Other minor fixing points to be filled with approved filler. Allow to polish entire panelling after infill works.

Fill cracks in flooring as scheduled with a fast setting filler suitable for that use and in colour to match background. Ensure existing cracks are free of loose and flaky material. Apply filler to crack with scraper or flat blade, smooth down and tool off to match existing flooring level. Provide samples and full technical data to heritage architect/consultant for approval before proceeding.

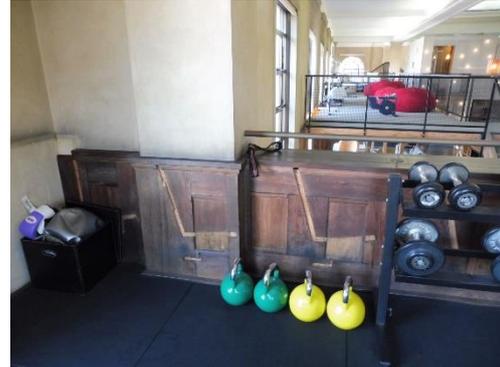
Figure 13 – Evidence of pews fixings to Mezzanine panelling above stair.

Where schedule to infill timber, insert new timber to fill existing aperture completely with only hair line joints. Aperture may not be enlarged or made square without the approval of the heritage architect/consultant.

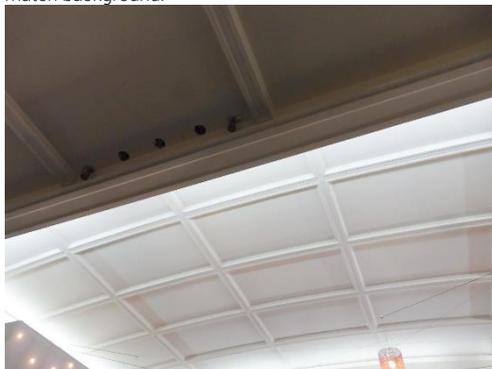
Figure 14 – Lights and lighting track above Auditorium Stage to be removed and ceiling and beam made good.

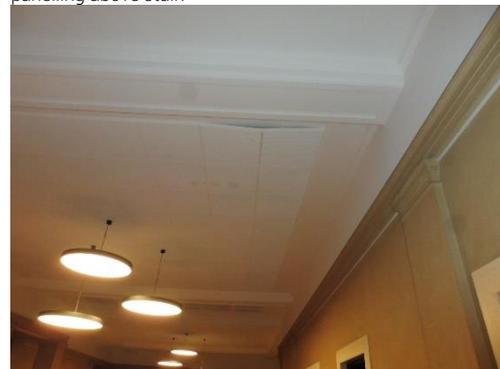
Figure 15 – Later ceiling to Entry Hall shown separating from original ceiling. Condition of ceiling above panels to be investigated during construction.

- Entry Hall floor and wall finishes to be retained. Check over floor tiles and repair as necessary and scheduled. Original ceiling is to be retained in place during construction. Ceiling condition below recent inserted panels to be investigated during construction in conjunction with heritage architect/consultant.

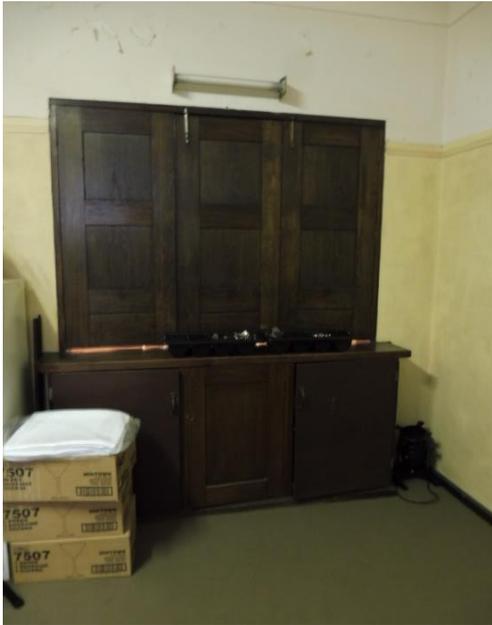
Figure 16 – Furniture below serveries to be retained, re-polished and made good.

- Two serveries to be retained, re-polished and made good, including furniture below sills in adjacent rooms G6 and G7.
- North Foyer will be extended to form new staircase and lift. Tiled flooring to be kept and conserved. Removed walls to be interpreted on the floor. Other ceiling, wall and floor finishes inside new room to be modern. Two doors to be retained and one door to be relocated to new wall.

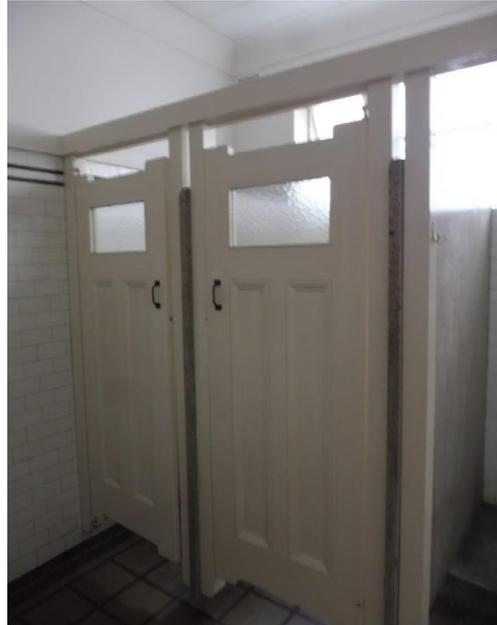
Figure 17 – Toilets partitions doors to be salvaged and reused whenever possible.

- All original or early doors including frames, windows including frames, partitions, panelling, furniture and other joinery noted to be removed are to be salvaged and reused whenever possible. Please consult heritage architect/consultant early in the construction phase to select items to be reused and/or kept.

Where joinery is scheduled to be salvaged and/or reused, carefully remove entire joinery as one piece whenever possible, or carefully take apart. All items must be carefully tagged noting original location.

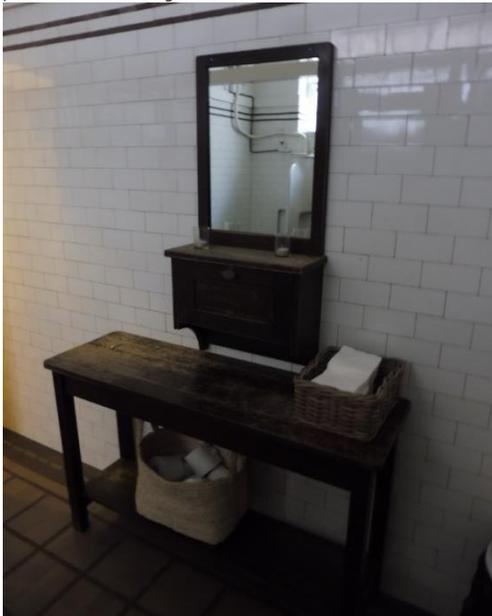
Figure 18 – Original furniture to be salvaged and reused.

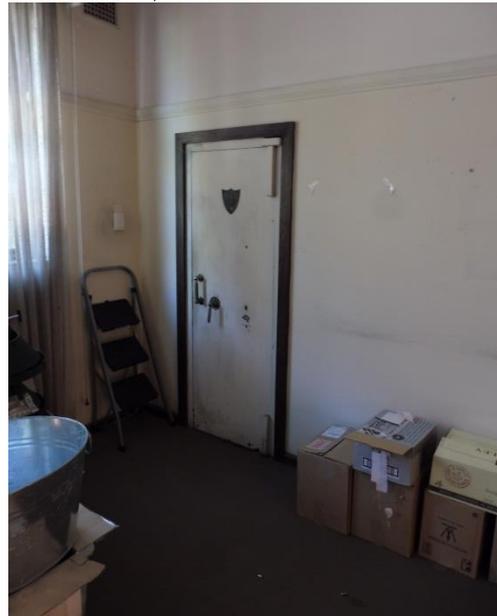
Figure 19 – Safe door to be retained.

- Retain safe door at its current location.

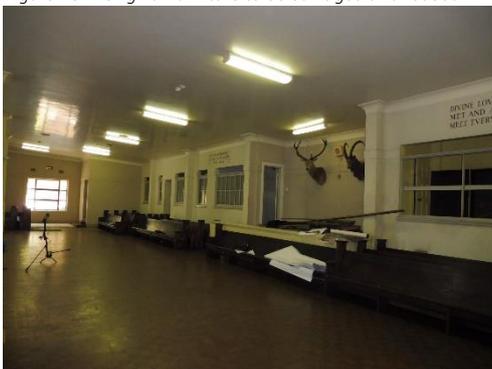
Figure 20 – Sunday School back wall to be reconstructed following car park works including reuse of glazed partitions.

- Sunday School back wall will be partially demolished to allow for car park construction. Keep demolition to a minimum and prop all other walls in accordance with structural engineers' details.
- If columns in this space require demolition, salvage timber panels for reuse following car park construction.
- Timber glazed partitions to be carefully dismantled as required for demolition and set aside for reuse during reconstruction of the room.
- Demolished walls to be reconstructed to current configuration following car park construction. All finishes and detailing to match existing. Allow to reconstruct missing timber glazed partitions to match existing.

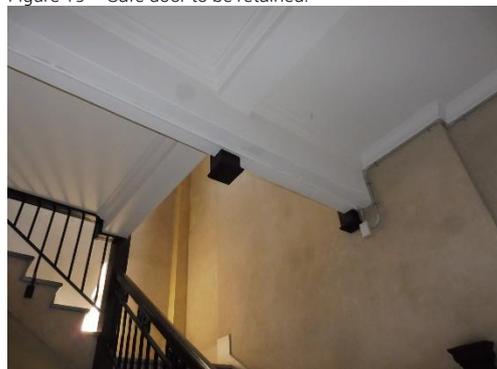
Figure 21 – Tidy up all visible services whenever possible.

- Remove unused services lines and tidy up used lines as much as possible and make good at previous fixings. (exception – all original organ related services to be kept even if found redundant)
