**Capitol Theatre Conservation Management  
Plan prepared by Urbis Pty Ltd**

# **CONSERVATION MANAGEMENT PLAN**

**CAPITOL THEATRE,  
HAYMARKET**

**3-21 CAMPBELL STREET,  
HAYMARKET**

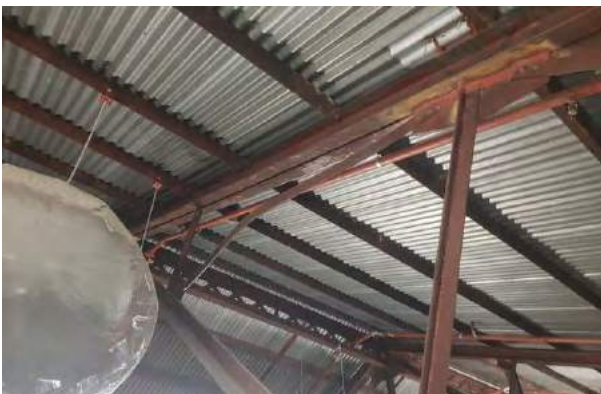
- Buckled flat truss chord members (Figure 158). It is uncertain when this failure occurred and could be caused by the cutting and rewelding of the truss members.

Figure 158 – Buckled truss chord in original theatre roof  
Source: Mott MacDonald

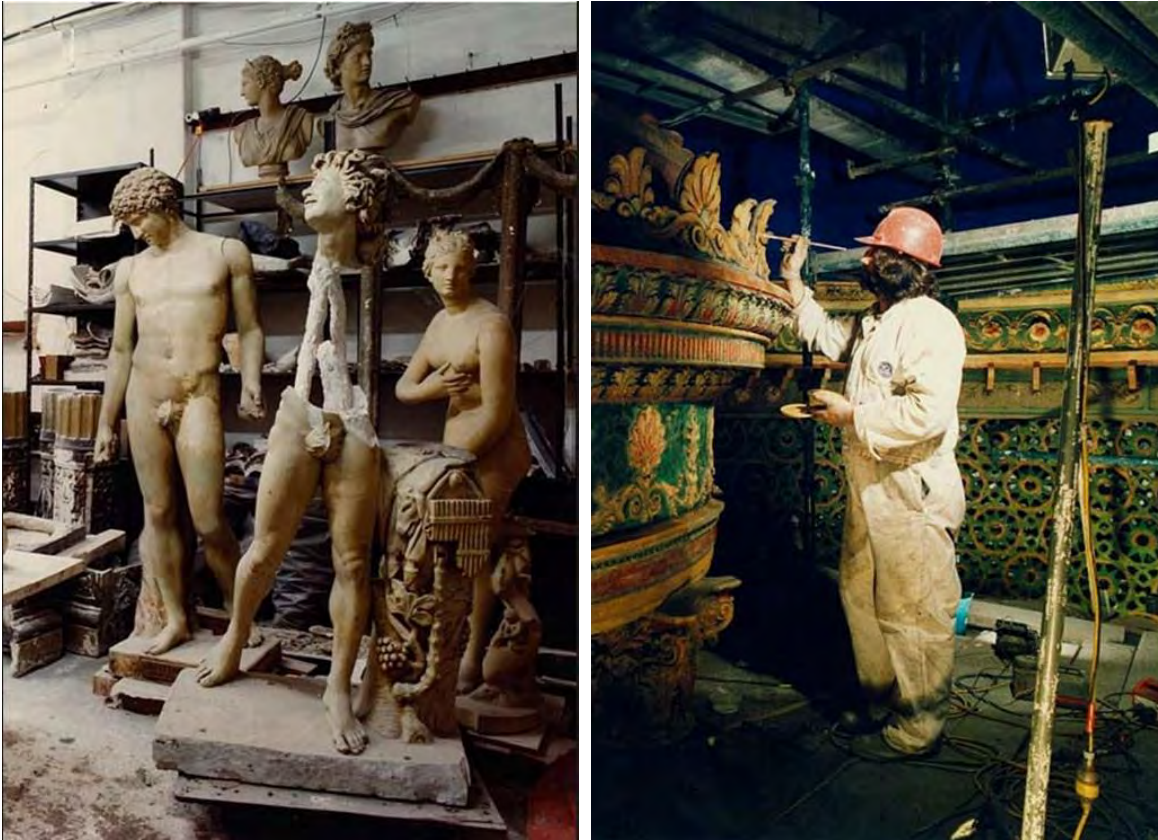
Figure 225 – Restoration work in progress at Capitol Theatre. One left: statues were repaired and recast based on replicas from other theatres (1994). On right: an artist at work during restoration (1994).

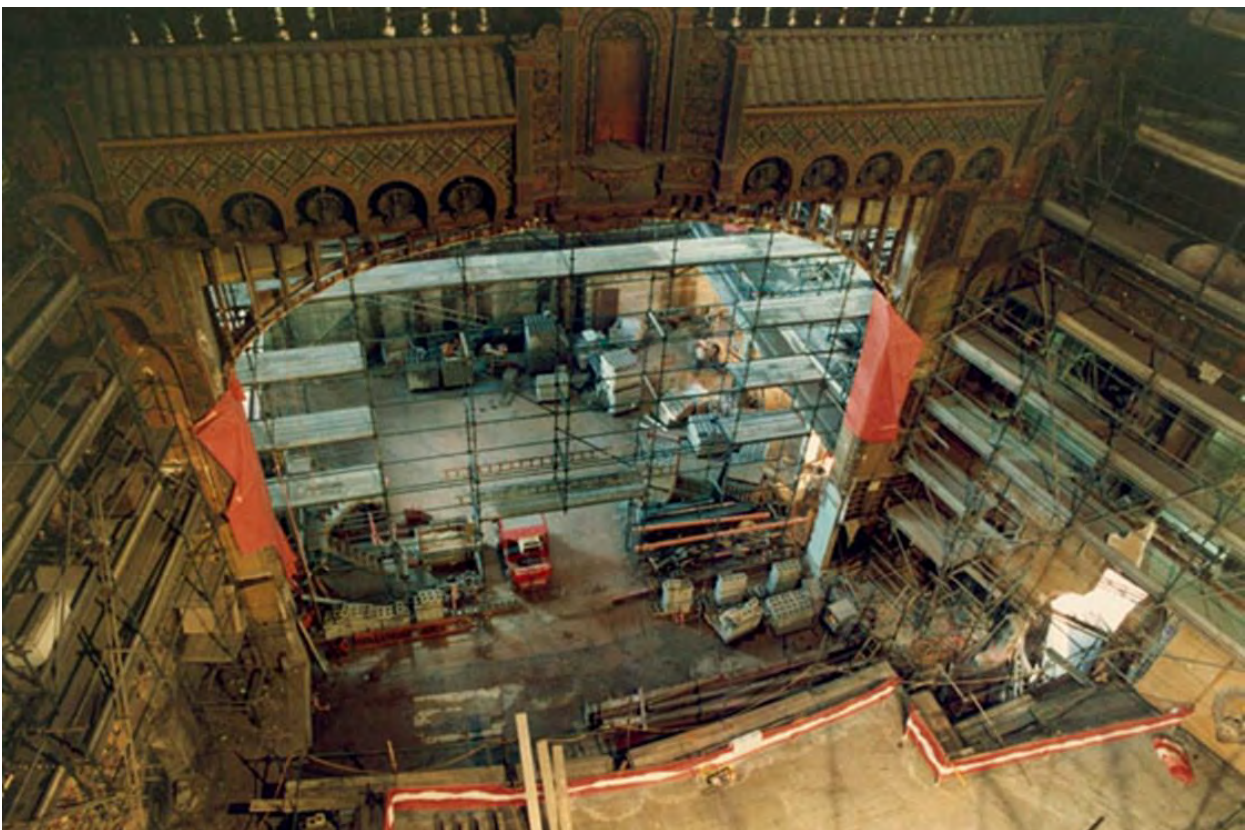
Figure 228 – Old stage and mechanics were replaced with modern theatre facilities during restoration, 1994.

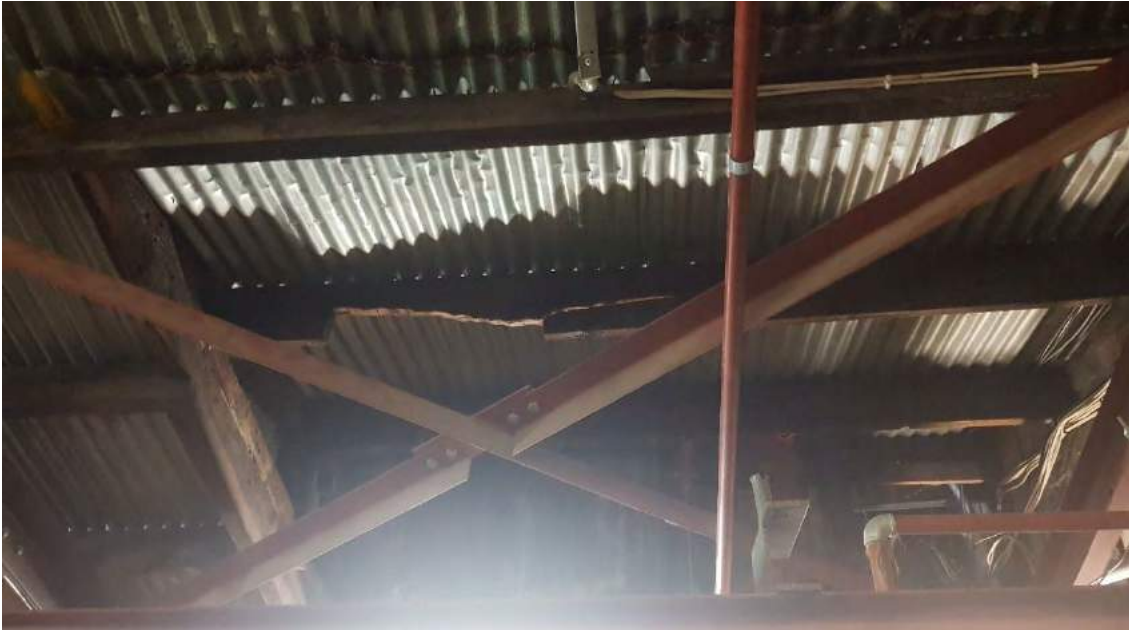
**Figure 2: Original Theatre Roof – Timber Purlin Damage**

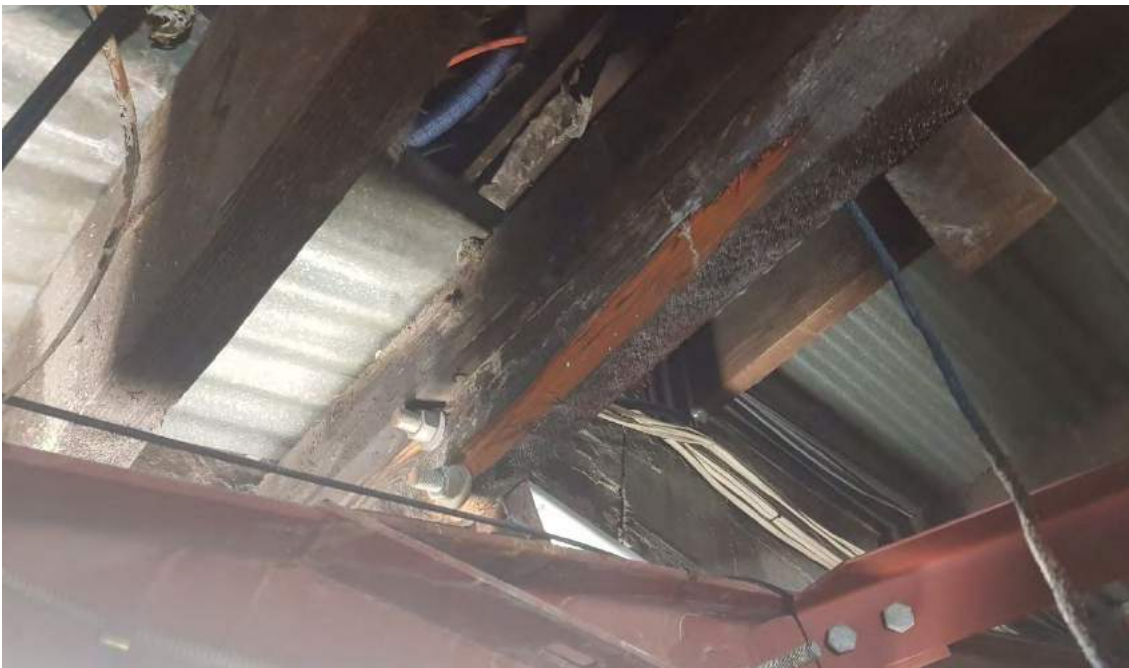
- Minor defects throughout the roof structure include:
  - Timber purlin damage. These defects are low risk as the timber roofing is only supporting the weight of the corrugated sheeting and services above;

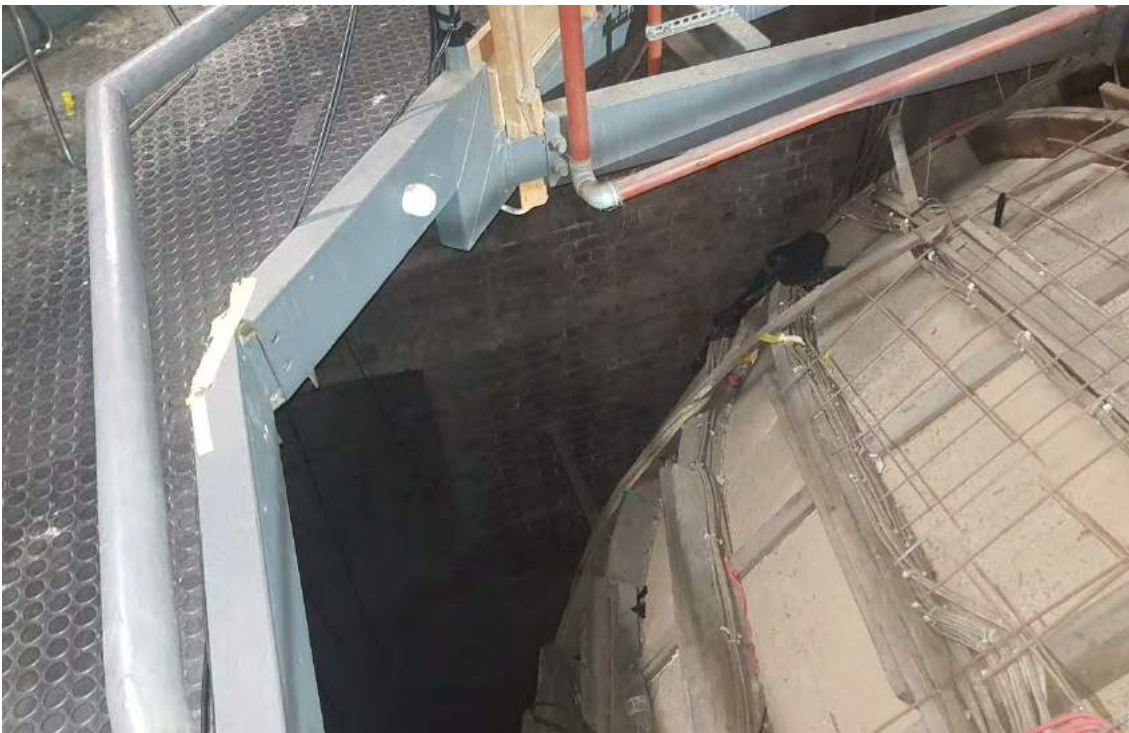
**Figure 28: Roof Access Structure – Missing Bolts**

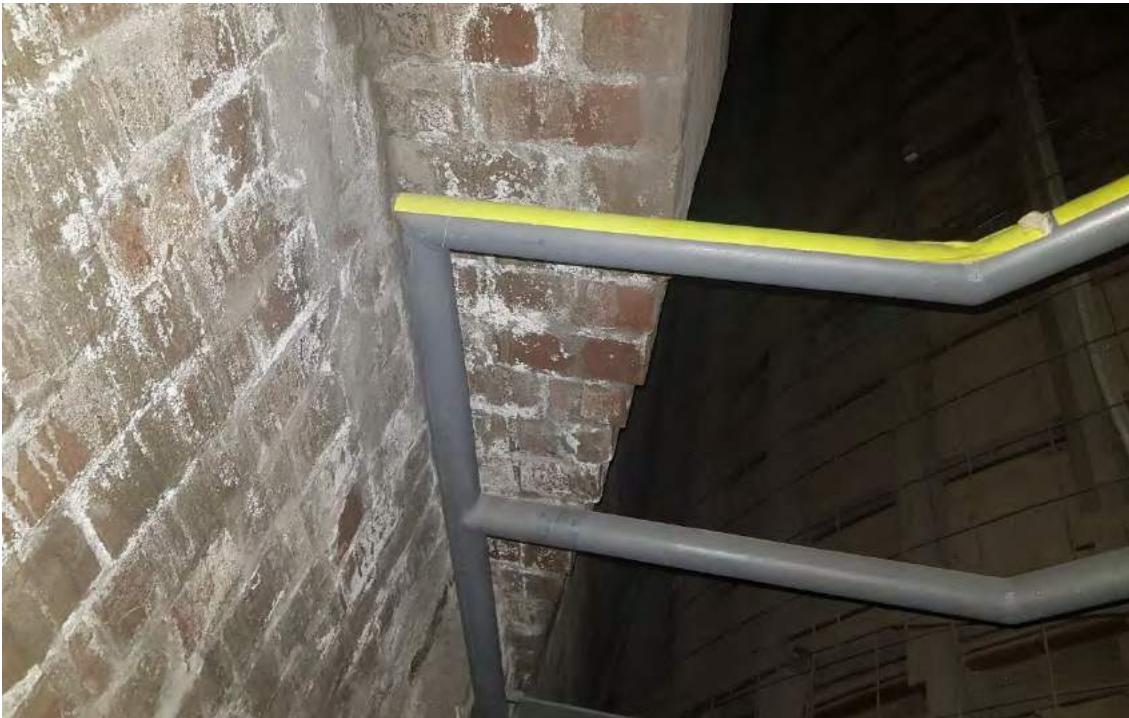
**Figure 29: Roof Access Structure – Wobbly Balustrade**

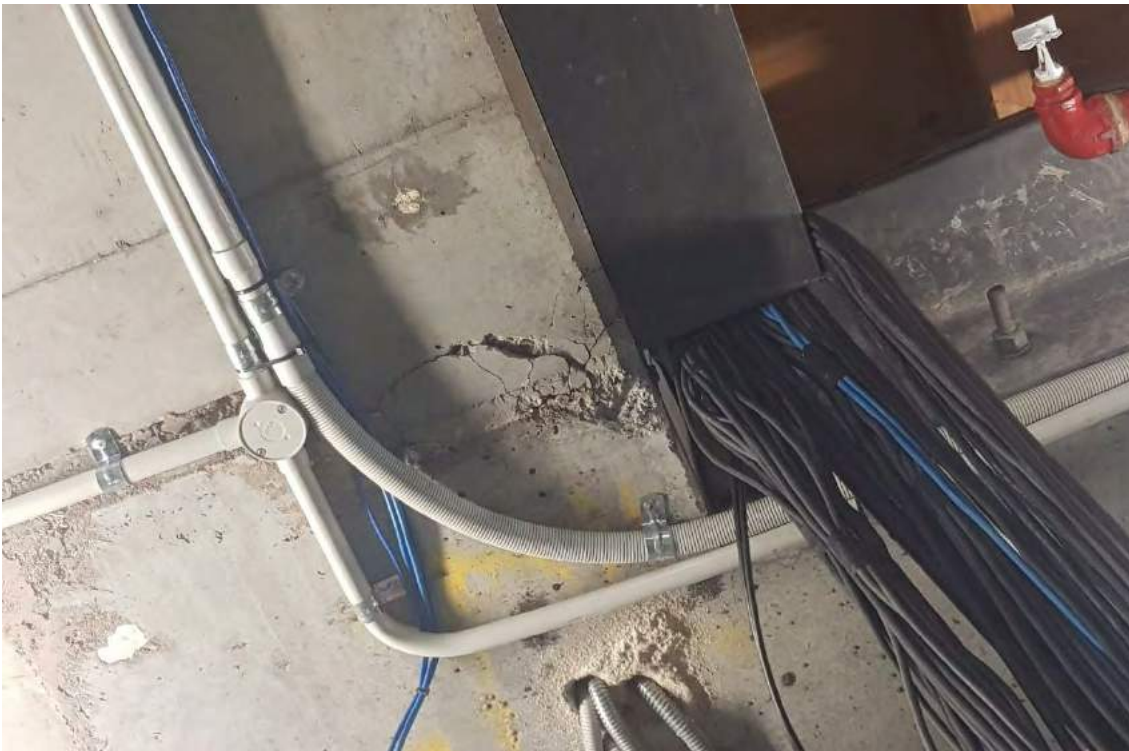
**Figure 30: Minor Cracking – Underside of New Concrete Slab**

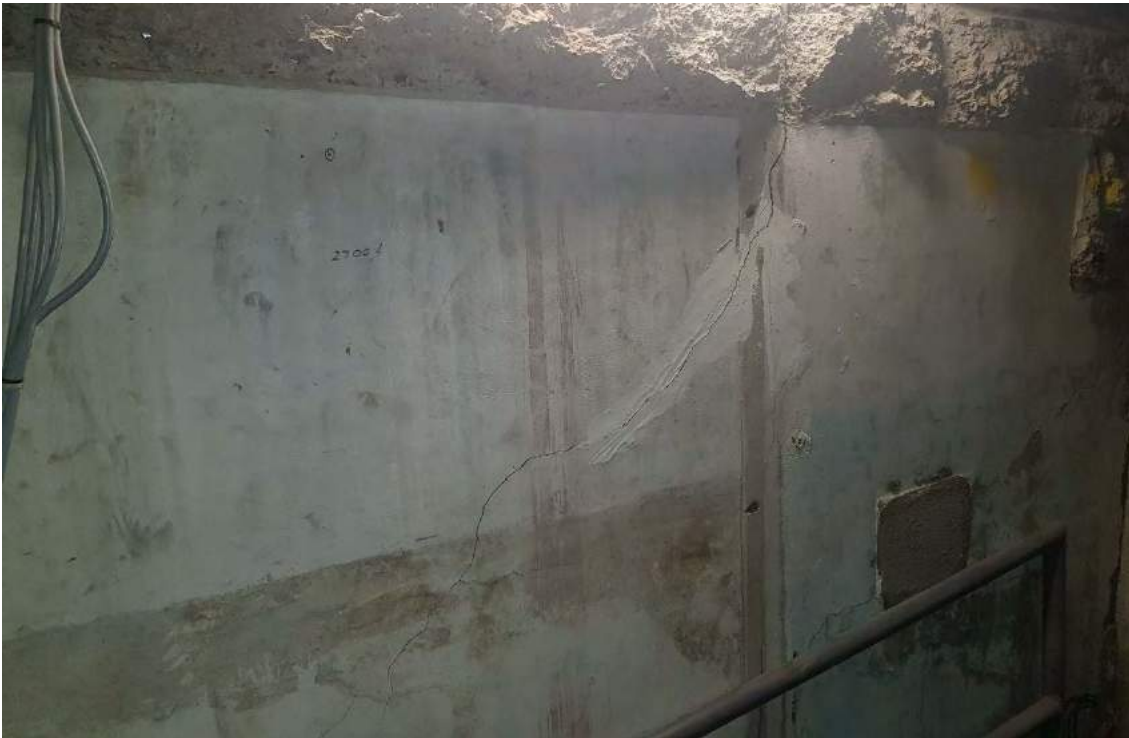
**Figure 31: Minor Cracking – Diagonal Crack in the Cement Rendered Masonry Wall**

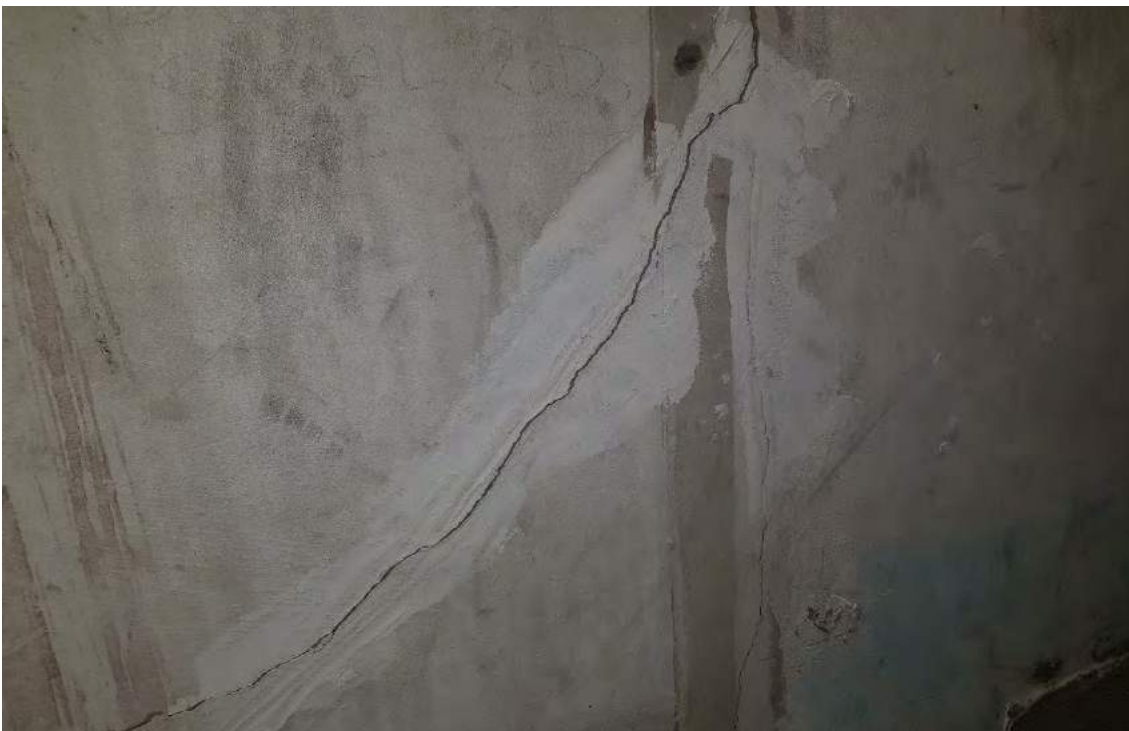
**Figure 32: Minor Cracking – Close up of Cement Rendered Masonry Wall Crack**

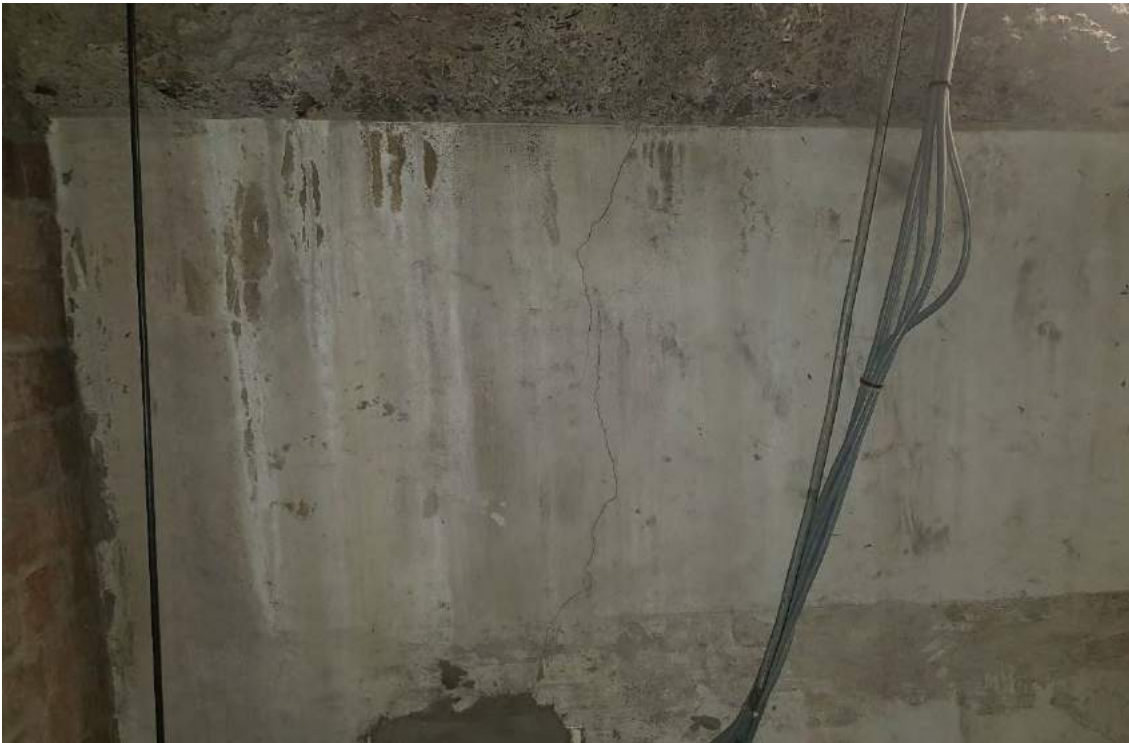
**Figure 33: Minor Cracking – Cement Rendered Masonry Wall Crack**

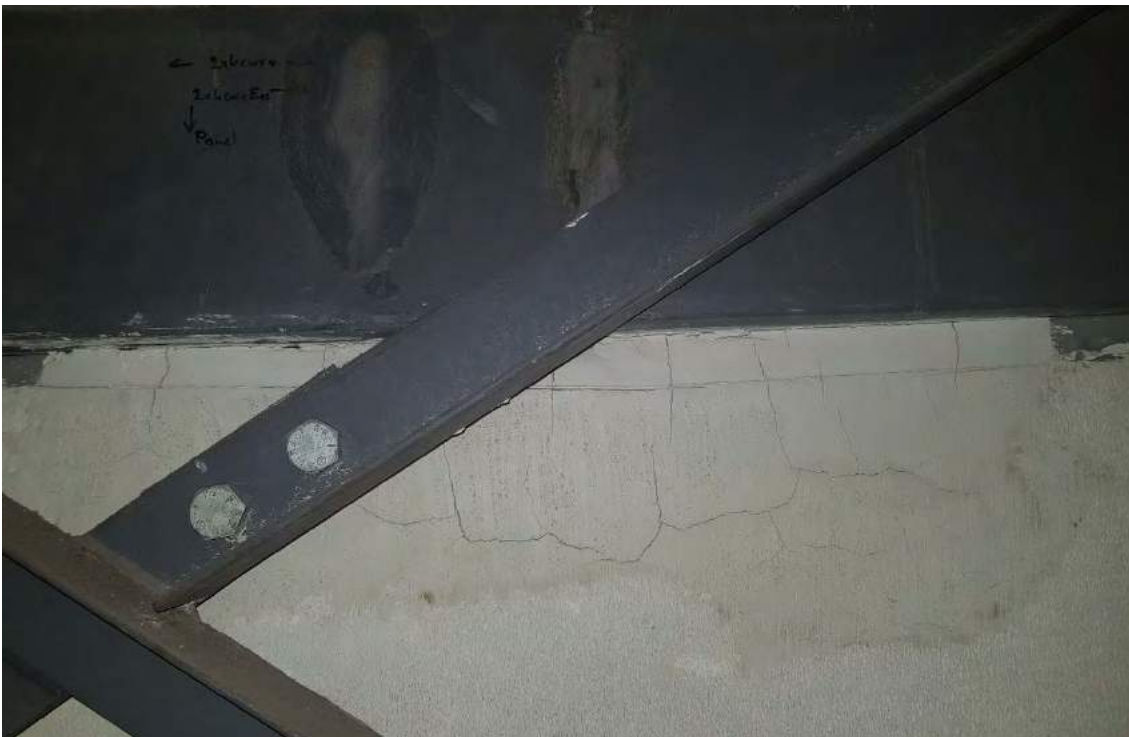
**Figure 34: Minor Cracking – Crushing of Pre-Cast Panel below Steel Member**

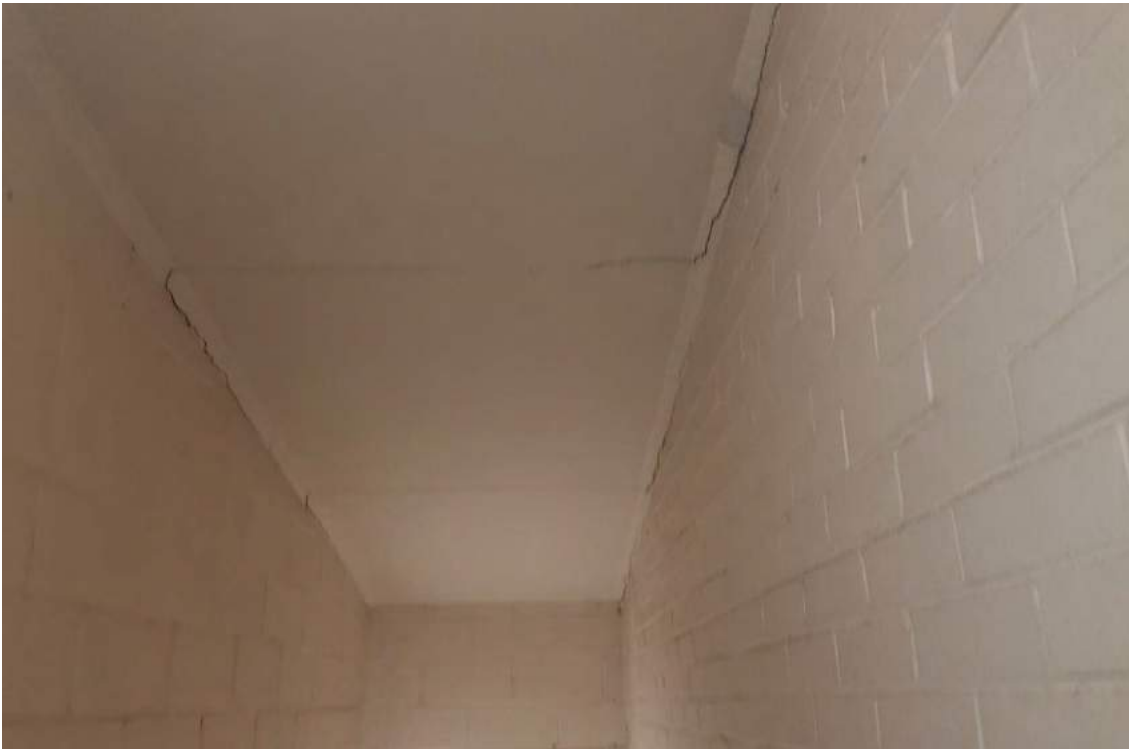
**Figure 35: Minor Cracking – Stairwell Roof**

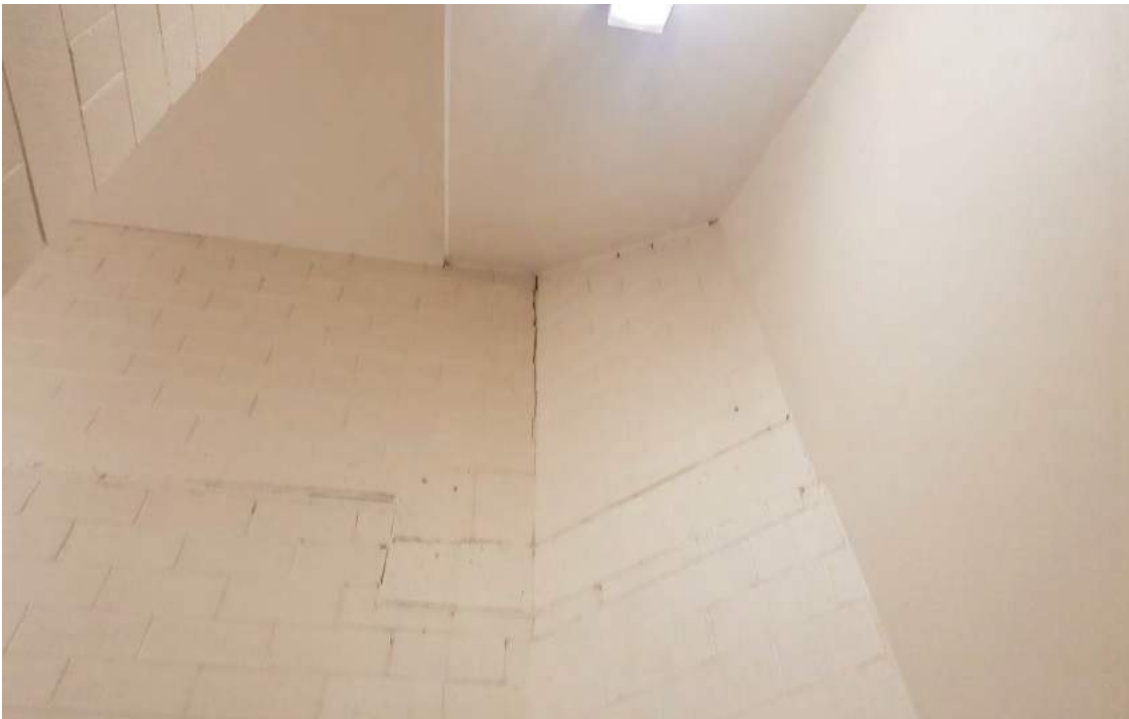
**Figure 36: Minor Cracking – Stairwell Wall**

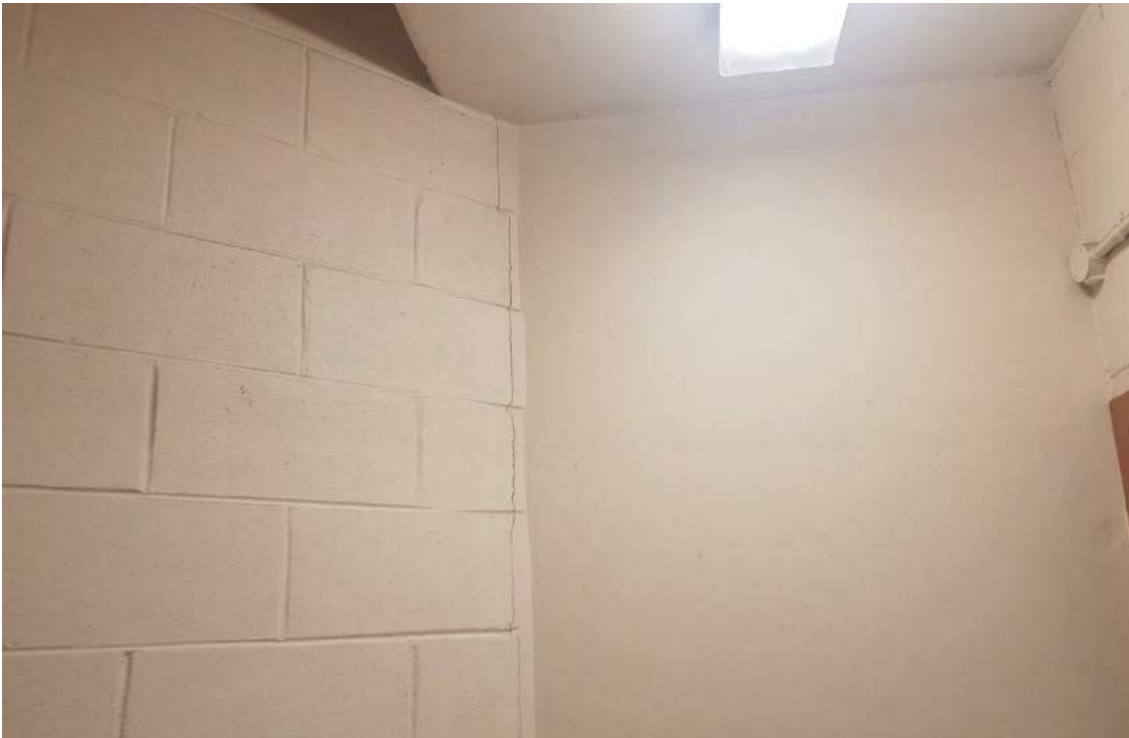
**Figure 37: Minor Cracking – Stairwell Wall**
