arboricultural impact assessment report

AIA-01

Revision A, Issued for Planning Proposal
13 May, 2020

GLEBE MID-RISE PROJECT

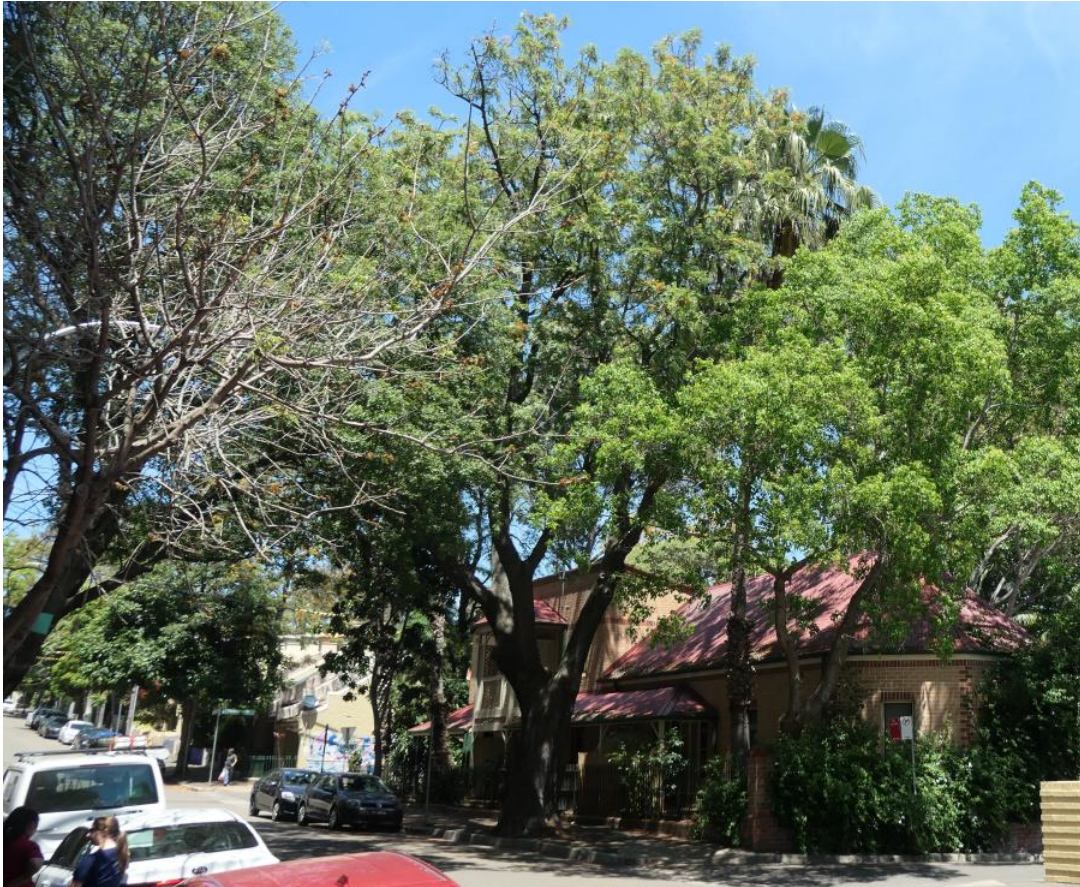
Figure 2 – Typical photo of the site and conditions. Many of the existing trees are located around the periphery of the site or on the adjoining street. There is a small group of trees located in the central courtyard of the southern buildings. View is to the west from Cowper Street with T13 *Grevillea robusta* to the centre of the frame. (Photo: Arterra 11/11/19)

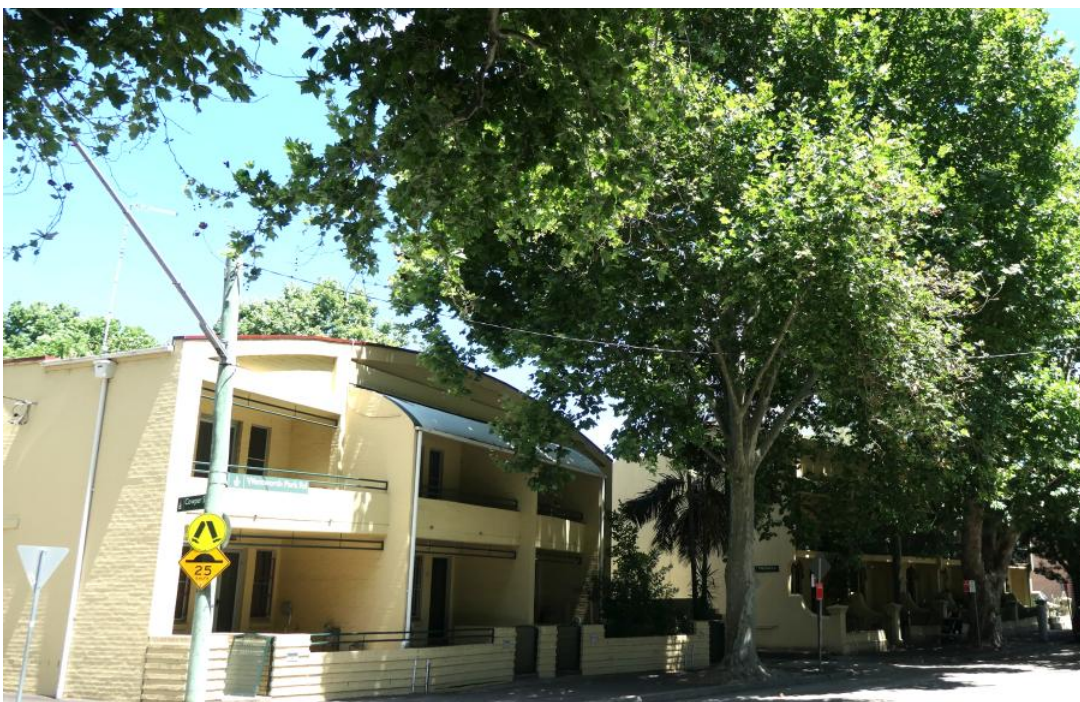
Figure 3 – 2 Wentworth Park Road. Note *Platanus x acerifolia* (London Plane Tree) street tree (T01). (Image: Arterra, Nov. 2019)

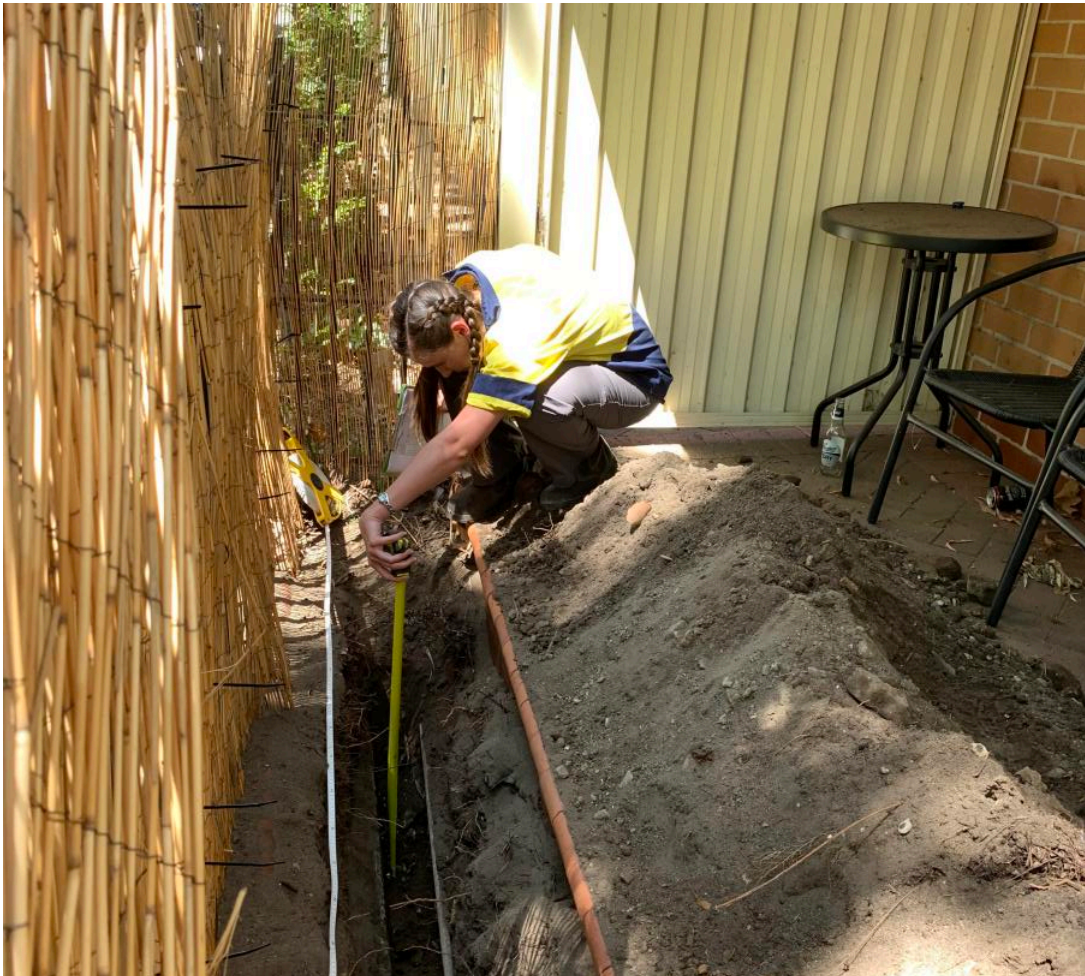
- No roots from T13 *Grevillea robusta* (Silky Oak) CoS street tree, were encountered in the exploratory trench to a depth of 600mm on the western side of the site boundary wall.

Figure 5 – Consulting arborist measuring the depth of the exploratory trench. (Photo Arterra 21.01.20)

Based on the above, it is our conclusion that no major roots from the street tree, (T13) *Grevillea robusta* (Silky Oak), remain or were encountered within the exploratory trench immediately inside the site boundary wall. The trench was excavated to a depth of 600mm for a distance of 4.5m along the boundary immediately adjacent to the subject tree. We therefore believe that excavation within the site can be undertaken for the proposed building with minimal impact to the tree. The required setback of the building has therefore been set to primarily limit the required pruning of the canopy that overhangs the site to acceptable levels. No root impacts are expected to this tree as part of the works.

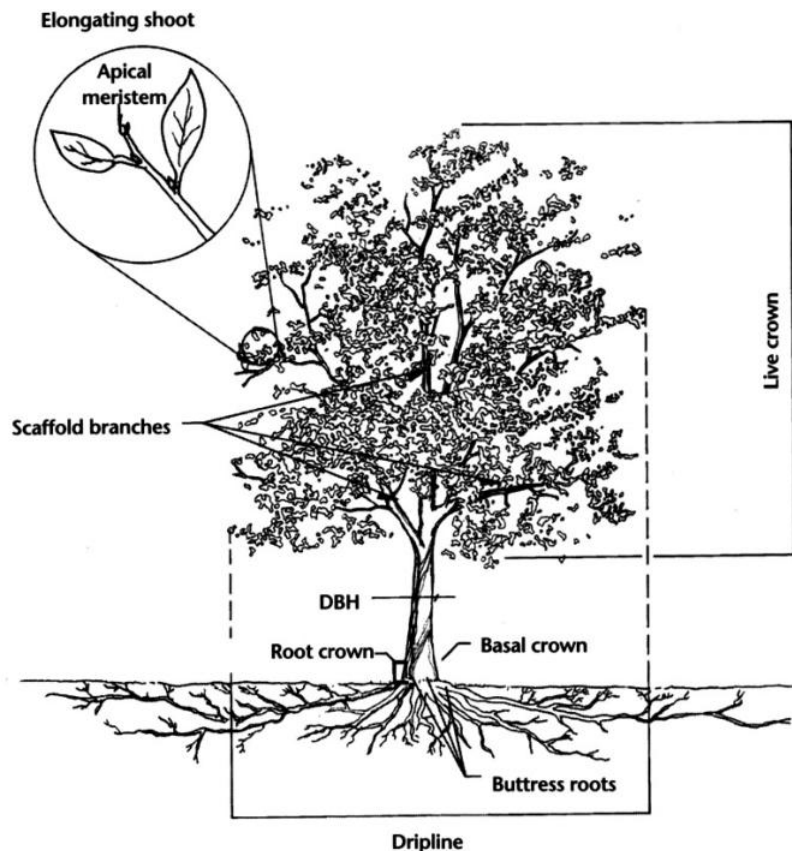
Figure 6 – Typical form and structure of a tree illustrating the typical form, location and extent of root growth (Source: Matheny and Clark, 1998)

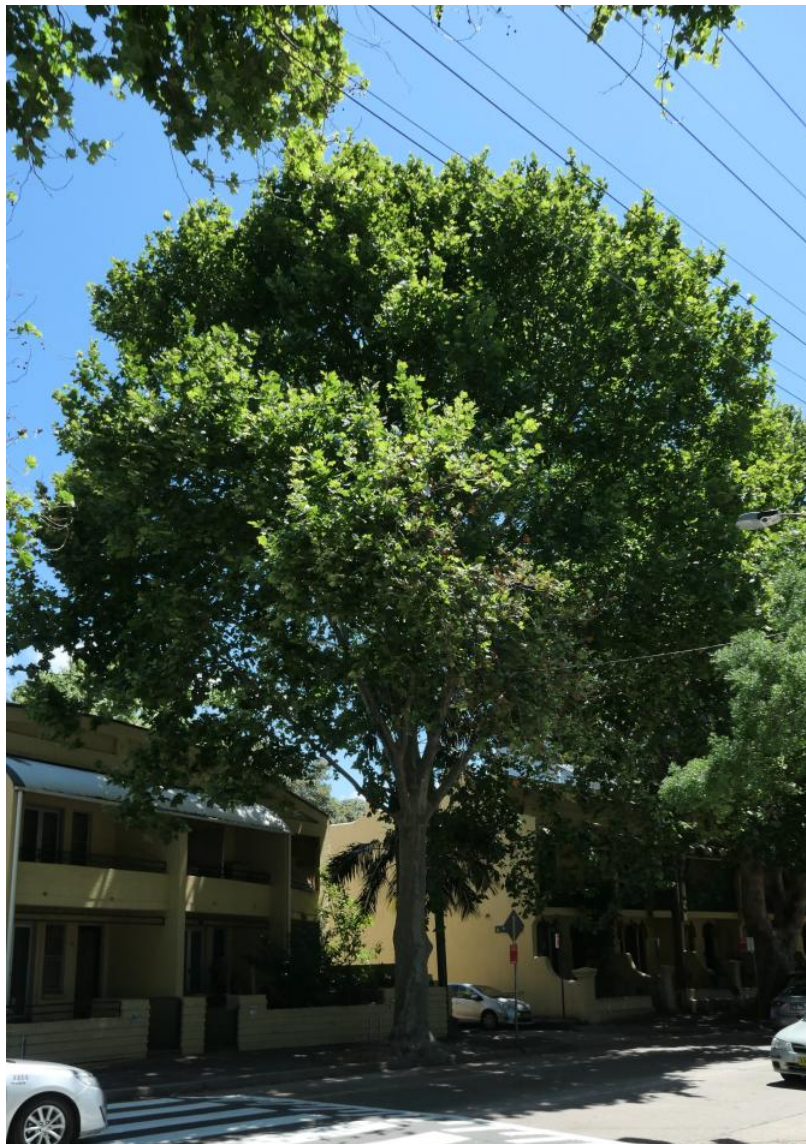
The proposed development is likely to result in an incursion from the pruning required to provide clearance to the tree for the construction of the upper levels of the building facing Wentworth Park Road. The proposed construction of the building has been set back to accommodate this tree. It has been calculated that the removal of roots to the southern side of the tree represents an incursion of approximately 7% of the nominal TPZ. According to AS4970-2009 this is considered a minor incursion and unlikely to adversely affect the condition of the tree in the longer-term. It is proposed that the existing structures between the proposed building and the tree will be carefully demolished and any roots existing below these structures will be retained and protected. It is the author's opinion that the proposed new structures to achieve access and landscaping in front of the proposed building can be built in a way to minimise the loss or damage of the existing roots.

Figure 7 – T01 - A large and prominent *Platanus x acerifolia* (London Plane Tree) – Street tree adjacent to 2 Wentworth Park Road.

Some canopy pruning will be required to the southern side of the tree to accommodate the new building and clearance for construction period scaffolding. This pruning is considered acceptable and is dealt with more specifically in **Section 3.2 - Canopy Pruning and Methodology**.

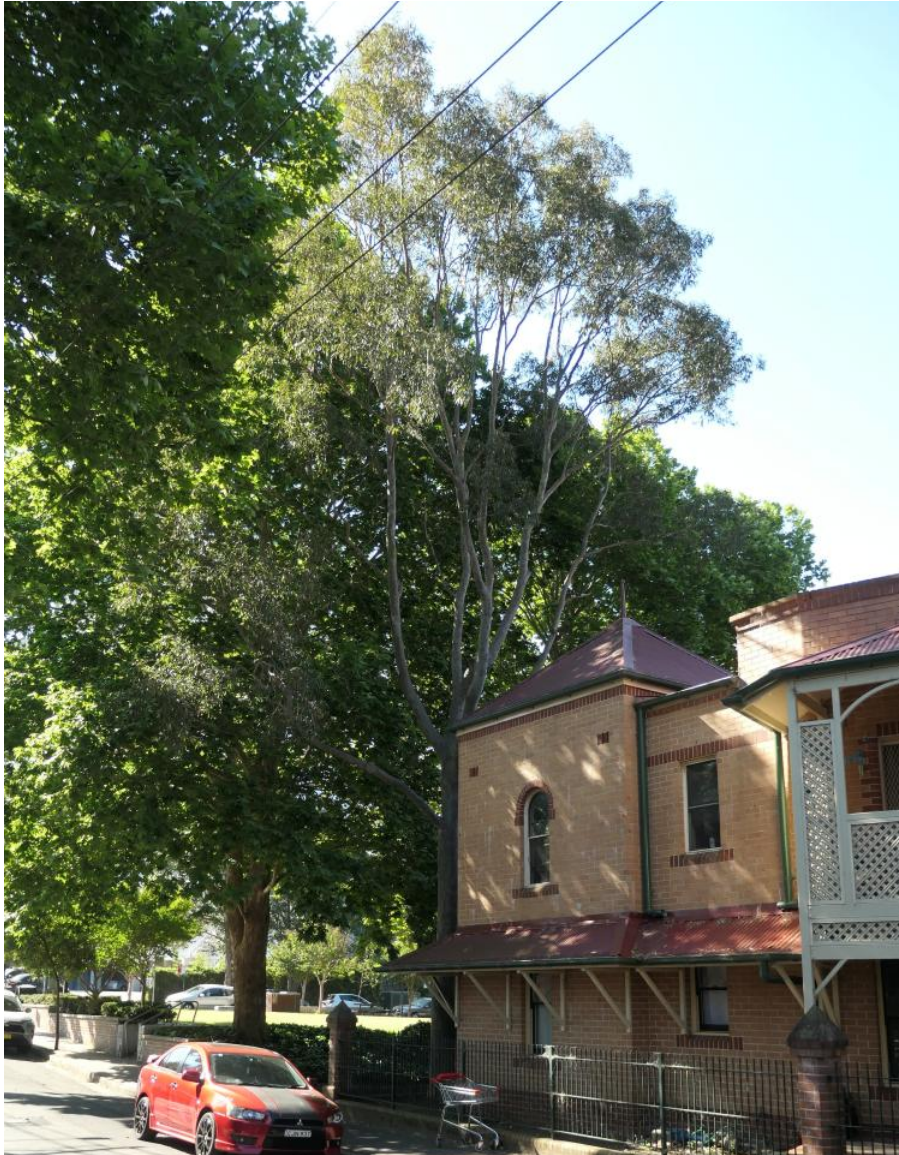
surface levels in an area that is already largely impacted by the pre-existing buildings (to be demolished). It is the author's opinion that this can be constructed with minimal impact to the tree if appropriate construction period measures are put in place and no excavation takes place in this area apart from supporting piles. The high branching nature of this tree means that the existing canopy and branches can be retained without the need for any pruning.

Figure 8 – T06 - A *Corymbia maculata* (Spotted Gum) on the site in the south-west corner.

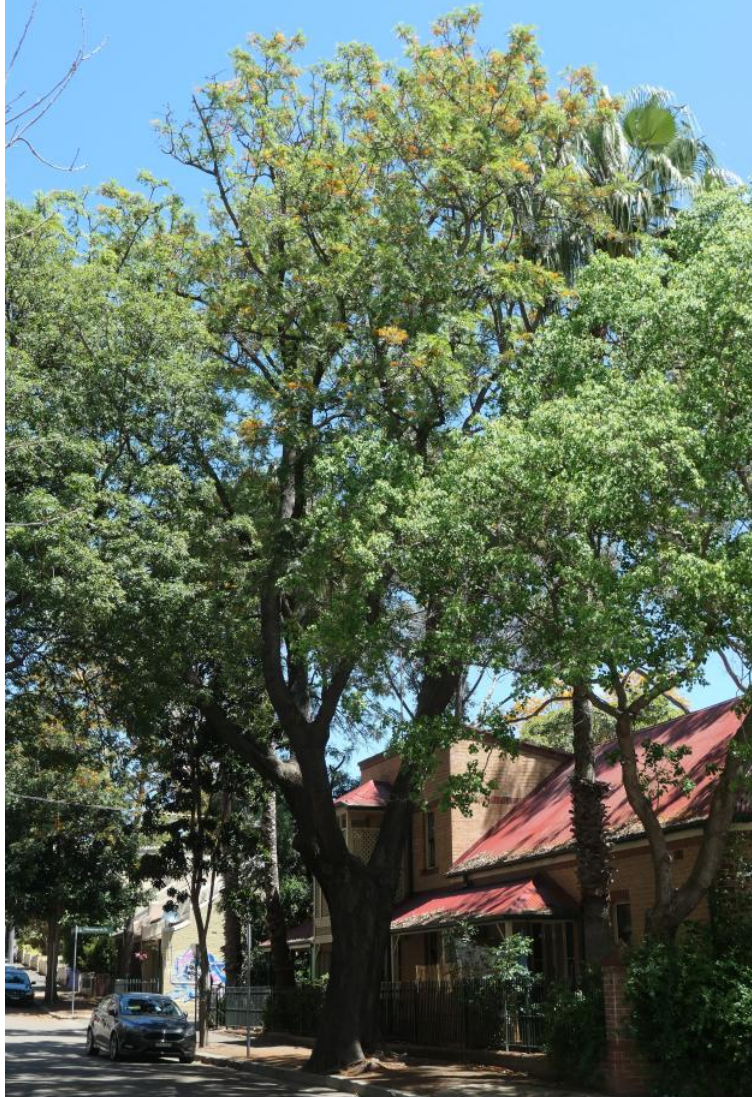
T13 – *Grevillea robusta* (Silky Oak). This is a very large street tree located on the eastern side of the proposed development. It is 18m tall with a canopy spread of 14m. It has a significant main branch crossing the eastern boundary at approximately 9.0m in height above the footpath level. This tree also forms part of the heritage listed group of street trees along Cowper Street, which include *Grevillea robusta* (Silky Oak), *Flindersia australis* (Australian Teak) and *Castanospermum australe* (Moreton Bay Chestnut) species. This results in this tree having greater significance in the landscape and should therefore be retained as part of the development. Though the tree is heritage listed, due to the tree being a less than desirable and somewhat invasive species and an older specimen with some defects it has been given only a 'Moderate' retention value.

Though basement excavations may not cause significant impact to the tree or restrict development at the ground level, it is still important to consider the extent of the proposed development above ground with respect to the existing canopy which overhangs the site to the west. This has constrained the building setback and extent of development on the eastern side of the site. Major pruning works that would remove substantial foliage or branches and make the tree lop-sided would not be supported by the Council.

Figure 9 – View from Cowper Street looking at 'High' retention value tree – T13 Grevillea robusta with proposed development site beyond to the right. (Photo: Arterra 05/11/19)

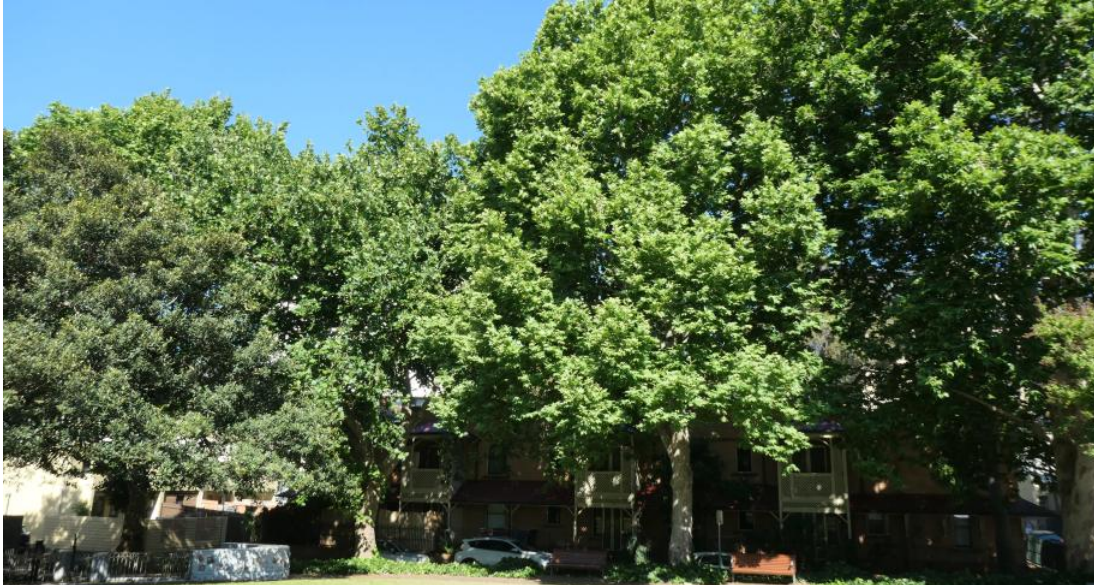
T02, T03, T04 & T05 – *Platanus x acerifolia* (London Plane). This is a row of four very visually and environmentally significant trees. These trees are situated to the west of the site, within the adjoining MJ Doherty Reserve and adjoining Mitchell Lane. These trees have been rated with a 'High' retention value. They have relatively large spreading canopies that extend over Mitchell Lane and are within close proximity to the site. These 'High' value trees provide good landscape amenity and serve to screen and soften any proposed development from the adjoining reserve and will provide a level of 'instant landscape' to any proposed building setting. Being large and deciduous trees they also provide excellent summer shade together with winter sun to the reserve and the development site. It is our assessment that these trees will have minimal to no impact from the proposed development.

Figure 10 – View to the east from MJ Doherty Reserve looking at ‘High’ retention value trees - T02, T03, T04 & T05 *Platanus x acerifolia* with proposed development site beyond. (Photo: Arterra 23/10/19)

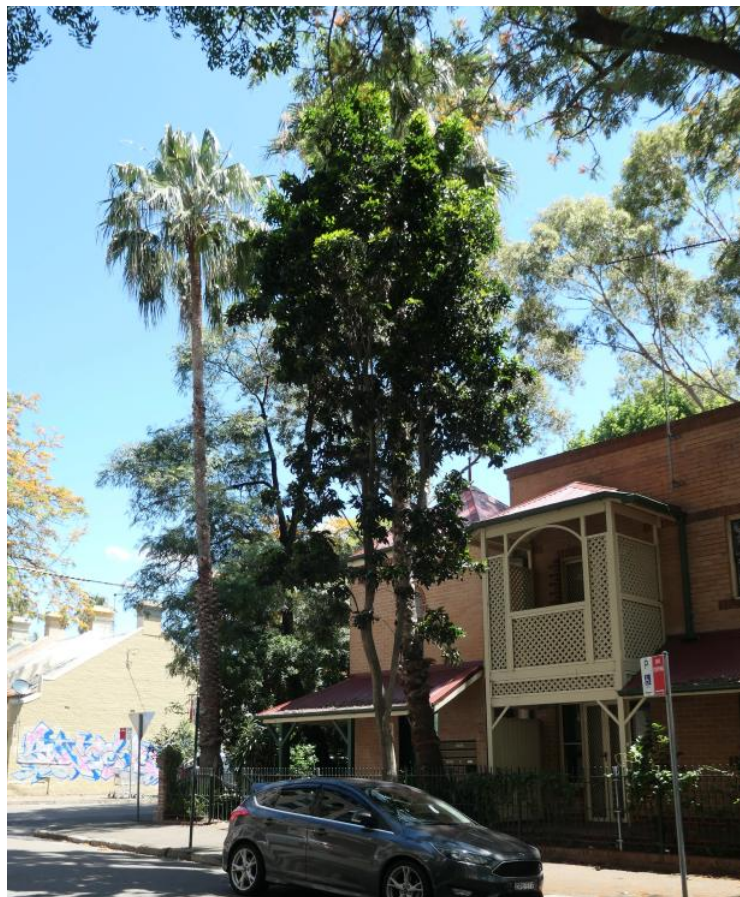
The other remaining ‘High’ value tree is a street tree T14 *Stenocarpus sinuatus* (Queensland Firewheel Tree). This tree ties in with two others, T15 & T16 of the same species which are of ‘Moderate’ retention value. The moderate value trees are smaller more recently planted specimens. This species are nominated as the preferred tree species in the current CoS’s Street Tree Master Plan for Cowper Street. They should be retained and protected.

Figure 11 – View from Cowper Street looking at ‘High’ retention value tree – T14 *Stenocarpus sinuatus* with proposed development site beyond. (Photo: Arterra 05/11/19)

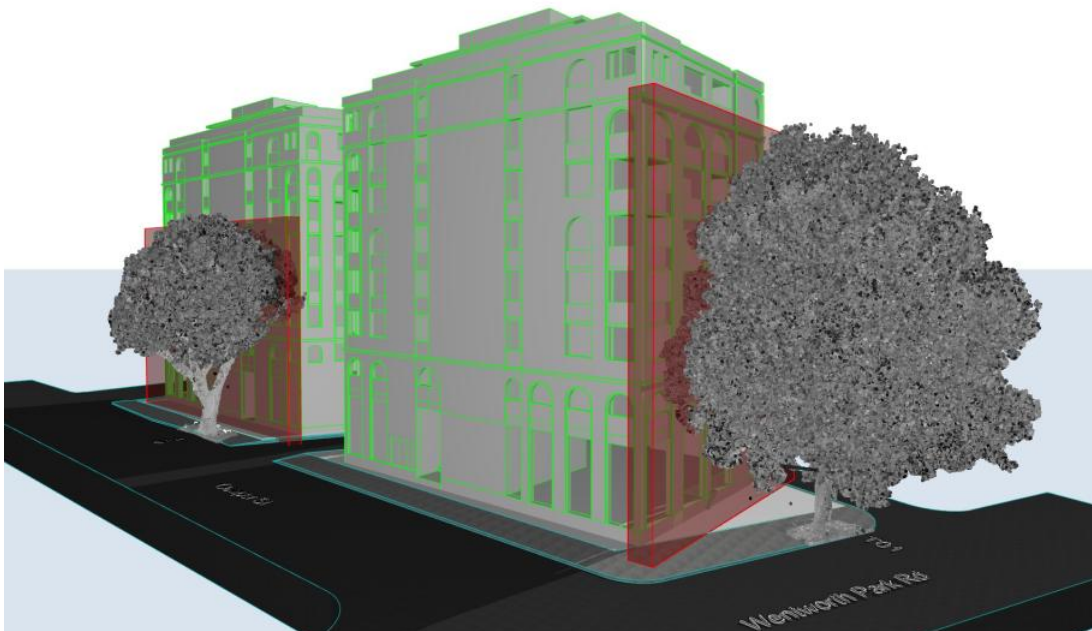
Figure 12 – View of 3D computer model of building and point cloud data obtained for trees – T01 to the right and T13 on Cowper Street to the left. Red zone indicates scaffold cut line. (Image Source: Arterra)

As shown in T-03 Canopy Pruning Plan (Appendix 4.3) the proposed line of the buildings have been set back from the boundaries to facilitate retention of the large adjoining street trees. To facilitate the construction of the building, a scaffold will need to be erected around its perimeter. It is assumed that a 2.0m wide frame will be used. These constraints still result in some impacts to the existing canopy and will result in the removal of some branches and foliage.

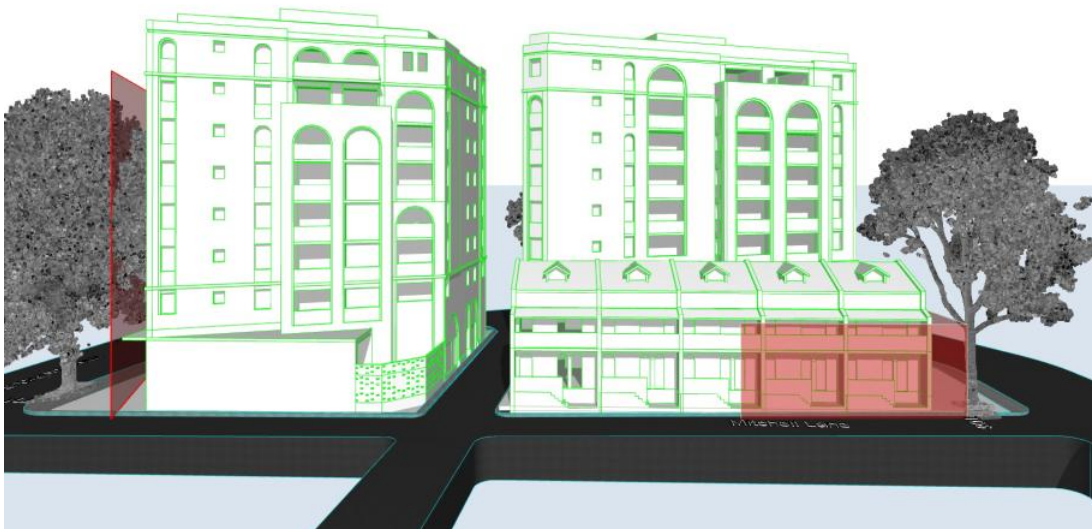
Figure 13 – View of 3D computer model of building and point cloud data obtained for trees – T01 to the left and T06 on the site to the right. Red zone indicates scaffold cut line. Note that the habit and foliage of T06 are well clear of terraces and should not require any pruning. (Image Source: Arterra)

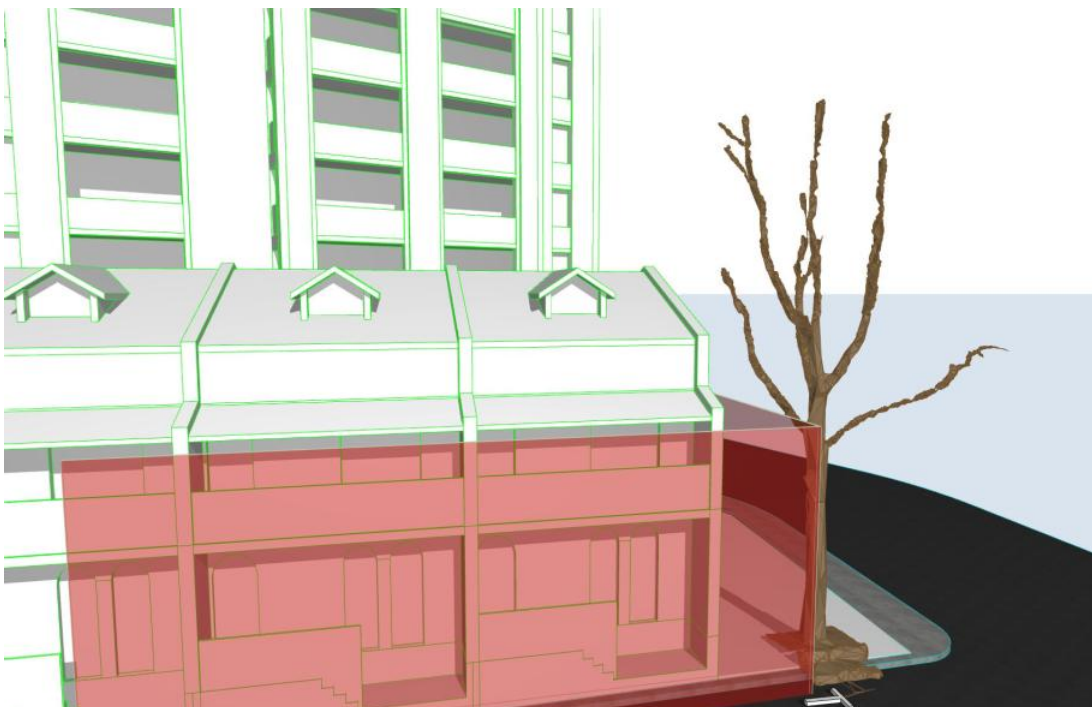
Figure 14 – View of 3D computer model of building and data obtained for trees stripped down to the major branches for T06. Red line/zone indicates scaffold cut line. Note that the majority of main branches are well clear of proposed building and should not require any pruning. (Image Source: Arterra)

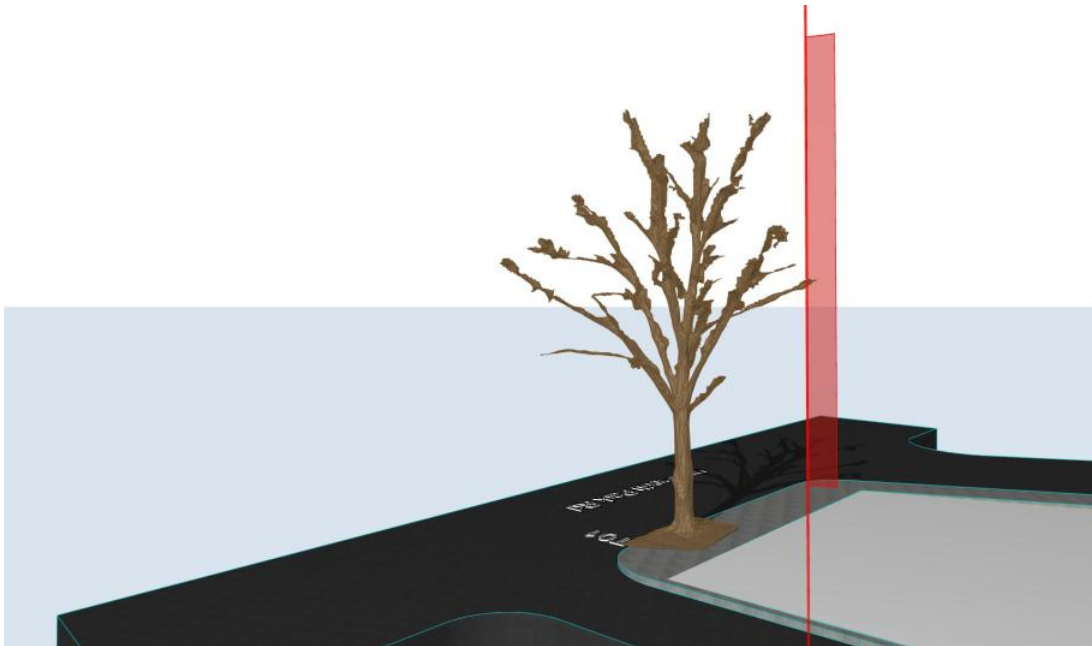
Figure 15 – View of 3D computer model of building and data obtained for trees stripped down to the major branches for T01. Red line/zone indicates scaffold cut line. Note that the majority of main branches are well clear and should not require any major pruning. (Image Source: Arterra)

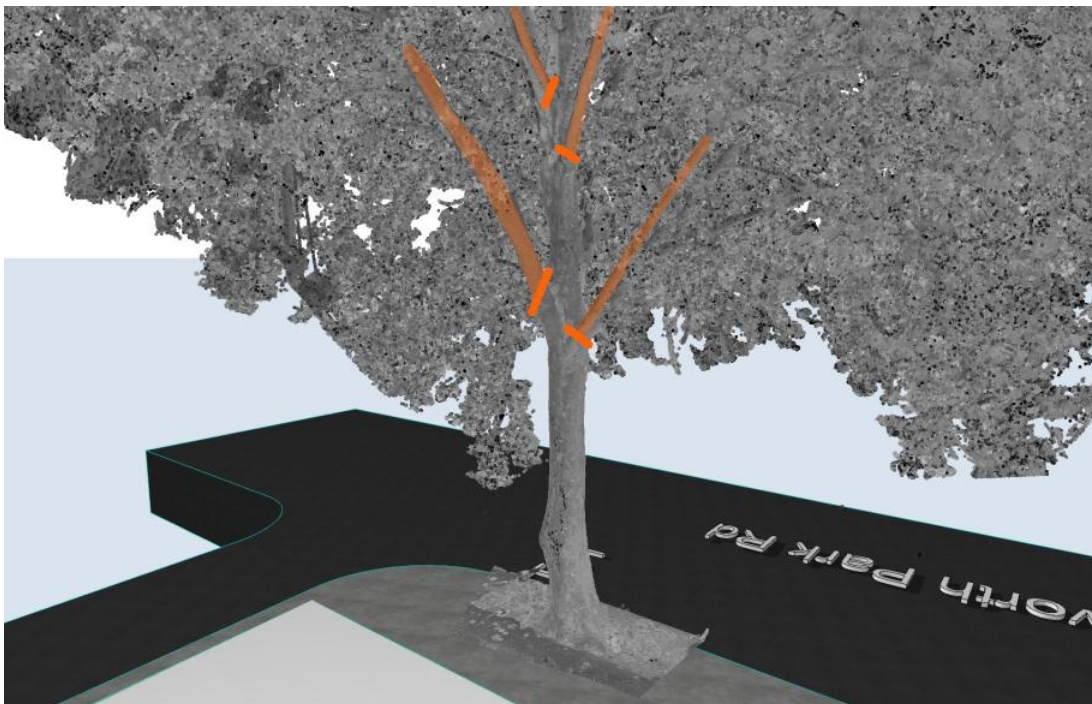
Figure 16 – View of 3D computer model of T01 point cloud data obtained for the tree. Viewed from inside site looking north. Diagram indicates the proposed branches and proposed line of pruning to be undertaken to achieve appropriate clearance for building and scaffold. (Image Source: Arterra)

Branch Qty and Size at Cut	Comment / Notes
1 x 150mm	Lowest branch to southern side of tree taken back to trunk
1 x 100mm	Mid canopy to southern side of tree taken back to trunk
1 x 100mm	To south-eastern side of tree taken back to trunk
1 x 75mm	Lowest branch to south-eastern side of tree taken back to trunk
3 x <50mm	Various small branchlets in upper canopy taken back to nearest appropriate junction

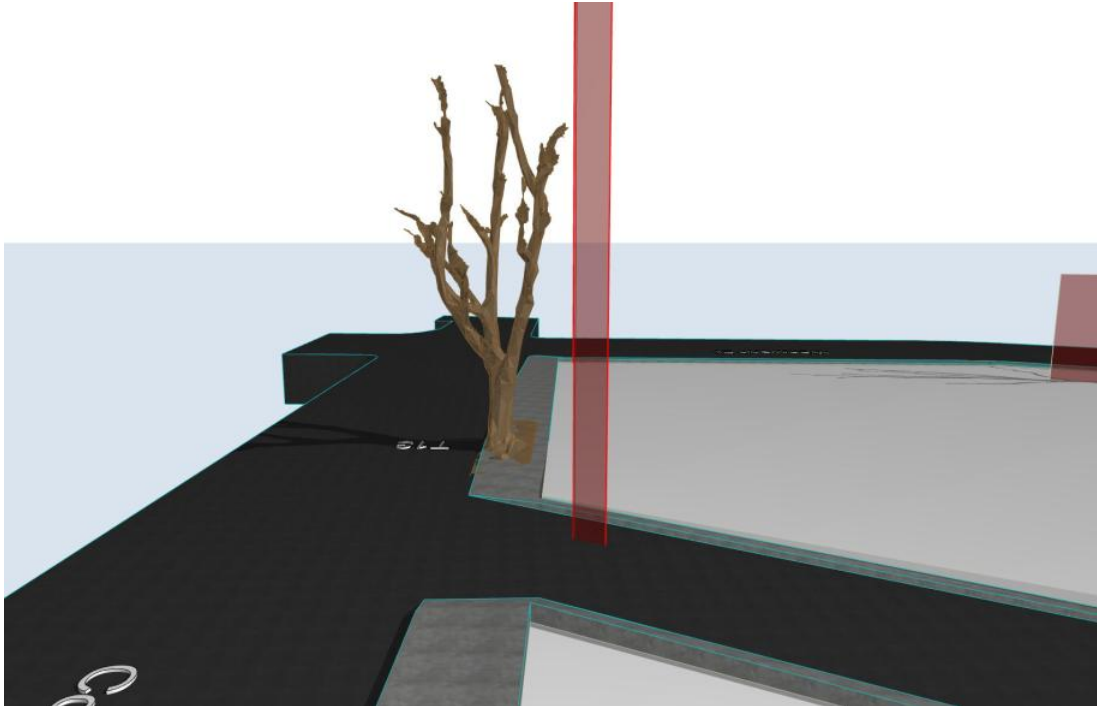
Figure 17 – View of 3D computer model of data obtained for trees stripped down to the major branches for T13. Red line/zone indicates scaffold cut line. Note that all main branches are well clear and should not require any major pruning. (Image Source: Arterra)

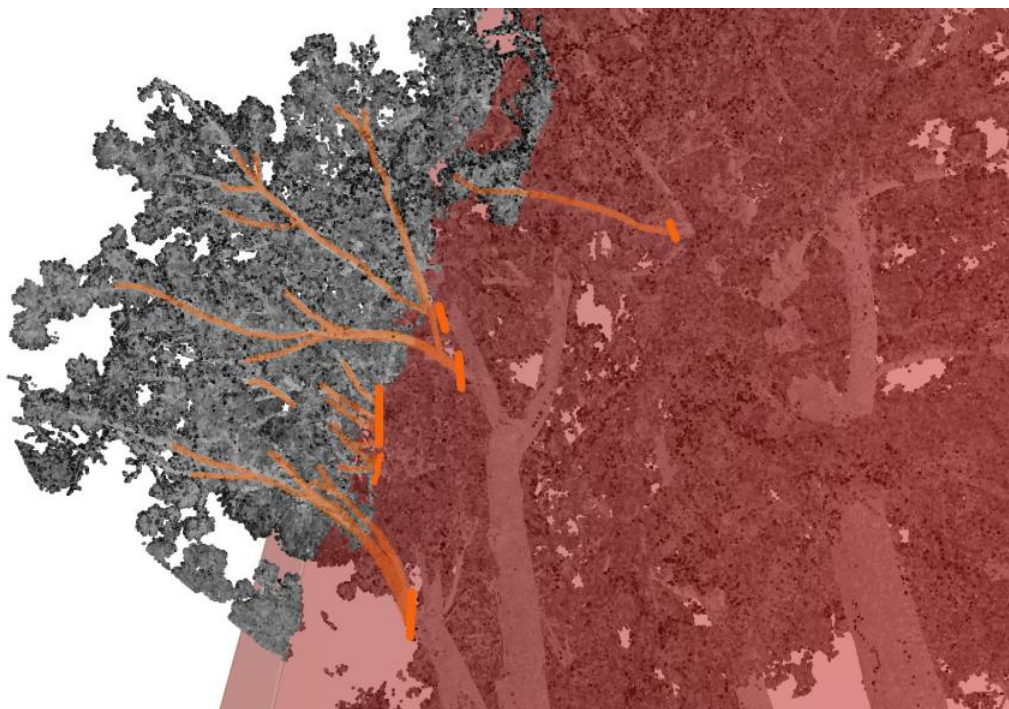
Figure 18 – View of 3D computer model of T13 point cloud data obtained for the tree. Viewed from inside site looking north-east. Diagram indicates the proposed branches and proposed line of pruning to be undertaken to achieve appropriate clearance for building and scaffold. (Image Source: Arterra)

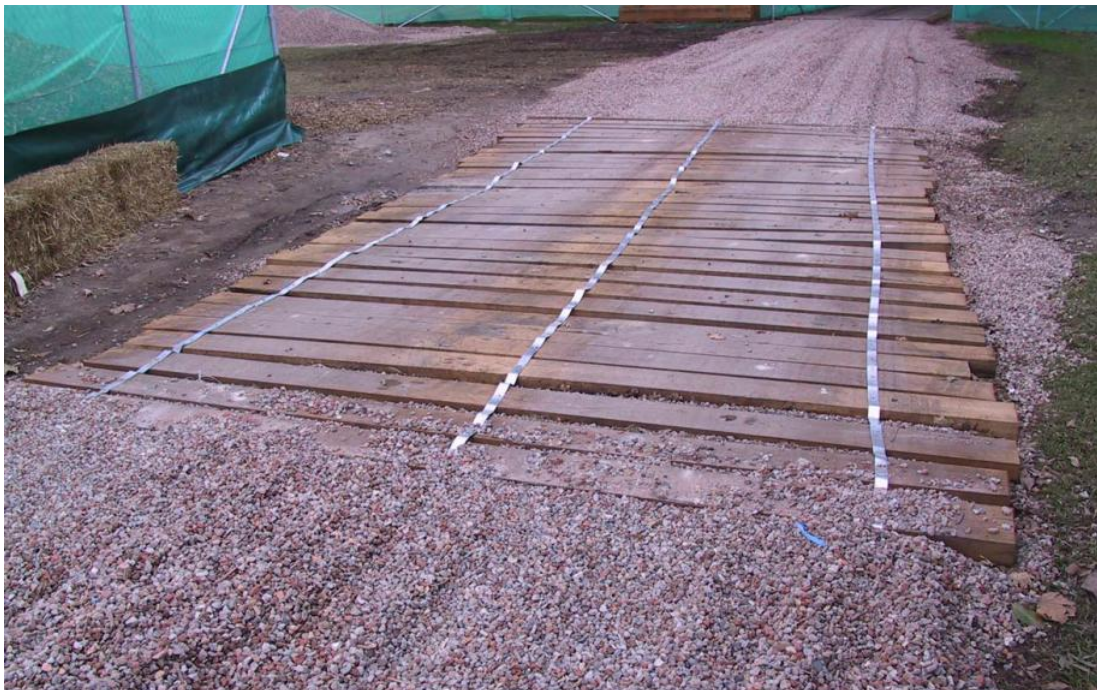
Figure 19 – Example of acceptable Tree Protection Area ground protection

Vehicular movement and access shall typically not be required or approved through the TPAs. If it is necessary and it is proposed to create any access or haul road, or similar, within the TPZ of a retained tree, the Contractor shall install rumble strips / boards over the TPZ ground surface. No excavation shall be allowed. Contractor shall first place a suitable permeable geotextile to the extent required and then a 100mm thick layer of wood chip mulch or coarse no-fines gravel over the extent to be covered with the rumble strip / boards. Then place hardwood boards (minimum 3600 x 200 x 75mm) on their flat edge, side by side, with a 30 - 50mm gap to form a rumble strip. These boards are to be held together with three galvanised metal bracing straps nailed to each board. The two outer straps are to be approximately 200mm in from the ends of the boards. The third strap is to be along the centre line of the boards.

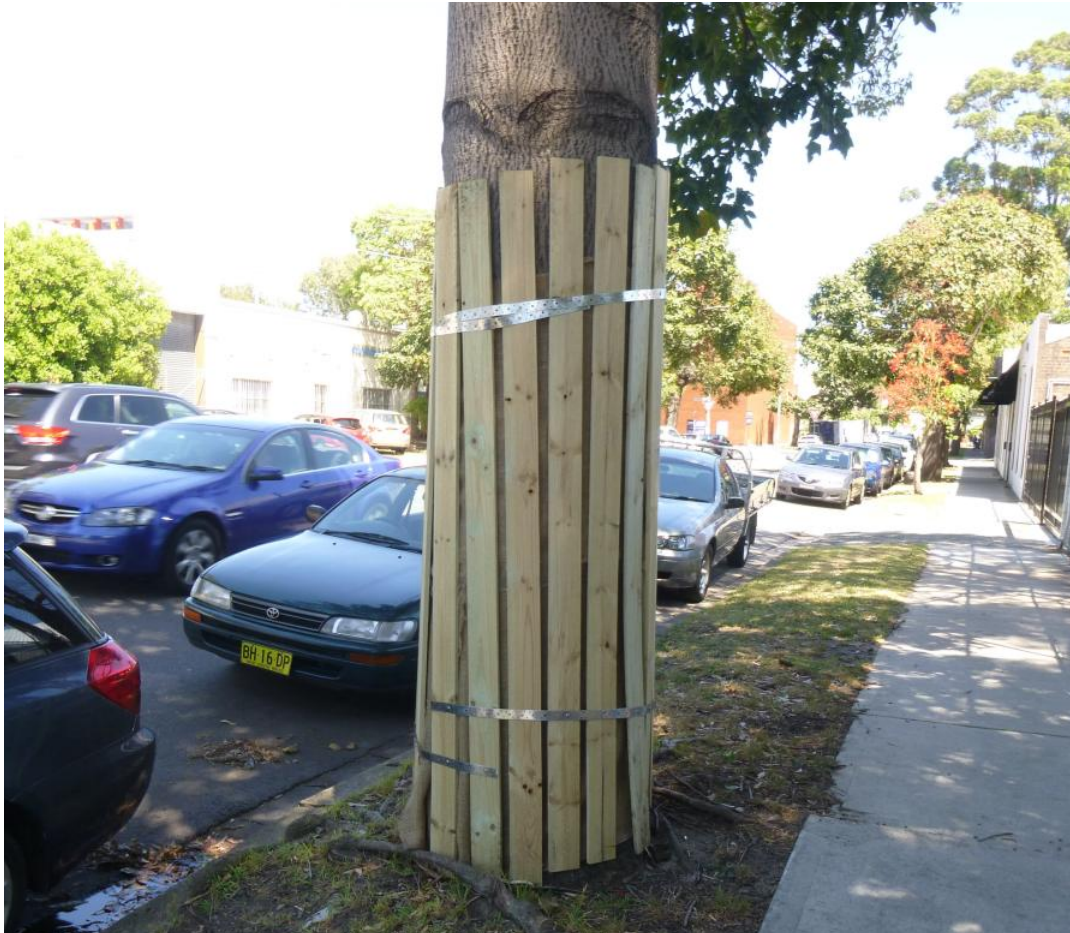
Figure 20 – Example of acceptable Trunk Protection batten installation

A trunk barrier is to be erected around the circumference of the tree trunk and trunk flare and root buttress. This barrier will consist of a double layer of suitable 'used' artificial grass matting, carpet or carpet underfelt placed around the trunk. A layer of battens is to be placed over the underfelt. The battens are to have a maximum spacing of 50-100mm. The height of the battens is to be 2 metres or to the height of the first branches. Lower large branches may require the same protection if they are likely to be damaged by passing vehicles or equipment. Secure in place with galvanised steel bracing straps. Do not nail into or otherwise injure the trunk or bark. Battens may be made from any suitable waste timber of similar sizes and depths. All sharp or protruding edges are to be properly covered with tape or similar padding.

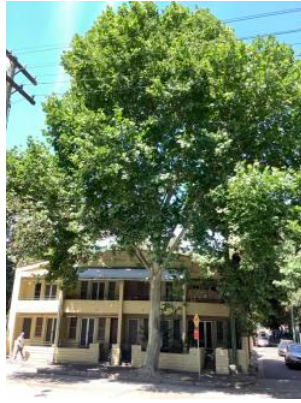
ID # 05
 Species: *Platanus x acerifolia*
 Common: London Plane

Height (m): 20.0
 DBH (m): 0.86 DGL (m): 0.92
 TPZ (m): 10.32 SRZ (m): 3.2
 Current Form: Good
 Current Vigour: Excellent
 Age Class: Mature
 SULE: Long (>40 years)

Retention Value: High

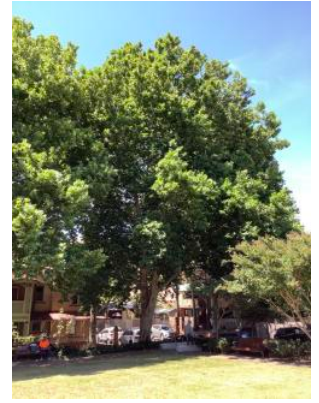
ID # 02
 Species: *Platanus x acerifolia*
 Common: London Plane

Height (m): 18.0
 DBH (m): 0.73 DGL (m): 1.07
 TPZ (m): 8.76 SRZ (m): 3.4
 Current Form: Good
 Current Vigour: Excellent
 Age Class: Mature
 SULE: Long (>40 years)

Retention Value: High

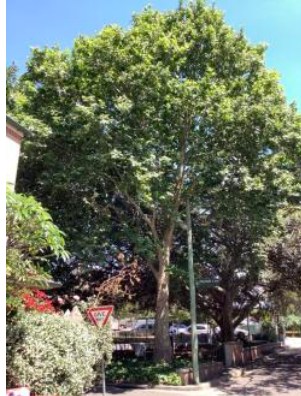
ID # 06
 Species: *Corymbia maculata*
 Common: Spotted Gum

Height (m): 18.0
 DBH (m): 0.56 DGL (m): 0.67
 TPZ (m): 6.72 SRZ (m): 2.8
 Current Form: Average
 Current Vigour: Good
 Age Class: Mature
 SULE: Long (>40 years)

Retention Value: Moderate

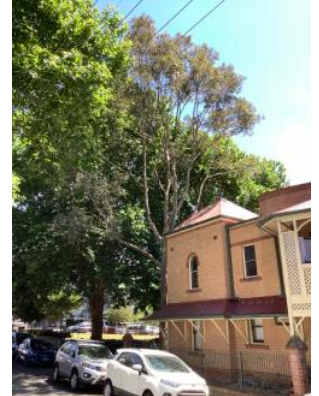
ID # 03
 Species: *Platanus x acerifolia*
 Common: London Plane

Height (m): 17.0
 DBH (m): 0.66 DGL (m): 0.87
 TPZ (m): 7.92 SRZ (m): 3.12
 Current Form: Good
 Current Vigour: Excellent
 Age Class: Mature
 SULE: Long (>40 years)

Retention Value: High

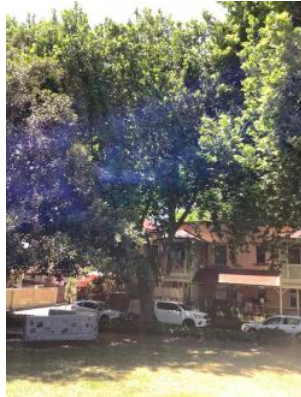
ID # 07
 Species: *Corymbia maculata*
 Common: Spotted Gum

Height (m): 19.0
 DBH (m): 0.52 DGL (m): 0.65
 TPZ (m): 6.24 SRZ (m): 2.76
 Current Form: Average
 Current Vigour: Good
 Age Class: Mature
 SULE: Long (>40 years)

Retention Value: Moderate

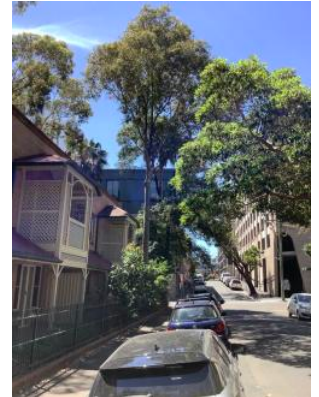
ID # 04
 Species: *Platanus x acerifolia*
 Common: London Plane

Height (m): 19.0
 DBH (m): 0.76 DGL (m): 0.78
 TPZ (m): 9.12 SRZ (m): 2.98
 Current Form: Good
 Current Vigour: Excellent
 Age Class: Mature
 SULE: Long (>40 years)

Retention Value: High

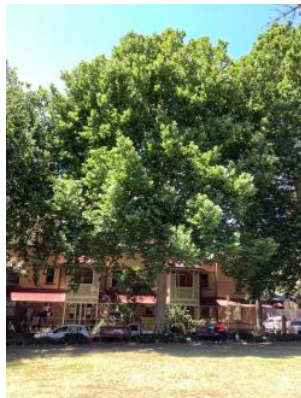
ID # 08
 Species: *Acacia elata*
 Common: Mountain Cedar Wattle

Height (m): 13.0
 DBH (m): 0.52 DGL (m): 0.63
 TPZ (m): 6.24 SRZ (m): 2.73
 Current Form: Poor
 Current Vigour: Fair
 Age Class: Mature
 SULE: Medium (15-40 years)

Retention Value: Low

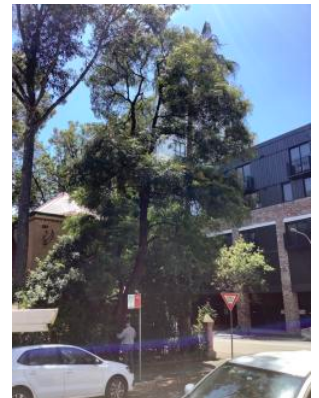
ID # 09
 Species: *Washingtonia robusta*
 Common: Washington Palm

Height (m): 13.5
 DBH (m): 0.52 DGL (m): 0.73
 TPZ (m): 6.24 SRZ (m): 2.9
 Current Form: Average
 Current Vigour: Good
 Age Class: Mature
 SULE: Long (>40 years)

Retention Value: **Moderate**

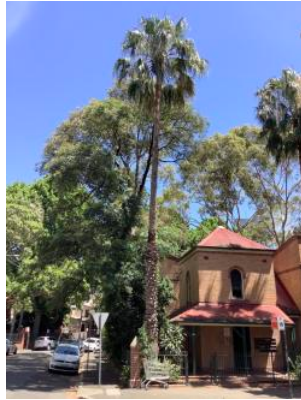
ID # 13
 Species: *Grevillea robusta*
 Common: Silky Oak

Height (m): 18.0
 DBH (m): 1.02 DGL (m): 1.25
 TPZ (m): 12.24 SRZ (m): 3.63
 Current Form: Average
 Current Vigour: Fair
 Age Class: Mature
 SULE: Long (>40 years)

Retention Value: **Moderate**

- There was evidence of roots on the western side of the T13 tree having previously been cut, possibly to accommodate footpath or services installation and or repairs.
- Trenching exposed a substantial concrete footing for the boundary hob brick wall at a depth of 300mm
- A copper water pipe was exposed at a depth of 300mm and ran along the face of the adjacent verandah on the western side of the trench.
- The first substantial root that was exposed at a distance of 4.7m from the BM, 70mm Ø, depth 340mm, growing through PVC pipe and perpendicular to boundary wall. The direction of growth, towards the boundary wall, indicated that the tree of origin was within the site. Given the direction of

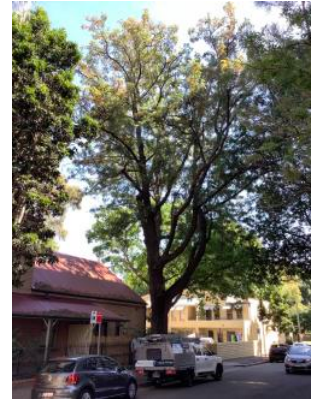
ID # 10
 Species: *Washingtonia robusta*
 Common: Washington Palm

Height (m): 12.0
 DBH (m): 0.46 DGL (m): 0.60
 TPZ (m): 5.52 SRZ (m): 2.67
 Current Form: Average
 Current Vigour: Good
 Age Class: Mature
 SULE: Long (>40 years)

Retention Value: **Moderate**

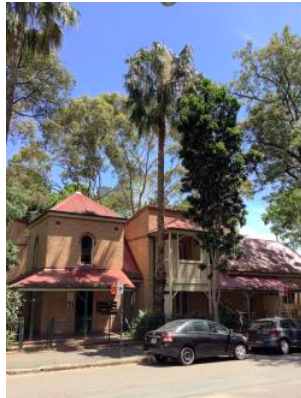
ID # 14
 Species: *Stenocarpus sinuatus*
 Common: Queensland Firewheel Tree

Height (m): 12.5
 DBH (m): 0.22 DGL (m): 0.26
 TPZ (m): 2.64 SRZ (m): 1.88
 Current Form: Average
 Current Vigour: Good
 Age Class: Semi-mature
 SULE: Long (>40 years)

Retention Value: **High**

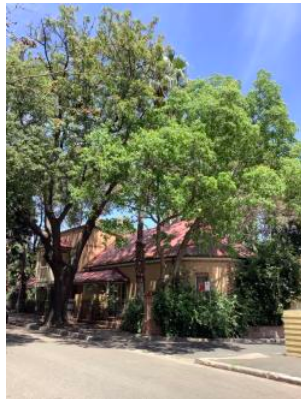
ID # 15
 Species: *Stenocarpus sinuatus*
 Common: Queensland Firewheel Tree

Height (m): 6.0
 DBH (m): 0.06 DGL (m): 0.09
 TPZ (m): 2 SRZ (m): 1.5
 Current Form: Average
 Current Vigour: Good
 Age Class: Young
 SULE: Long (>40 years)

Retention Value: **Moderate**

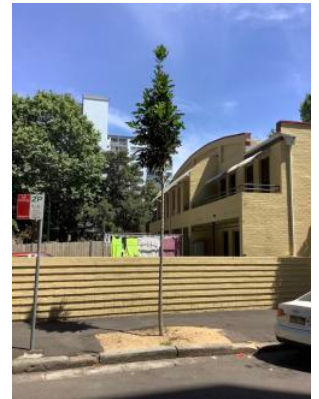
ID # 12
 Species: *Sapium sebiferum*
 Common: Chinese Tallow Tree

Height (m): 11.5
 DBH (m): 0.46 DGL (m): 0.60
 TPZ (m): 5.52 SRZ (m): 2.67
 Current Form: Poor
 Current Vigour: Good
 Age Class: Mature
 SULE: Long (>40 years)

Retention Value: **Low**

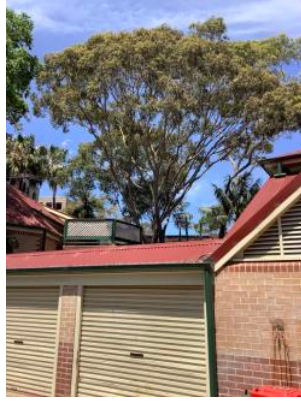
ID # 17
 Species: *Corymbia citriodora*
 Common: Lemon Scented Gum

Height (m): 12.5
 DBH (m): 0.44 DGL (m): 0.52
 TPZ (m): 5.28 SRZ (m): 2.51
 Current Form: Average
 Current Vigour: Good
 Age Class: Mature
 SULE: Long (>40 years)

Retention Value: Moderate

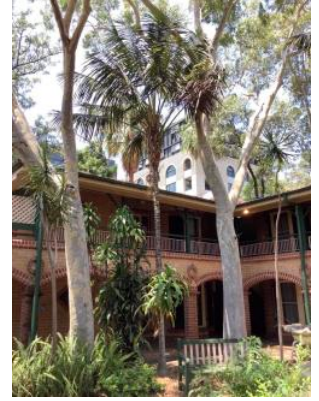
ID # 21
 Species: *Howea forsteriana*
 Common: Kentia Palm

Height (m): 7.0
 DBH (m): 0.12 DGL (m): 0.22
 TPZ (m): 2 SRZ (m): 1.75
 Current Form: Good
 Current Vigour: Good
 Age Class: Mature
 SULE: Long (>40 years)

Retention Value: Low

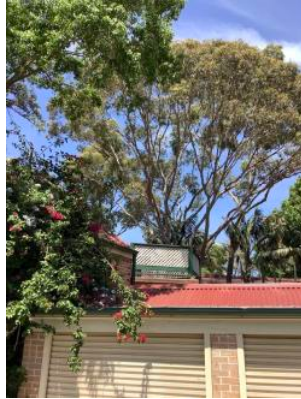
ID # 18
 Species: *Corymbia citriodora*
 Common: Lemon Scented Gum

Height (m): 14.0
 DBH (m): 0.50 DGL (m): 0.63
 TPZ (m): 6 SRZ (m): 2.73
 Current Form: Average
 Current Vigour: Good
 Age Class: Mature
 SULE: Long (>40 years)

Retention Value: Moderate

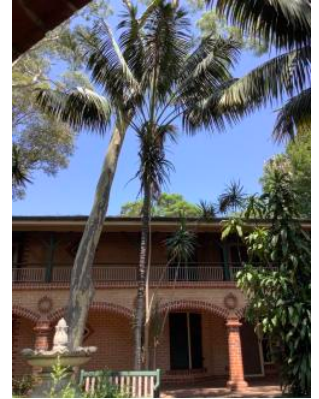
ID # 22
 Species: *Howea forsteriana*
 Common: Kentia Palm

Height (m): 7.5
 DBH (m): 0.14 DGL (m): 0.19
 TPZ (m): 2 SRZ (m): 1.65
 Current Form: Good
 Current Vigour: Good
 Age Class: Mature
 SULE: Long (>40 years)

Retention Value: Low

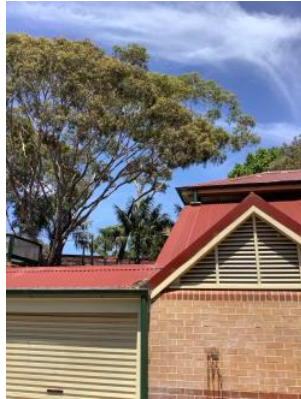
ID # 19
 Species: *Corymbia citriodora*
 Common: Lemon Scented Gum

Height (m): 14.0
 DBH (m): 0.51 DGL (m): 0.62
 TPZ (m): 6.12 SRZ (m): 2.71
 Current Form: Average
 Current Vigour: Good
 Age Class: Mature
 SULE: Long (>40 years)

Retention Value: Moderate

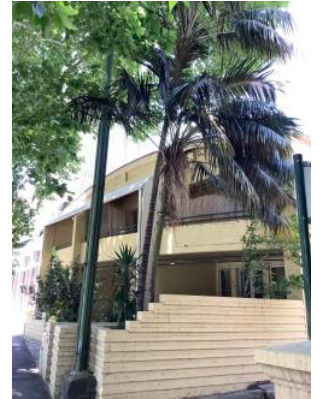
ID # 23
 Species: *Howea forsteriana*
 Common: Kentia Palm

Height (m): 6.0
 DBH (m): 0.20 DGL (m): 0.42
 TPZ (m): 2.4 SRZ (m): 2.3
 Current Form: Average
 Current Vigour: Fair
 Age Class: Mature
 SULE: Long (>40 years)

Retention Value: Low

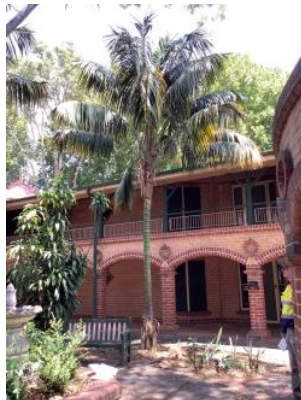
ID # 20
 Species: *Howea forsteriana*
 Common: Kentia Palm

Height (m): 6.0
 DBH (m): 0.15 DGL (m): 0.26
 TPZ (m): 2 SRZ (m): 1.88
 Current Form: Good
 Current Vigour: Good
 Age Class: Mature
 SULE: Long (>40 years)

Retention Value: Low
