Report on
Geotechnical Investigation

Glebe Mid-Rise Project
31 Cowper Street and 2A-2D Wentworth Park Road,
Glebe

Prepared for
New South Wales Land and Housing Corporation

Project 99554.00
May 2020

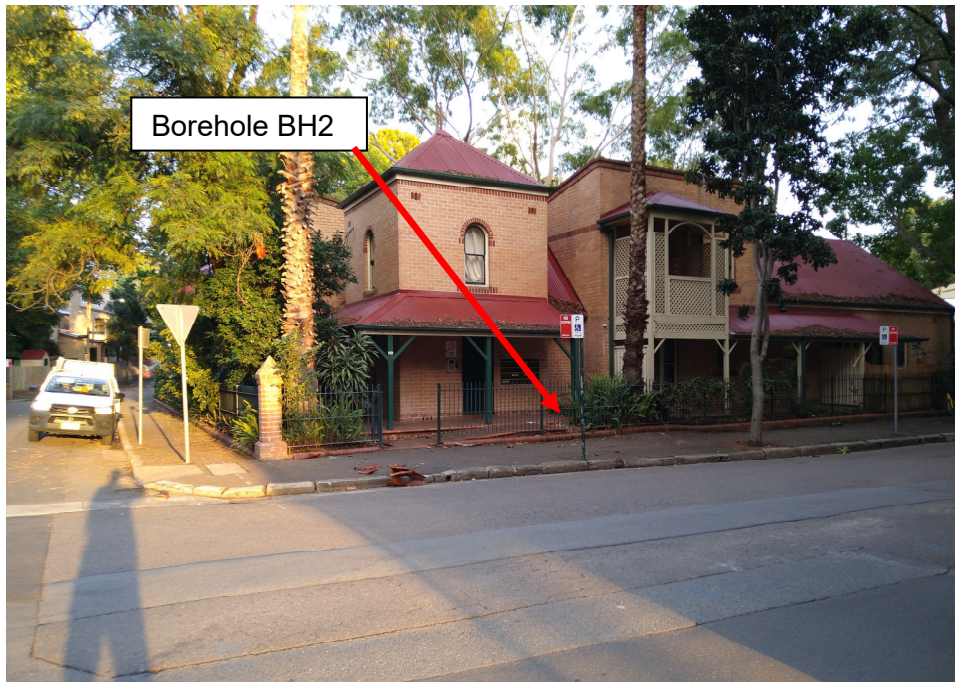
Photograph 4 – View west across Cowper Street. The approximate position of Borehole BH2 is indicated as shown.

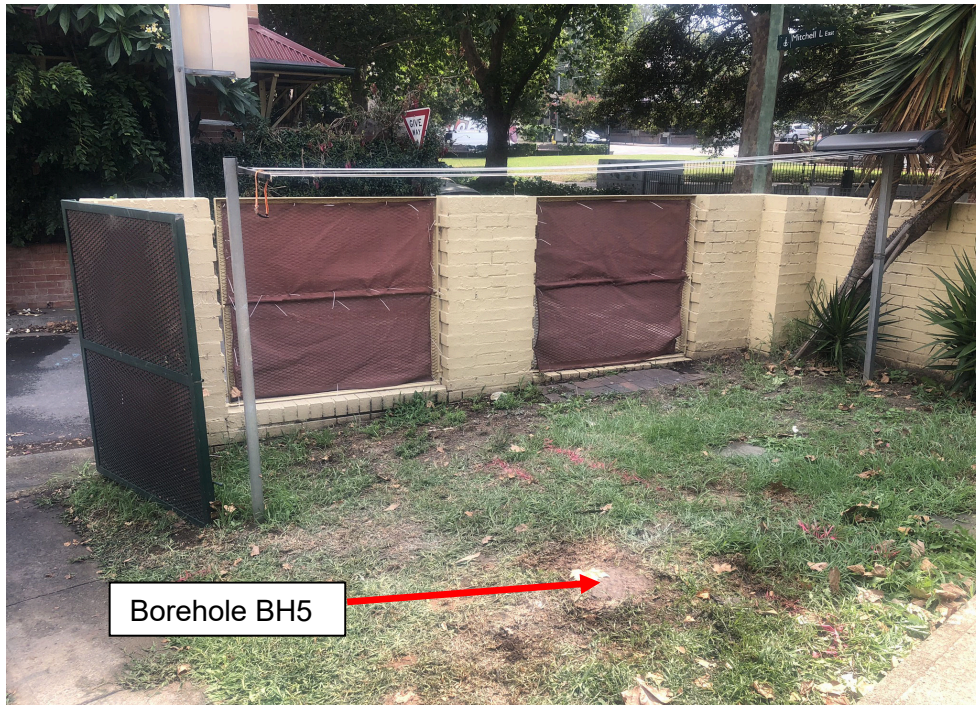
Photograph 11 – View south within the rear of the 2D Wentworth Park Road property, with Park Lane in the background. The approximate position of Borehole BH5 is indicated as shown.

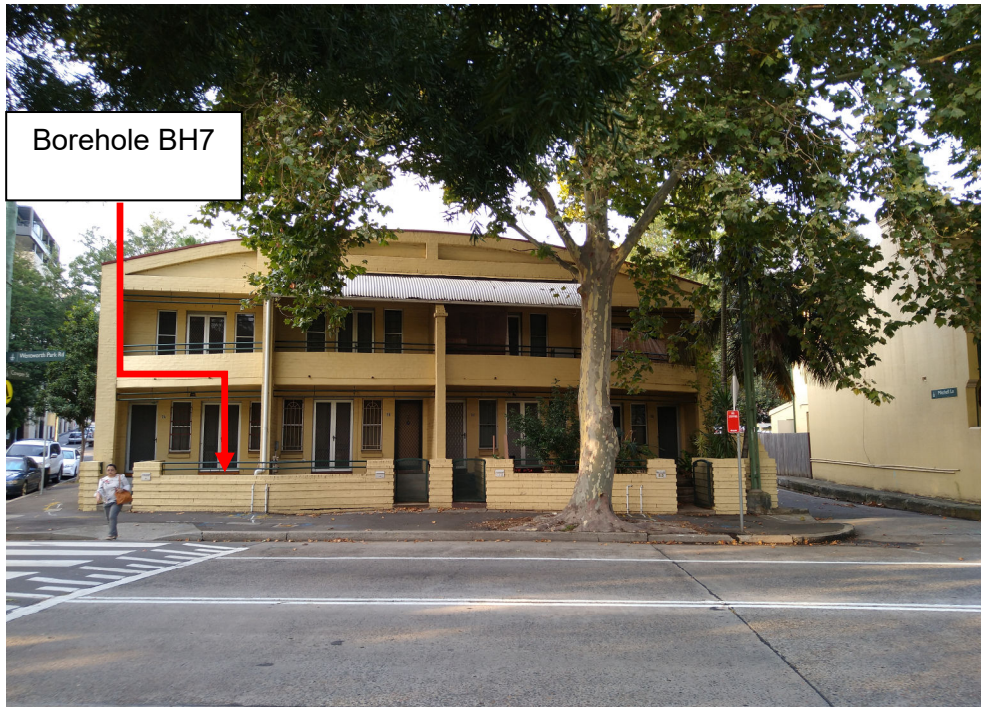
Photograph 13 – View south across Wentworth Park Road towards the position of Borehole BH7, which is indicated as shown.

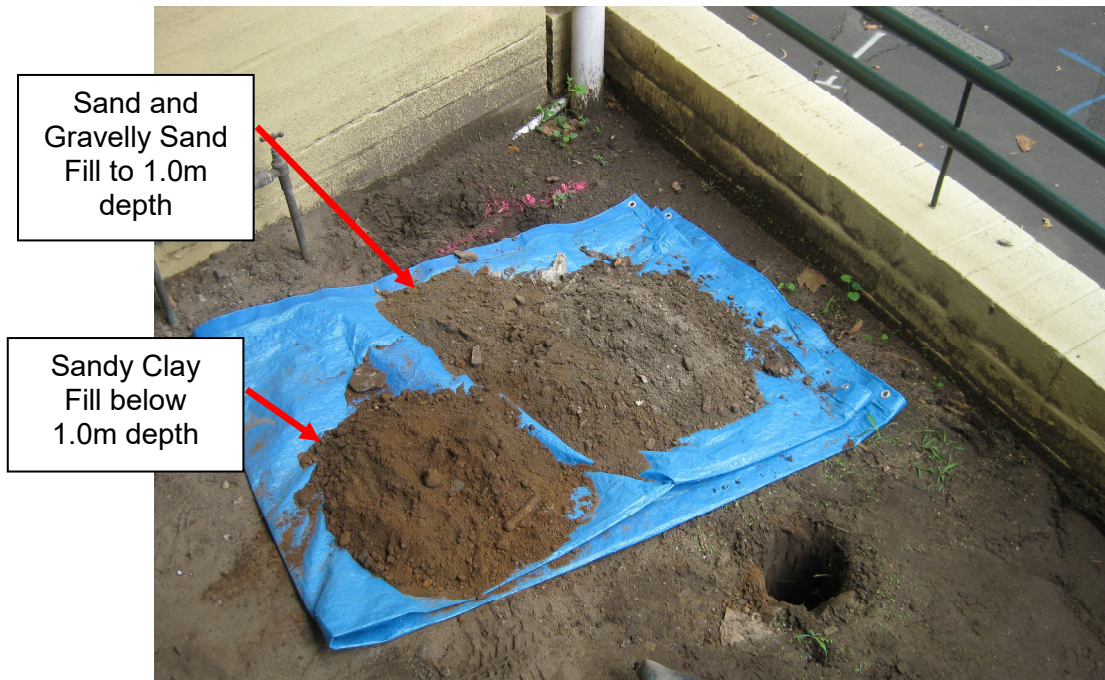
Photograph 14 – View of drilling spoil obtained from Borehole BH7.

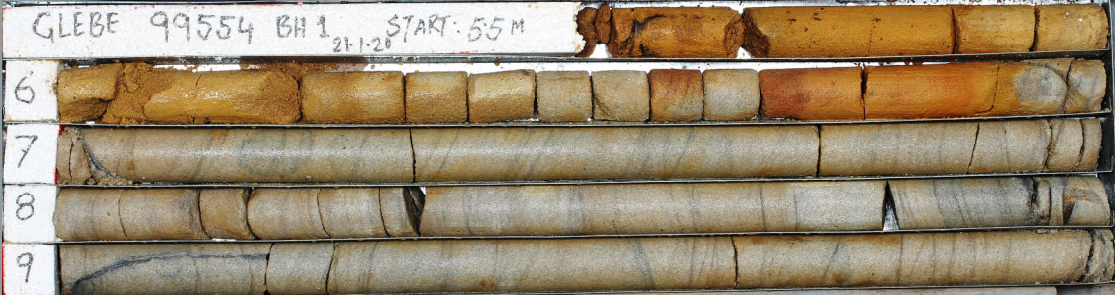
Project No: 99554.00
BH ID: 8#1
Depth: 5.50 - 10.00 m
Core Box No.: 1

5.50 - 10.00 m

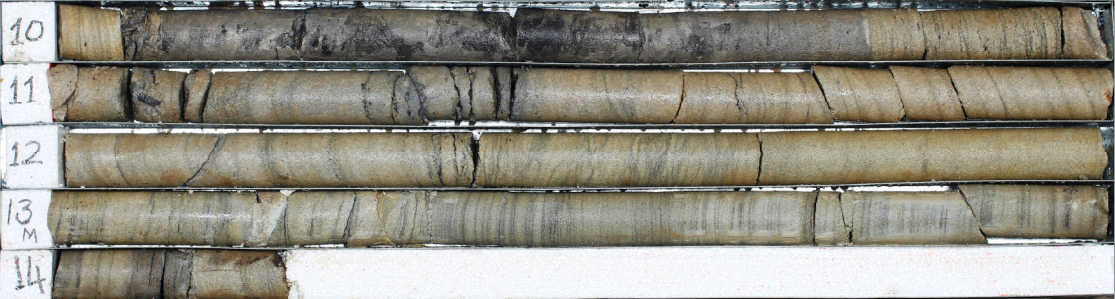
Project No: 99554.00
BH ID: 8#1
Depth: 10.00 - 14.20 m
Core Box No.: 2

10.00 - 14.20 m

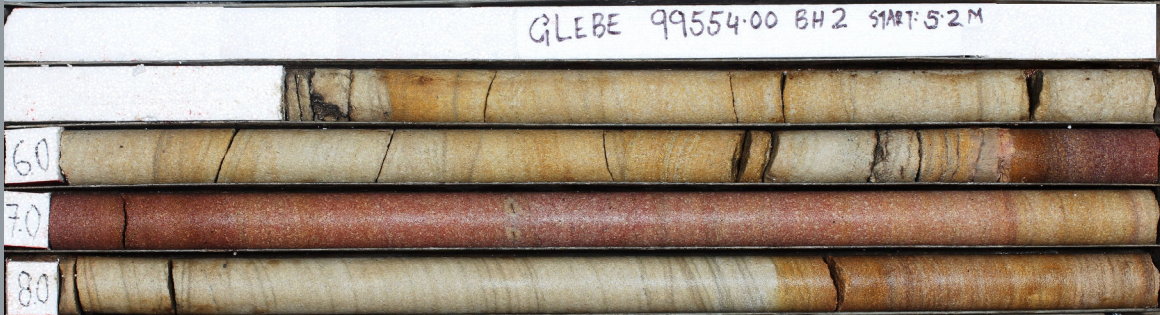
Project No: 99554.00
BH ID: BH 2
Depth: 5.20 - 9.00 m
Core Box No.: 1

5.20 - 9.00m

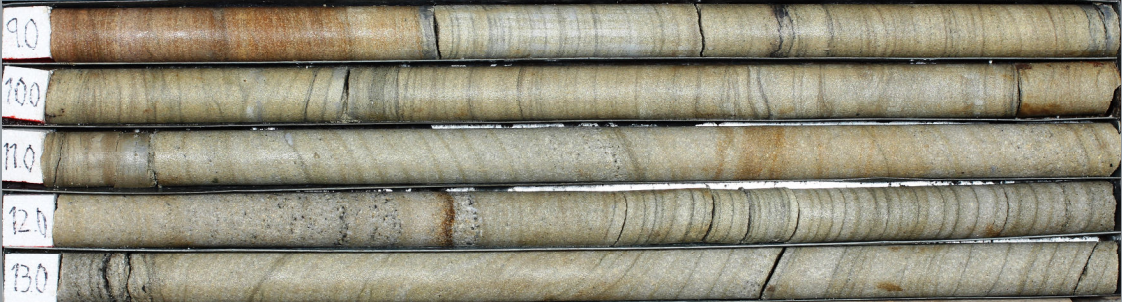
Project No: 99554.00
BH ID: BH 2
Depth: 9.00 - 14.00 m
Core Box No.: 2

9.00 - 14.00m

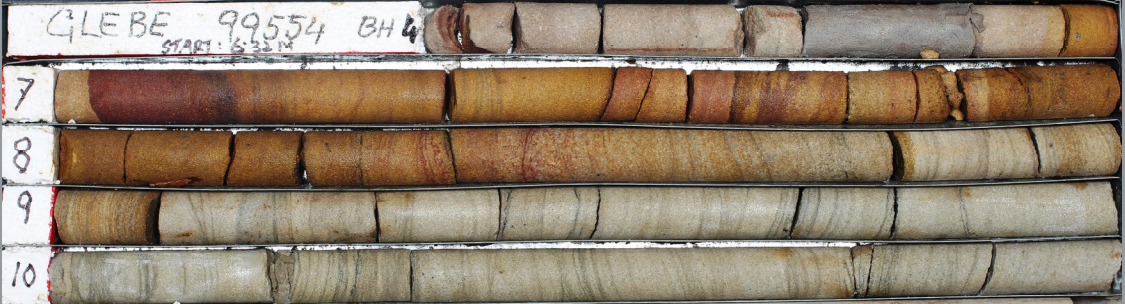
Project No: 99554.00
BH ID: BH 4
Depth: 6.32 - 11.00 m
Core Box No.: 1

6.32 - 11.00 m

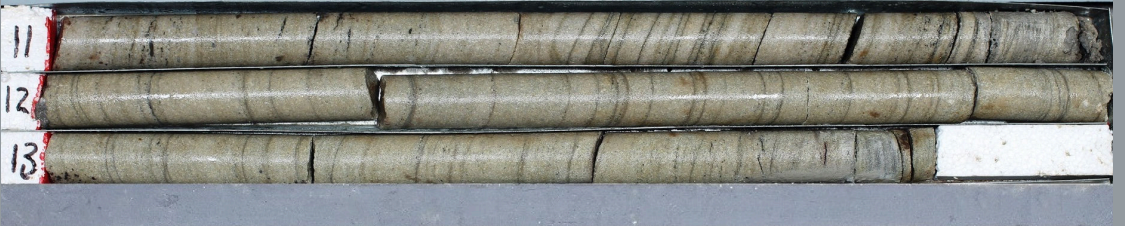
Project No: 99554.00
BH ID: BH 4
Depth: 11.00 - 13.80 m
Core Box No.: 2

11.00 - 13.80 m

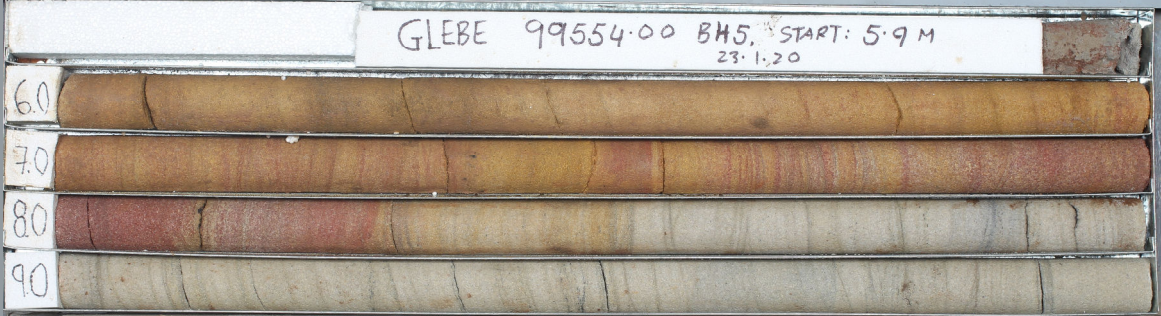
Project No: 99554.00
BH ID: BH5
Depth: 5.90 - 10.00m
Core Box No.: 1

5.9 – 10.0 m

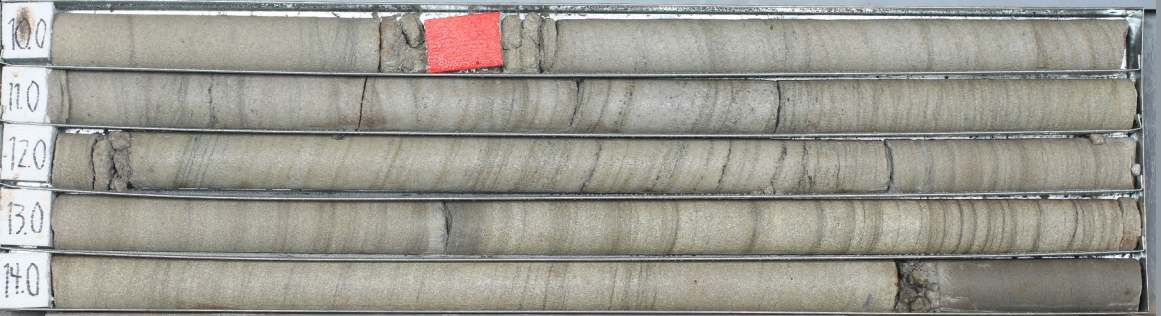
Project No: 99554.00
BH ID: BH5
Depth: 10.00 - 15.00m
Core Box No.: 2

10.0 – 15.0 m
