Report on  
Geotechnical Investigation

Glebe Mid-Rise Project  
31 Cowper Street and 2A-2D Wentworth Park Road,  
Glebe

Prepared for  
New South Wales Land and Housing Corporation

Project 99554.00  
May 2020

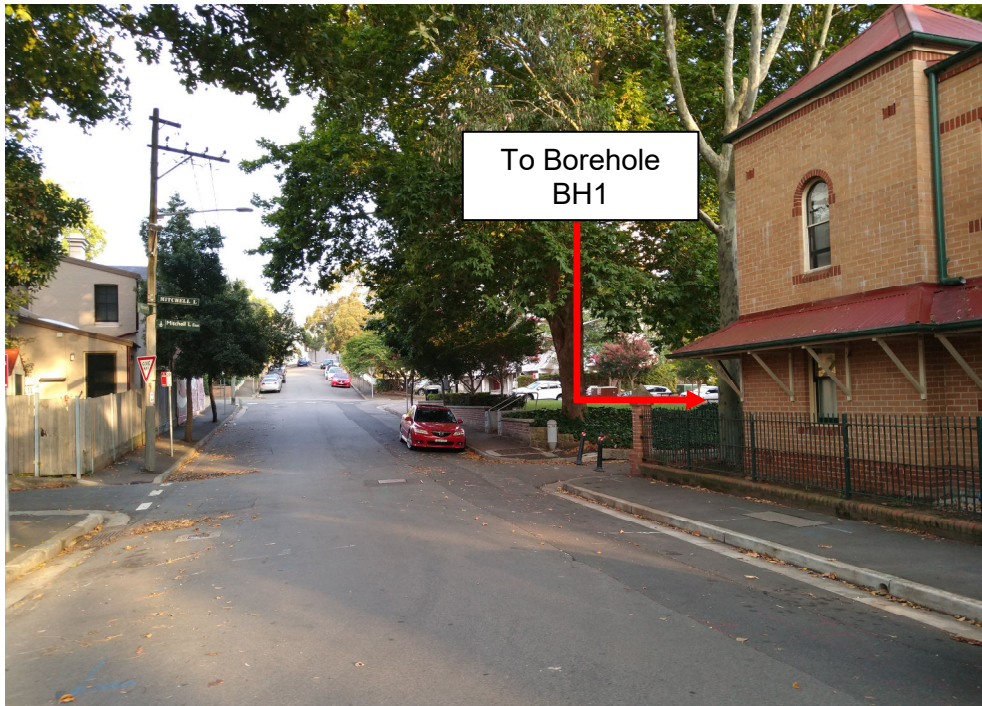
Photograph 1 – View west along Wentworth Street. The approximate position of Borehole BH1 along Mitchell Lane is indicated as shown.

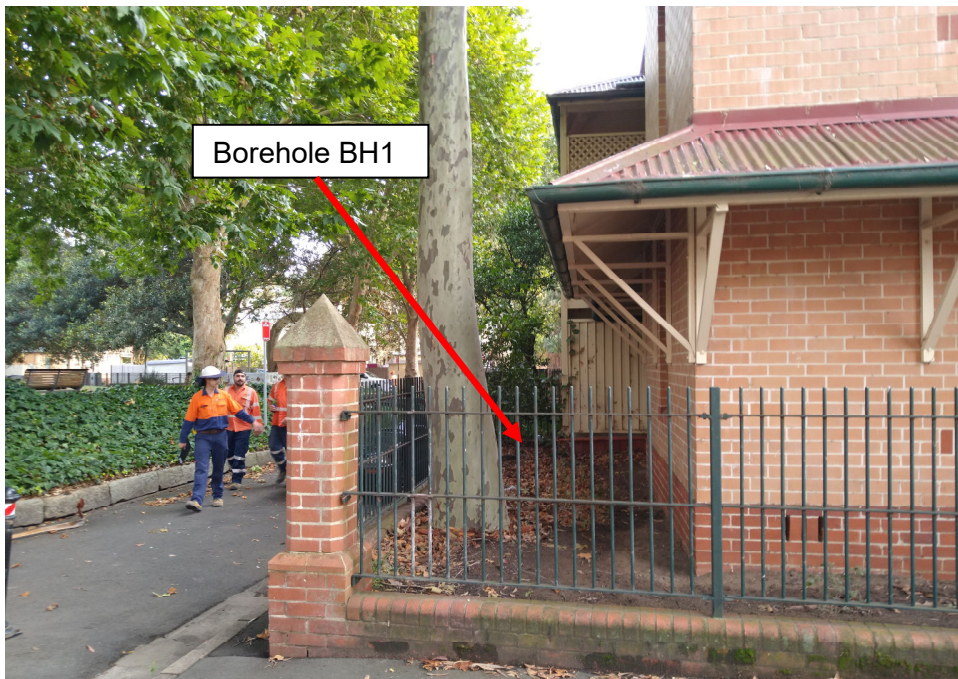
Photograph 2 – View north along Mitchell Lane. The approximate position of Borehole BH1 is indicated as shown.

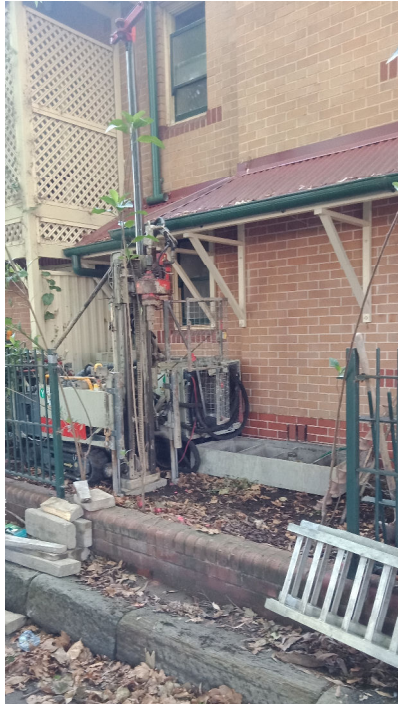
Photograph 3 – View north-east at the location of Borehole BH1.

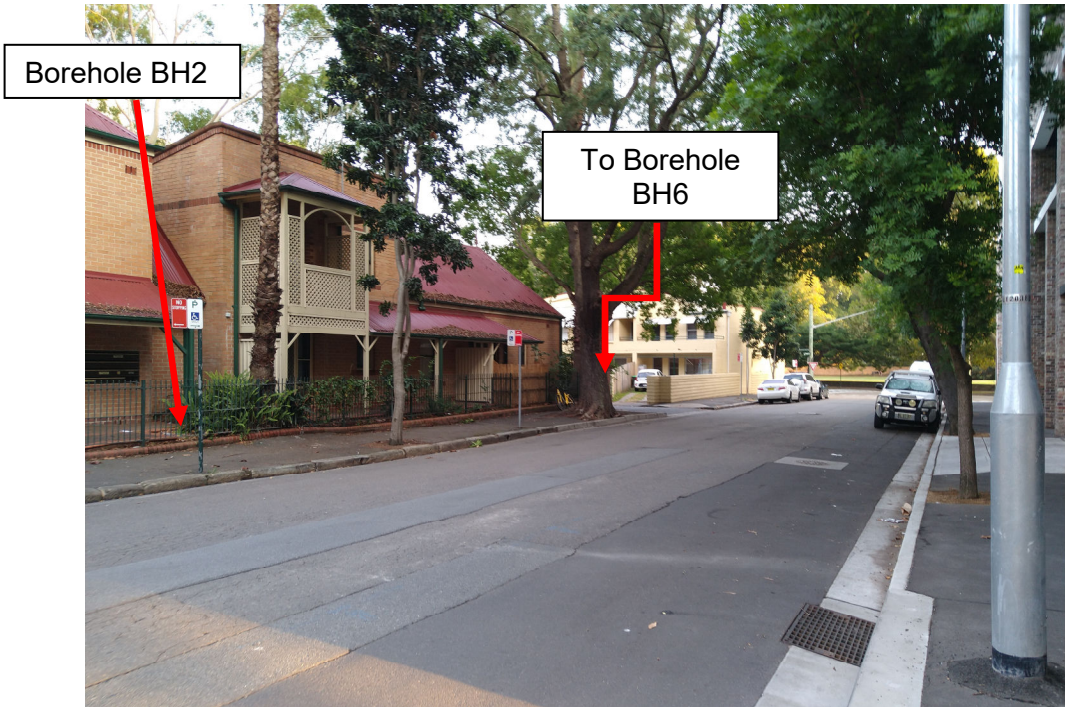
Photograph 5 – View north-west across Cowper Street. The approximate position of Boreholes BH2 and BH6 are indicated as shown.

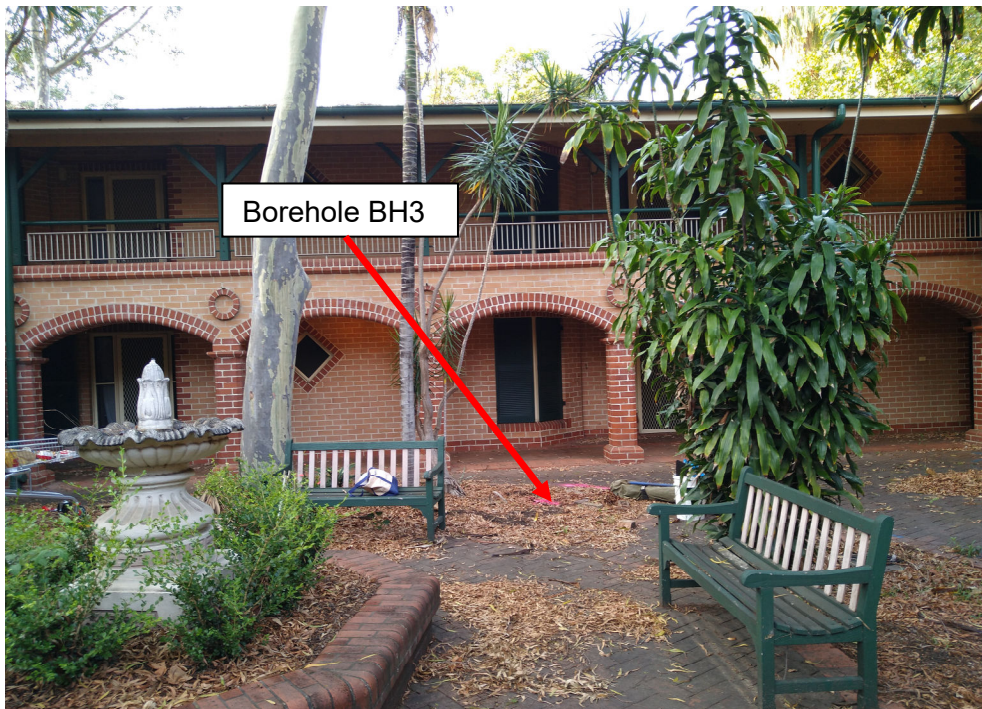
Photograph 7 – View south within the 31 Cowper Street property. The position of Borehole BH3 is indicated as shown.

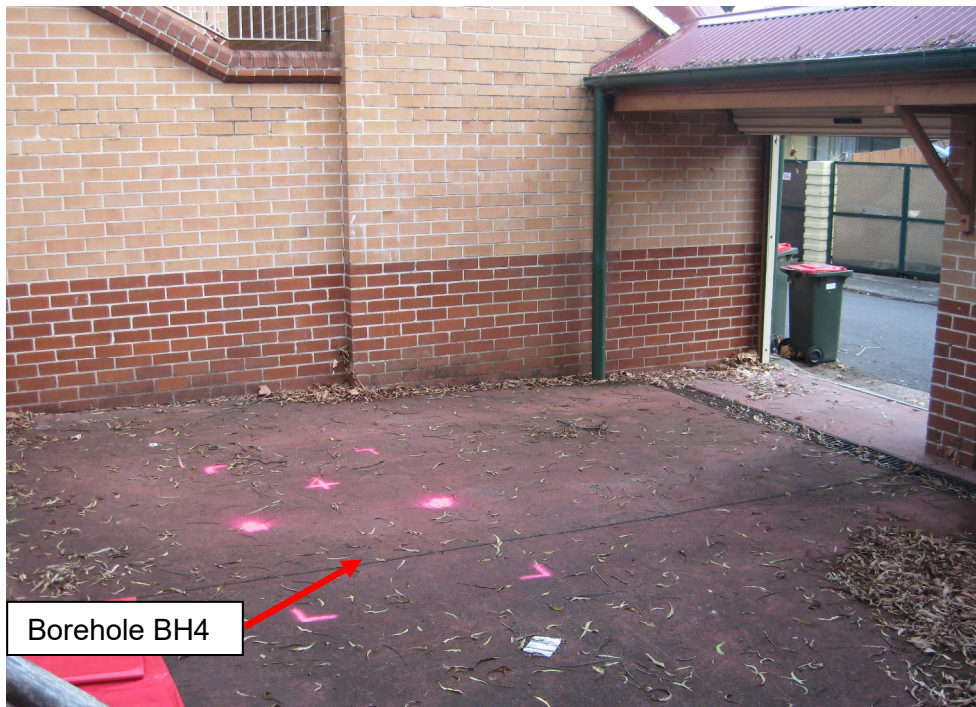
Photograph 9 – View west within the 31 Cowper Street property, with Park Lane in the background. The approximate position of Borehole BH4 is indicated as shown.

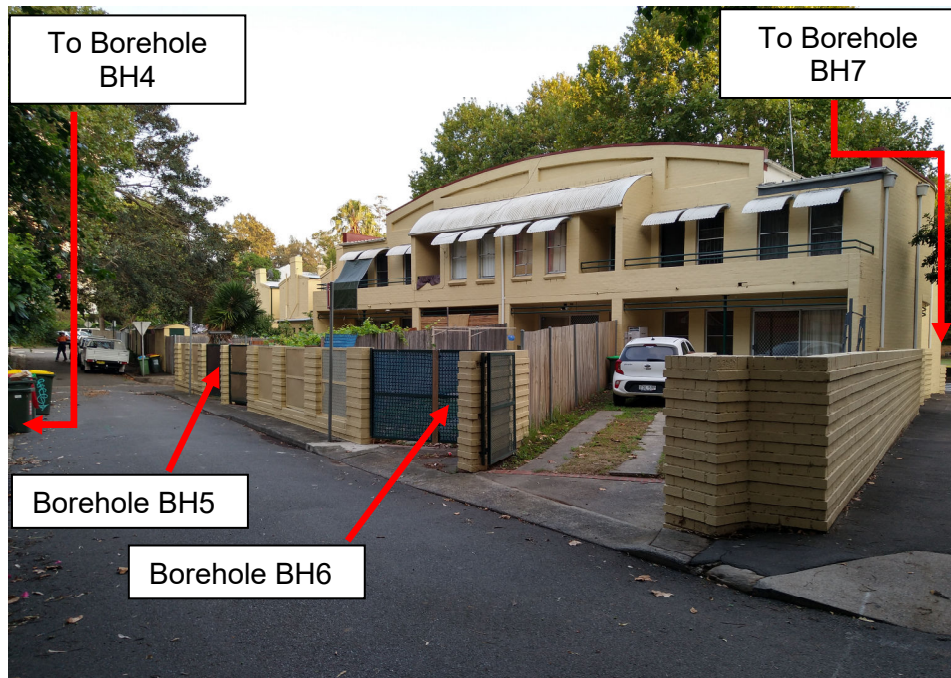
Photograph 10 – View west along Park Lane. The approximate positions of Boreholes BH4 to BH7 are indicated as shown.

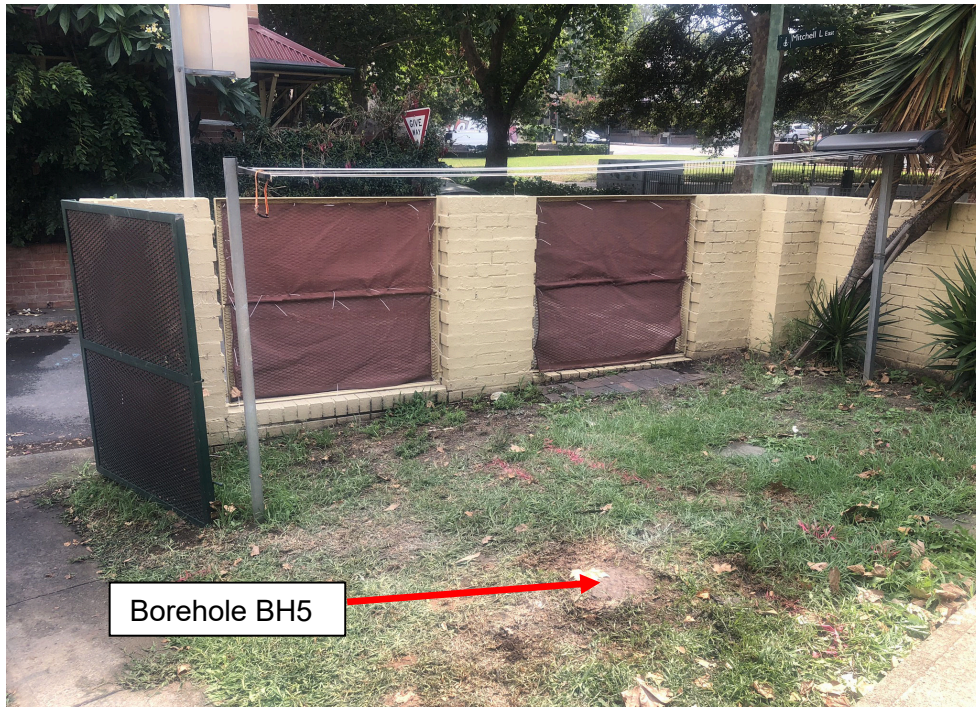
Photograph 11 – View south within the rear of the 2D Wentworth Park Road property, with Park Lane in the background. The approximate position of Borehole BH5 is indicated as shown.

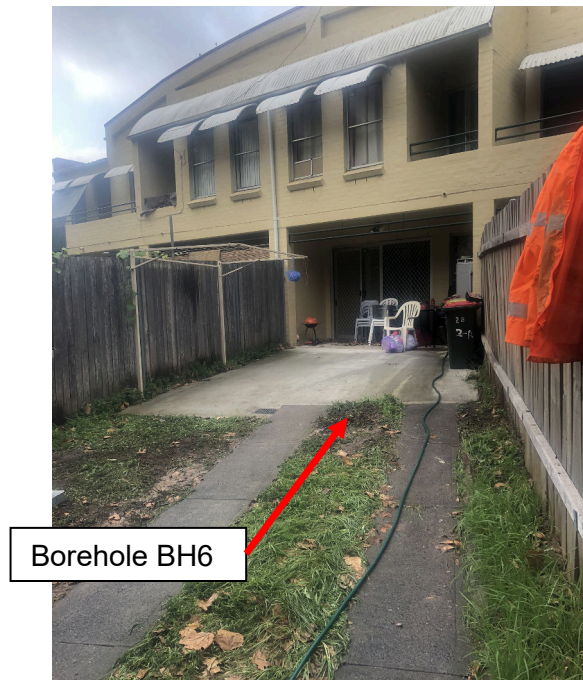
Photograph 12 – View north within the rear of the 2B Wentworth Park Road property. The approximate position of Borehole BH6 is indicated as shown.

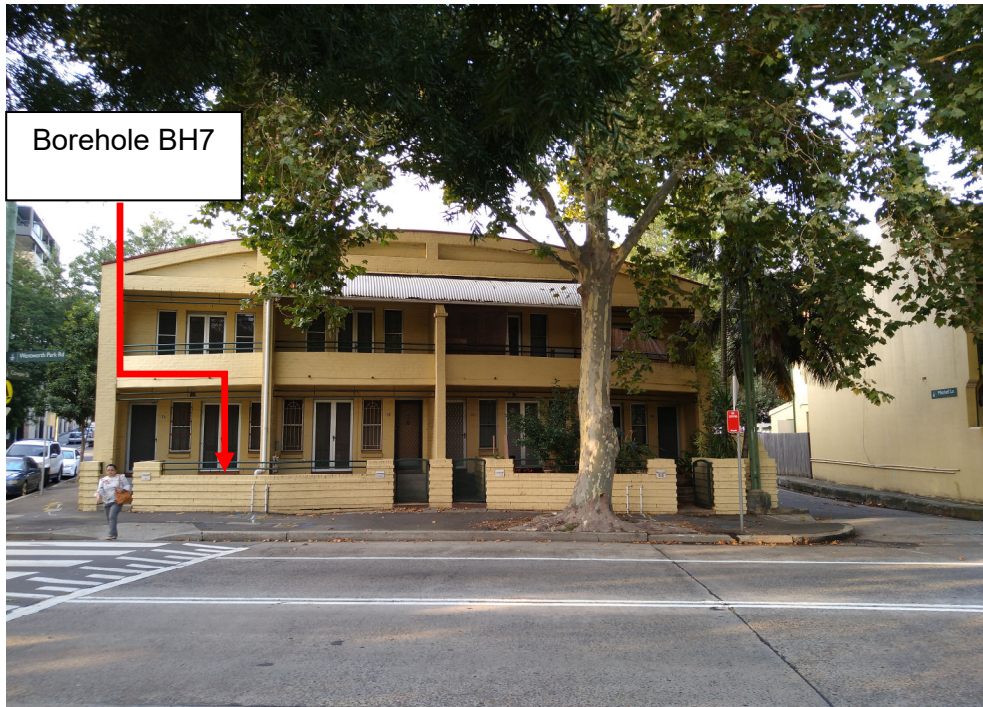
Borehole BH7

Photograph 13 – View south across Wentworth Park Road towards the position of Borehole BH7, which is indicated as shown.

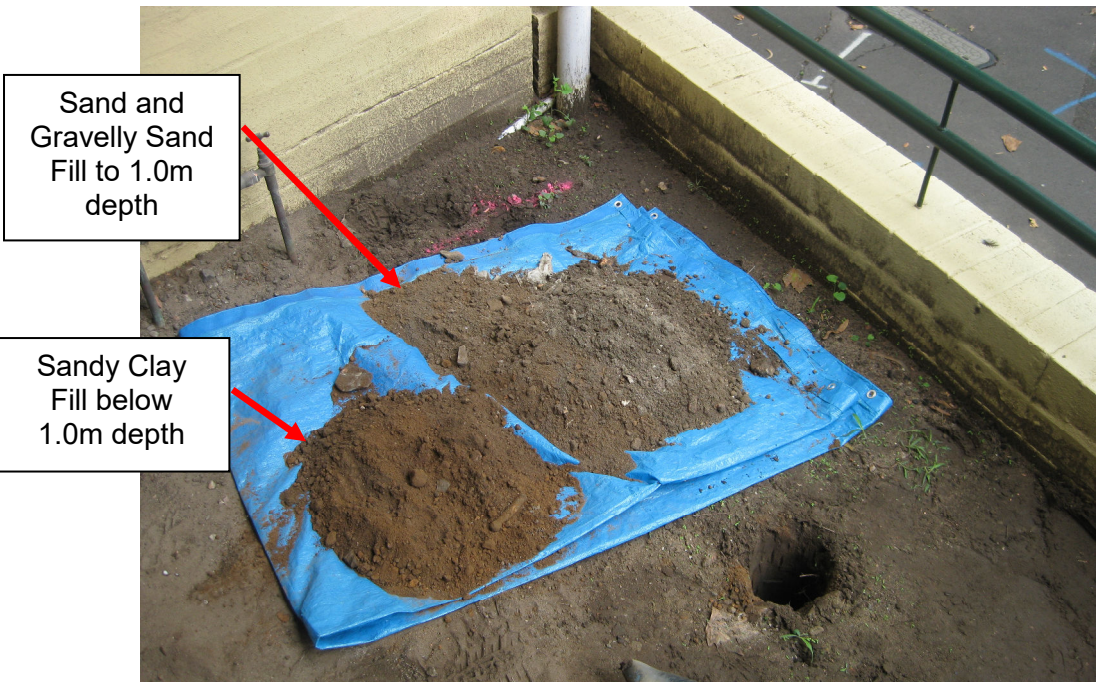
Sand and Gravelly Sand Fill to 1.0m depth

Sandy Clay Fill below 1.0m depth

- *Within the North Site*
  - o FILL – sand and gravelly sand fill up to 1.0 m depth, over sandy clay filling with some brick, sandstone gravel, ash, plastic, charcoal, slag, glass and ceramic tile to 1.9 m depth (elevation down to RL0.8 m), generally in a loose or medium dense condition; over

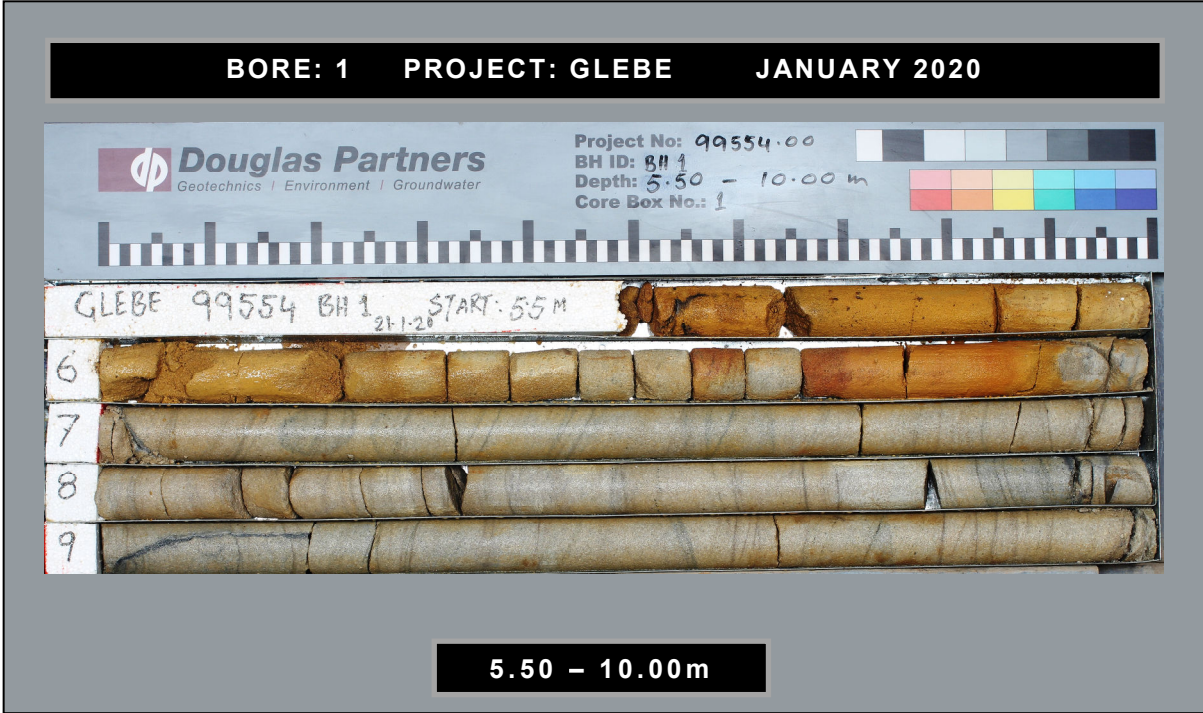
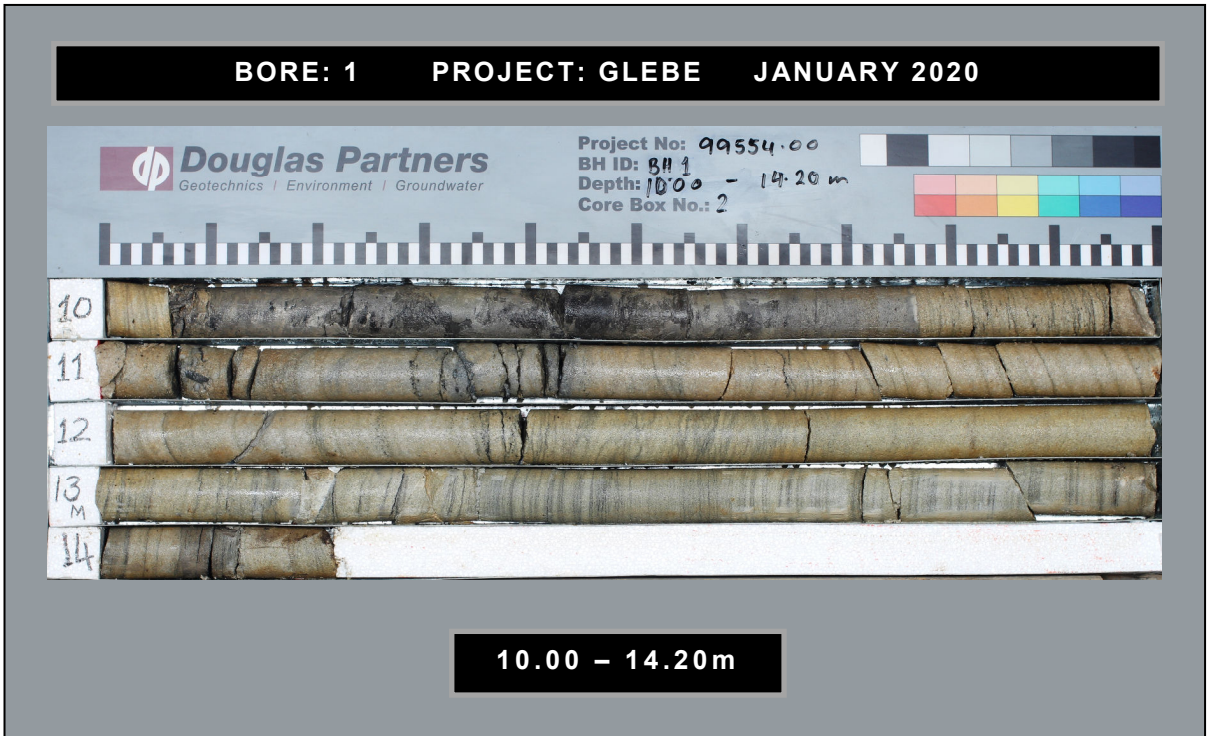
**RIG:** XC100      **DRILLER:** Terratest      **LOGGED:** IT      **CASING:** HW to 5.5m  
**TYPE OF BORING:** Diatube (250mm) to 0.3m, Solid flight auger (TC-bit) to 5.2m, NMLC coring to 14.0m  
**WATER OBSERVATIONS:** Free groundwater observed at 3.2m whilst augering  
**REMARKS:** Surface level obtained from Mepstead and Associates Pty Ltd, drawing 5743 dated 18/12/2018. Co-ordinates obtained using Nearmap & site measurements

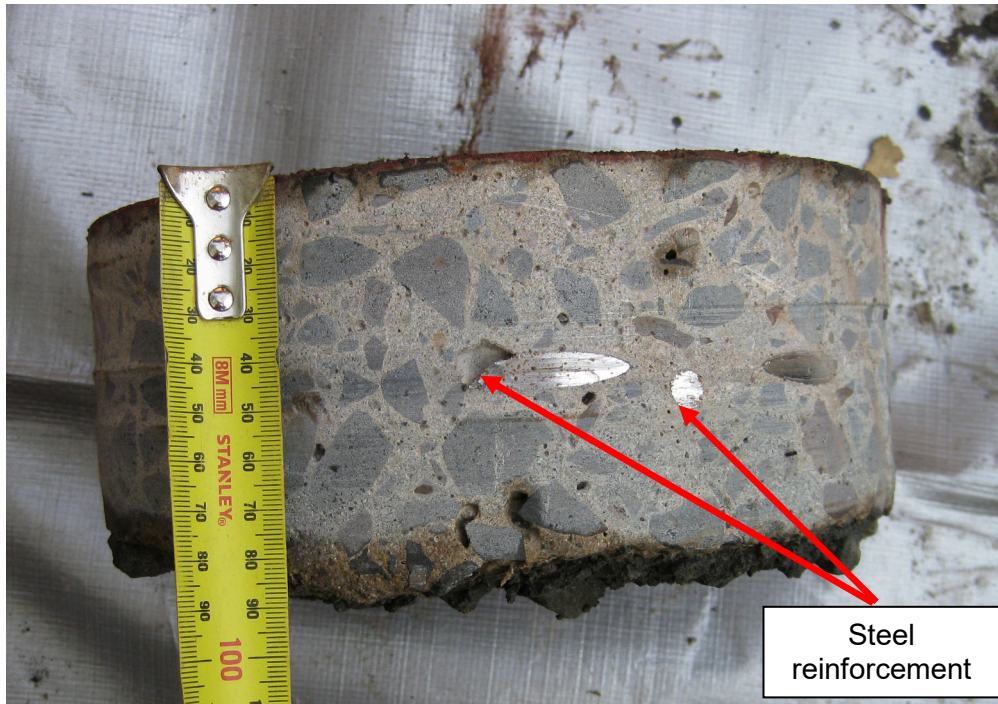
Photograph D1 – View of concrete core from surface of Borehole BH4, with steel reinforcement indicated as shown.

It is noted that the surface pavers and concrete in boreholes BH2 and BH4 were dia-cored. The boreholes were drilled within soils (and between 0.1 m to 0.3 m into weathered sandstone within Boreholes BH1, BH2 and BH6) using auger drilling methods. With the exception of Boreholes BH3 and BH7, five of the boreholes were extended into the underlying rock using rotary diamond core drilling techniques.
