Report on  
Preliminary and Detailed Site (Contamination)  
Investigation

Glebe Mid-Rise Project  
31 Cowper Street and 2A-2D Wentworth Park Road,  
Glebe

Prepared for  
New South Wales Land and Housing Corporation

Project 99554.01  
May 2020

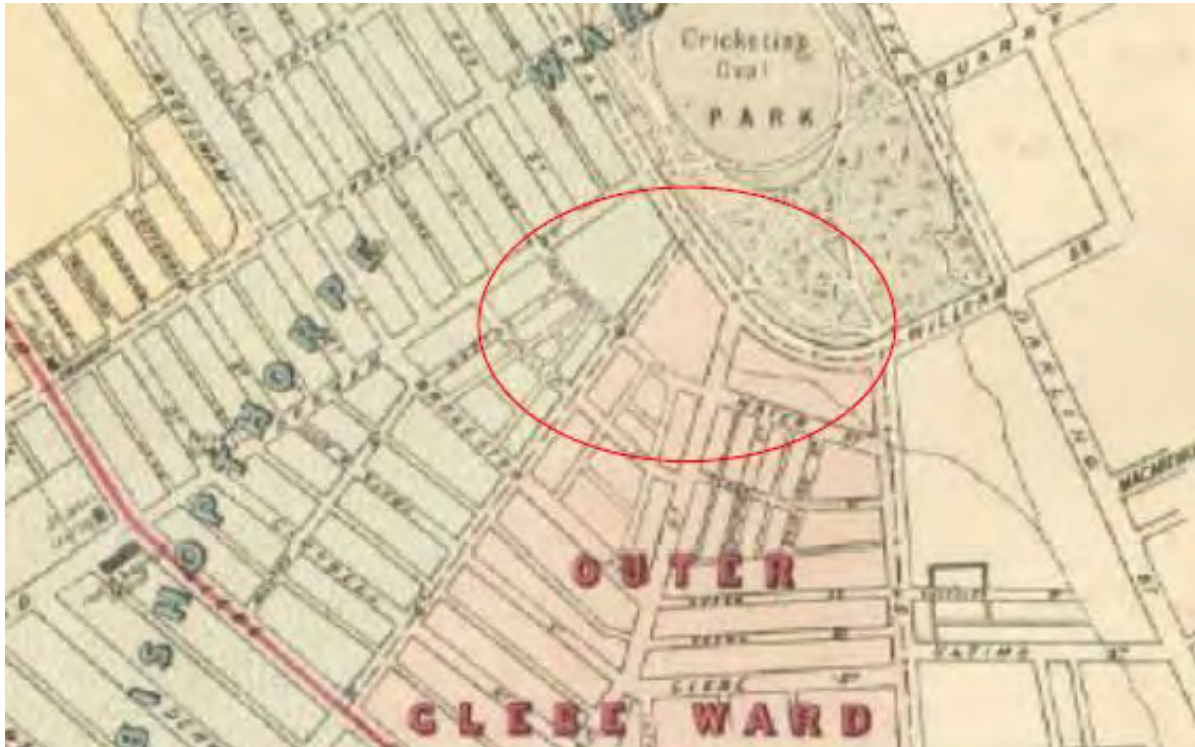
Figure 5: Plan, possibly dated circa 1930, showing what may be a creek line potentially entering the site

An extract from the title deeds potentially showing a water course entering the site is provided in Figure 5, below.

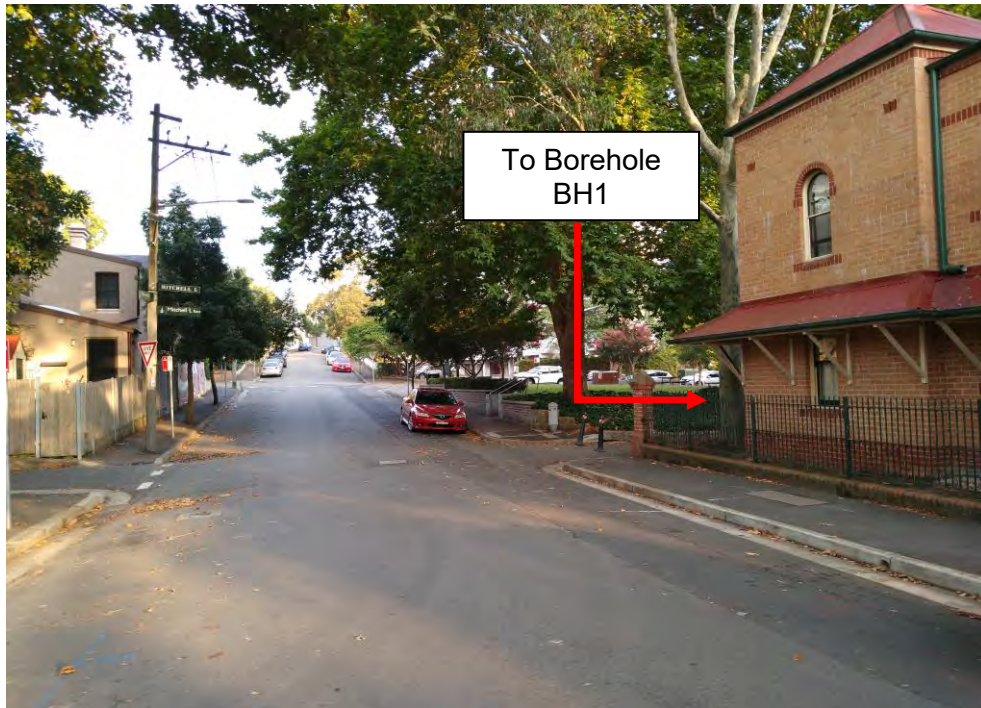
Photograph 1 – View west along Wentworth Street. The approximate position of Borehole BH1 along Mitchell Lane is indicated as shown.

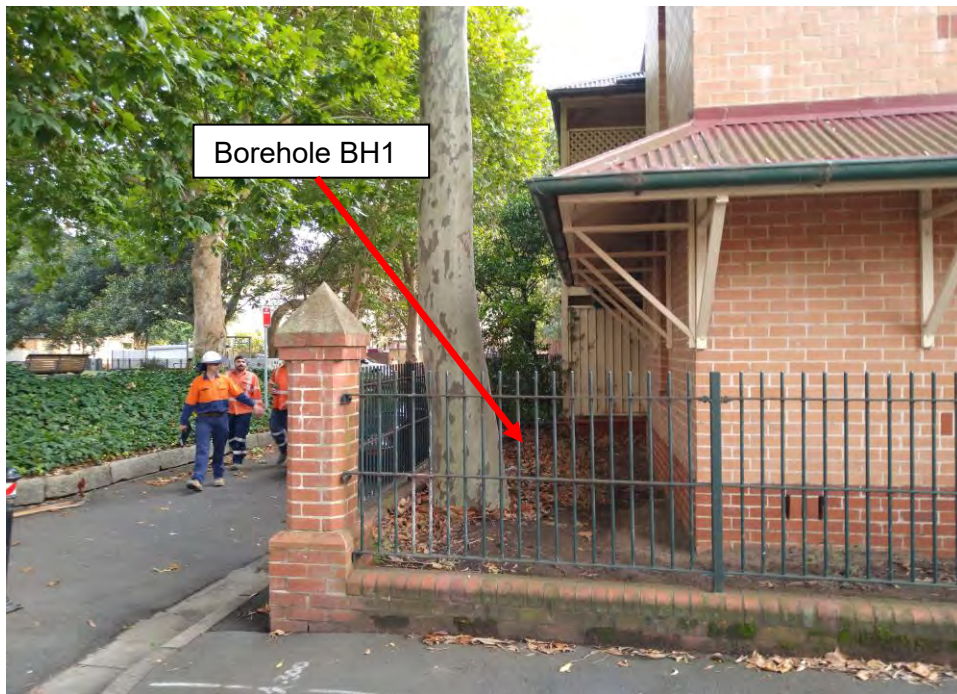
Photograph 2 – View north along Mitchell Lane. The approximate position of Borehole BH1 is indicated as shown.

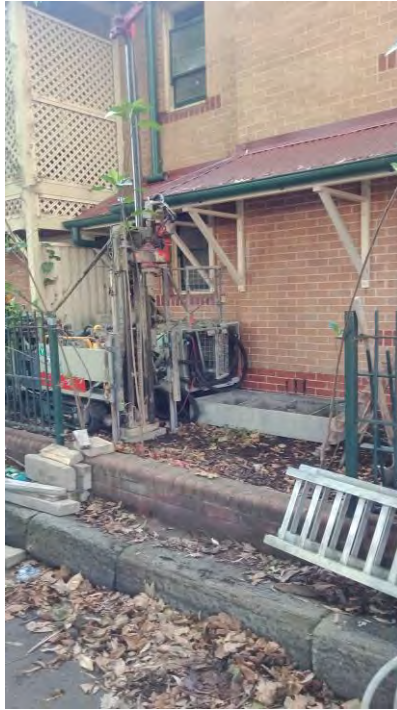
Photograph 3 – View north-east at the location of Borehole BH1.

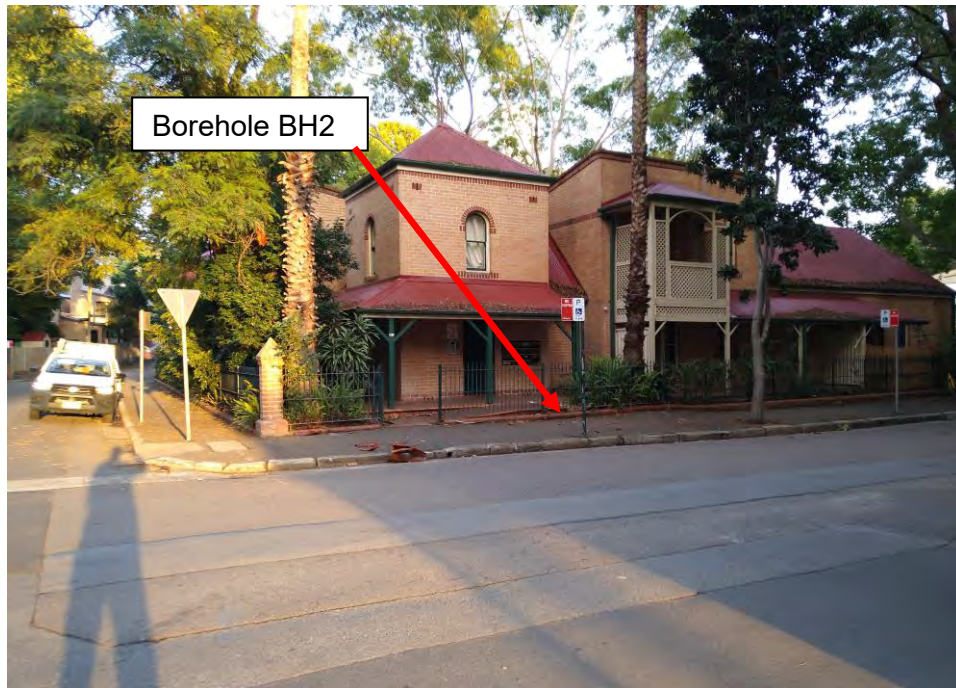
Photograph 4 – View west across Cowper Street. The approximate position of Borehole BH2 is indicated as shown.

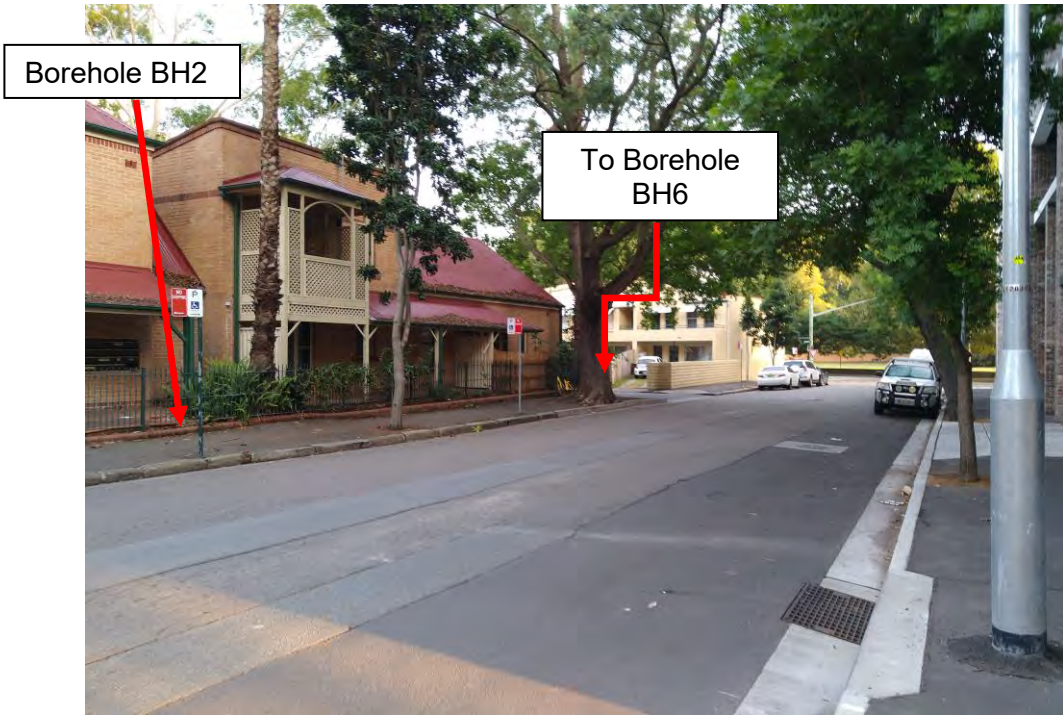
Photograph 5 – View north-west across Cowper Street. The approximate position of Boreholes BH2 and BH6 are indicated as shown.

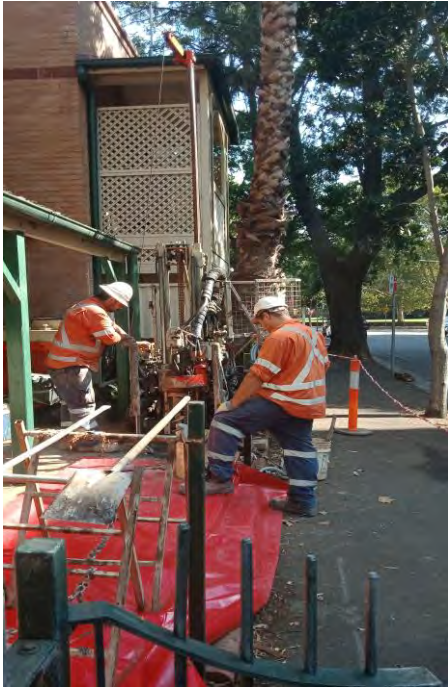
Photograph 6 – View north along Cowper Street at Borehole BH2.

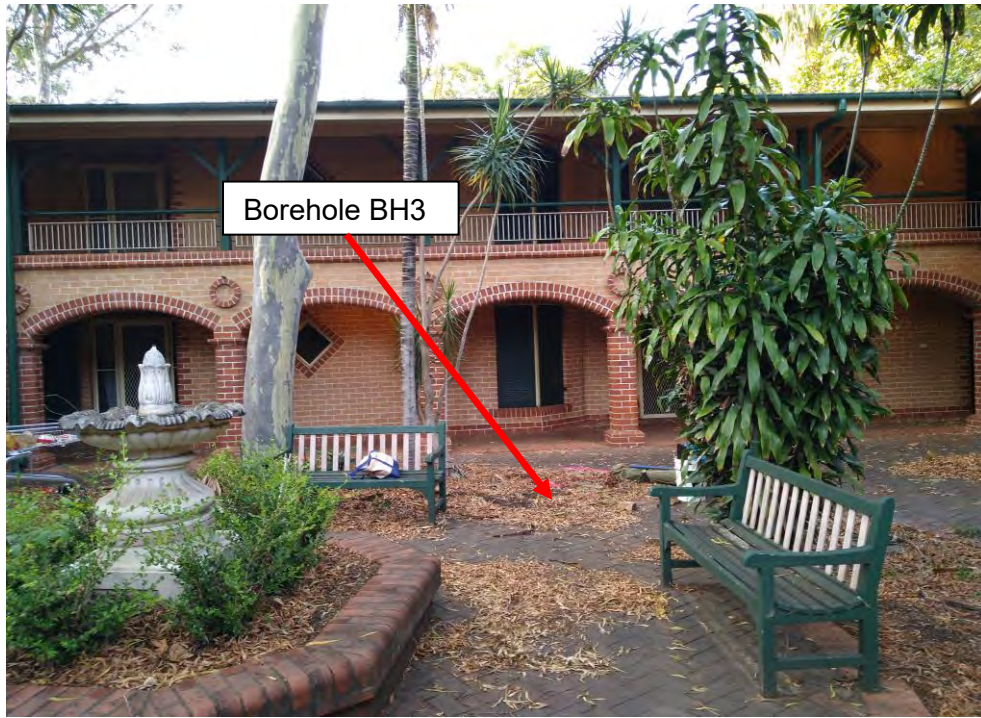
Photograph 7 – View south within the 31 Cowper Street property. The position of Borehole BH3 is indicated as shown.

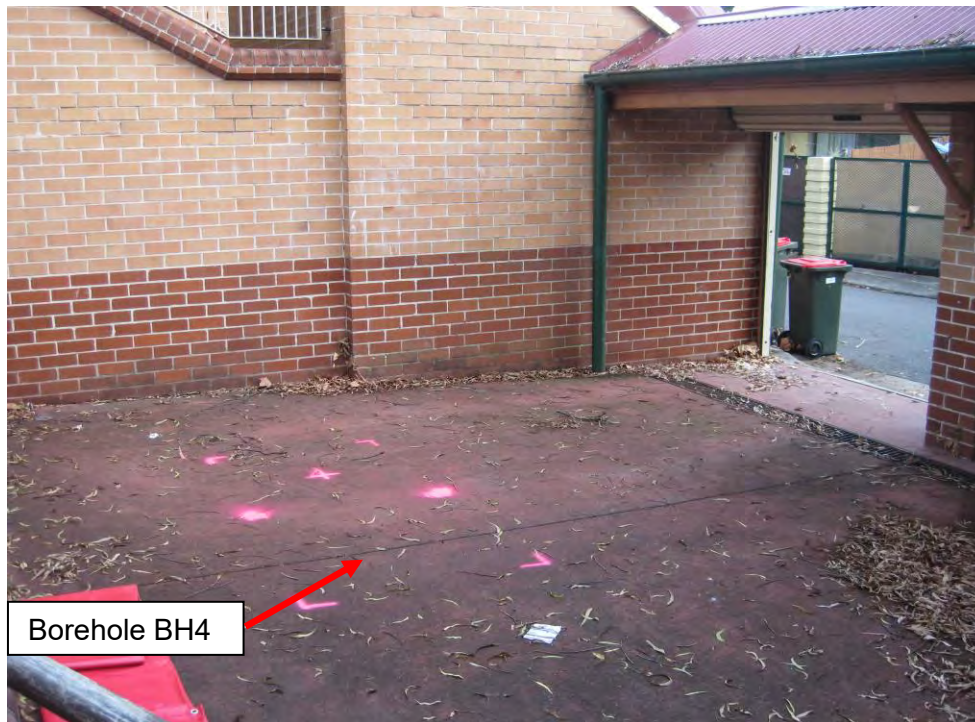
Photograph 9 – View west within the 31 Cowper Street property, with Park Lane in the background. The approximate position of Borehole BH4 is indicated as shown.

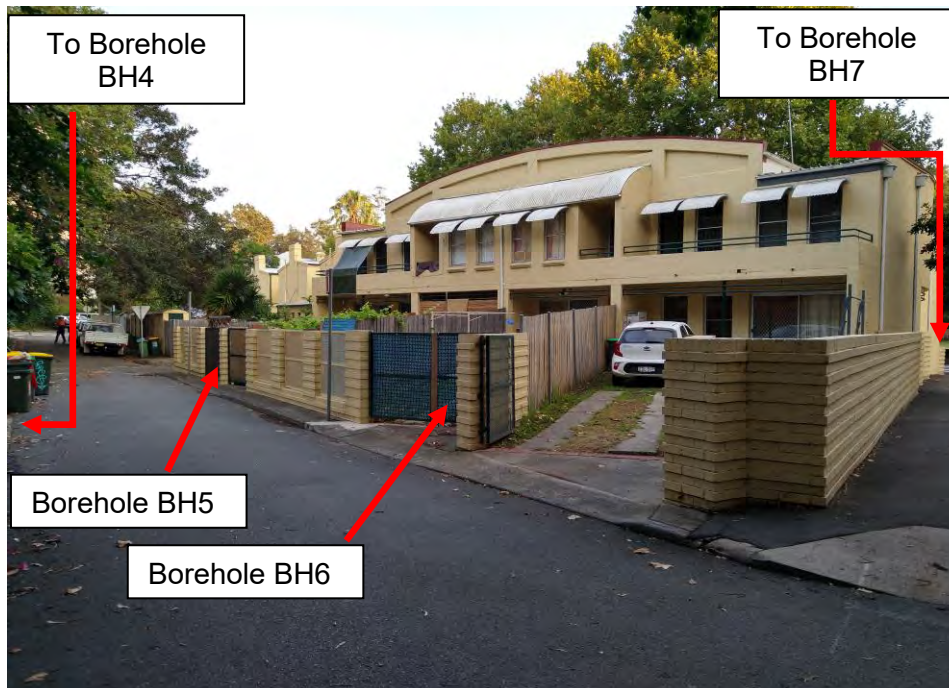
Photograph 10 – View west along Park Lane. The approximate positions of Boreholes BH4 to BH7 are indicated as shown.

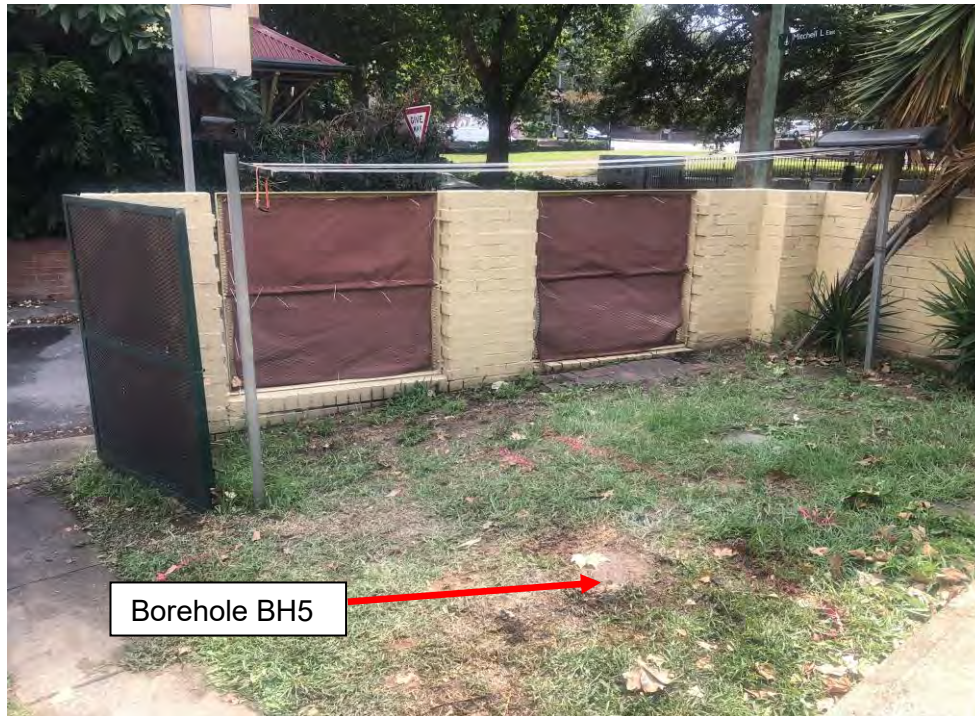
Photograph 11 – View south within the rear of the 2D Wentworth Park Road property, with Park Lane in the background. The approximate position of Borehole BH5 is indicated as shown.

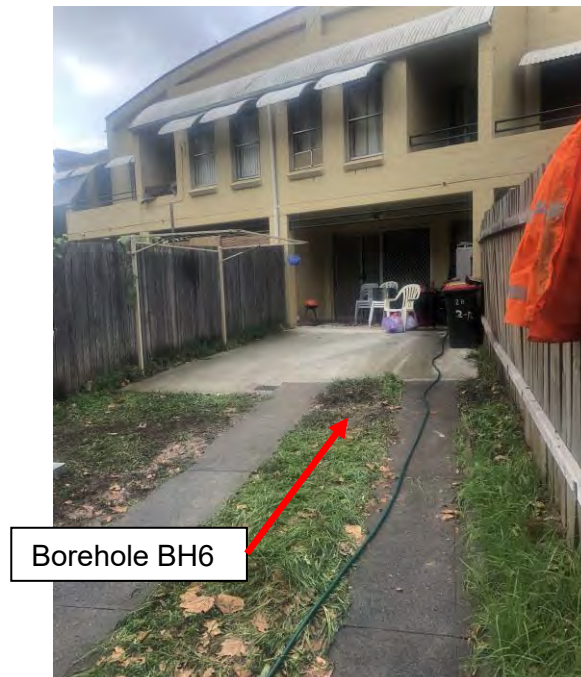
Photograph 12 – View north within the rear of the 2B Wentworth Park Road property. The approximate position of Borehole BH6 is indicated as shown.

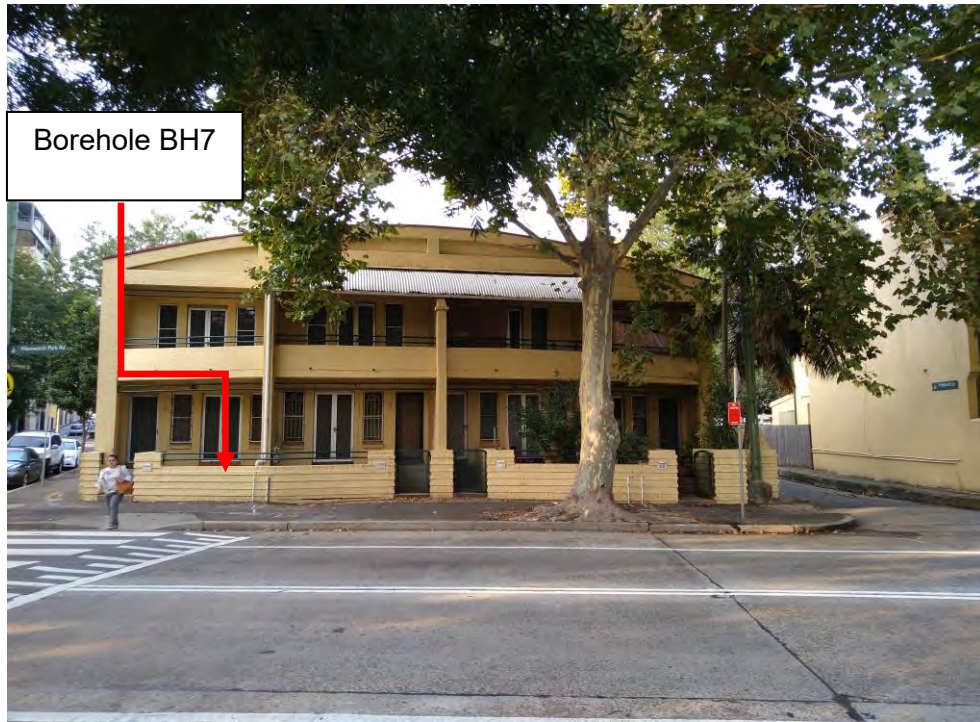
Photograph 13 – View south across Wentworth Park Road towards the position of Borehole BH7, which is indicated as shown.

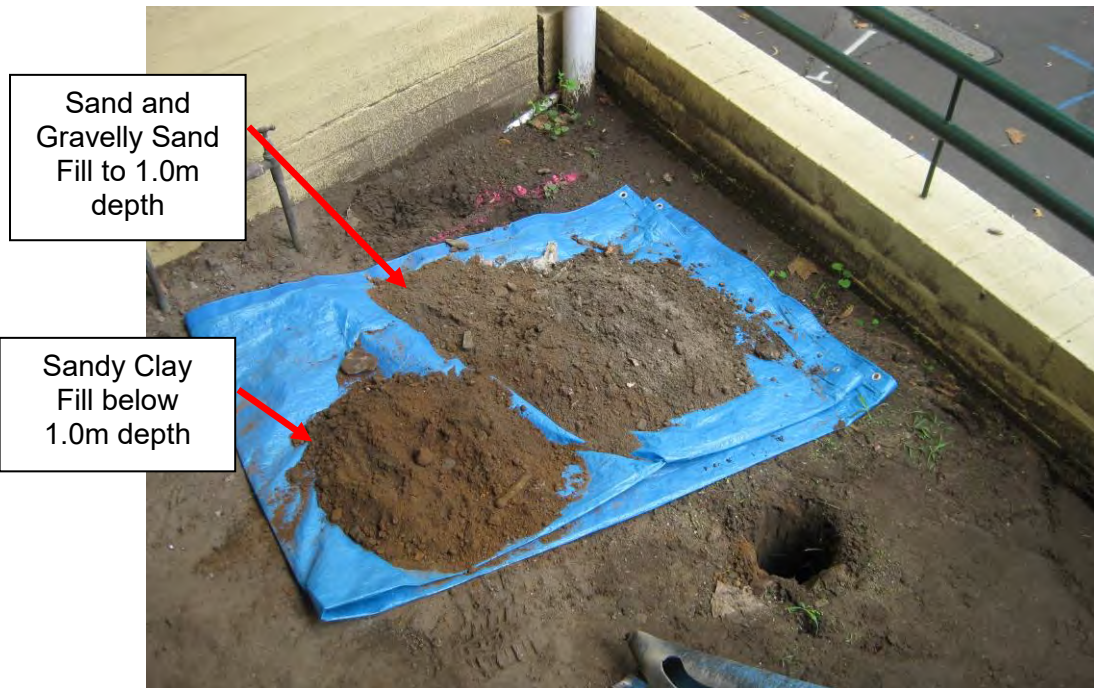
Photograph 14 – View of drilling spoil obtained from Borehole BH7.
